Re: Consent Decree Case No. 2:05-cv-00199-WOB

Nine Minimum Controls Annual Compliance Report

Sanitation District No. 1
May 11, 2009

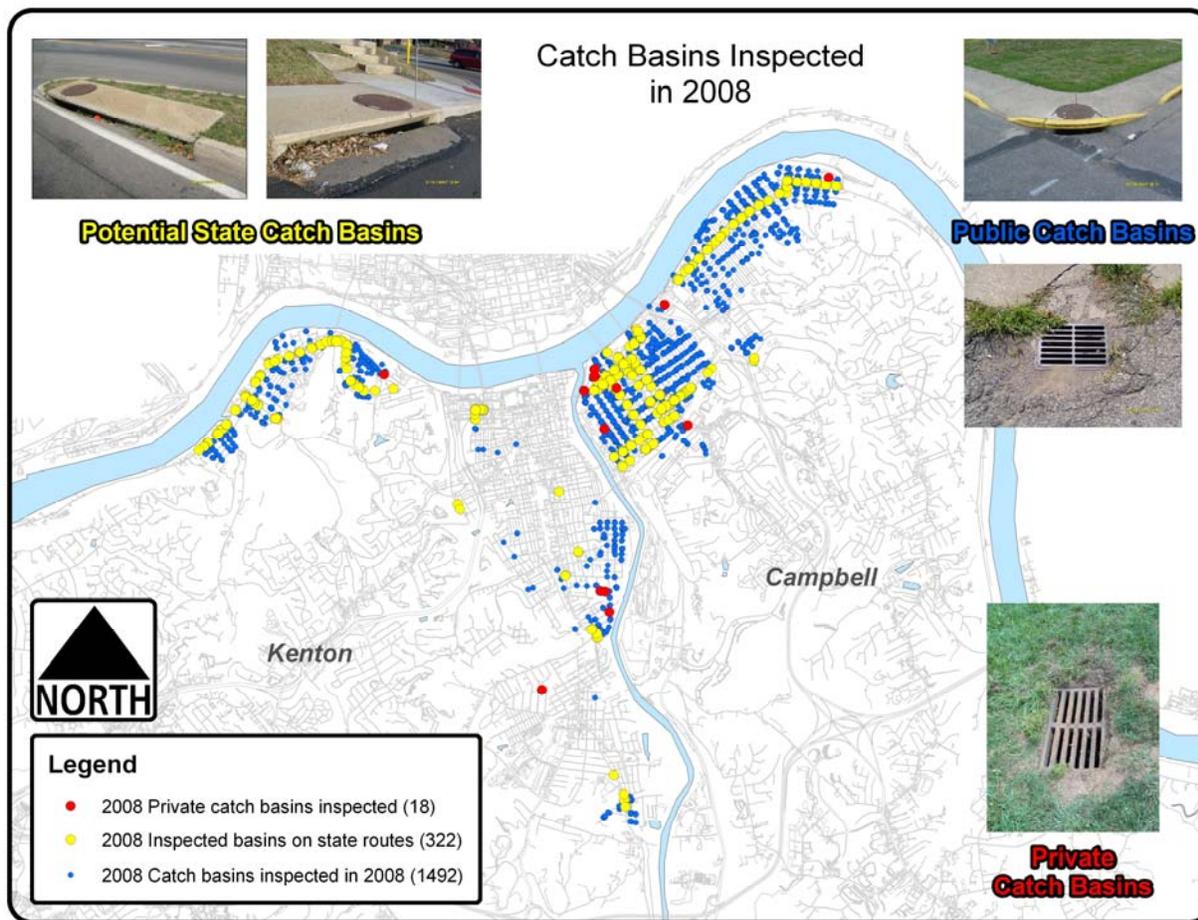
Figure 3.1 2008 Catch Basin Inspections Map

Because these additional catch basins influence the effectiveness of SD1's measures to keep S&F from entering the CSS, the location, condition, and debris levels of these additional catch basins needed to be determined. Therefore, SD1 began identifying, mapping and inspecting the additional catch basins identified along with the catch basins owned by SD1. The catch basin inspections were organized by drainage area and the additional catch basins were inspected along with SD1 owned basins. Data, condition, and amount of debris were recorded for each inspected catch basin. The map in Figure 3.1 illustrates SD1's inspection progress throughout 2008.

From January 1, 2008 to December 31, 2008 SD1 inspected 340 catch basins owned by others and 1,492 of the 3,302 catch basins owned by SD1 (SD1 actually conducted 1,717 inspections on its own catch basins but some were inspected multiple times throughout the year due to the frequency of cleaning). Although this modified inspection program has slowed the progress of inspecting all SD1-owned catch basins on a yearly basis, the data being collected is providing a comprehensive understanding of all catch basins in the CSS. This data will allow SD1 to make informed decisions on its methods of capturing debris across the CSS before it enters the sewers. SD1 estimates that this inspection process will continue through 2010 in order to verify SD1's catch basin data and to identify and map the location of the additional catch basins owned by others. To ensure adequate and proper maintenance of SD1's catch basins throughout this process, additional personnel have been assigned to inspect all catch basins that were inspected in 2008, while one full-time person continues inspecting all remaining catch basins in the CSS not already inspected in 2008. This process will ensure that all SD1-owned catch basins are inspected on a yearly basis as well as continuing the inventorying and mapping of the additional catch basins identified. Once complete, SD1 will be able to better assess the frequency and need for inspections and cleaning of all the catch basins in the CSS.

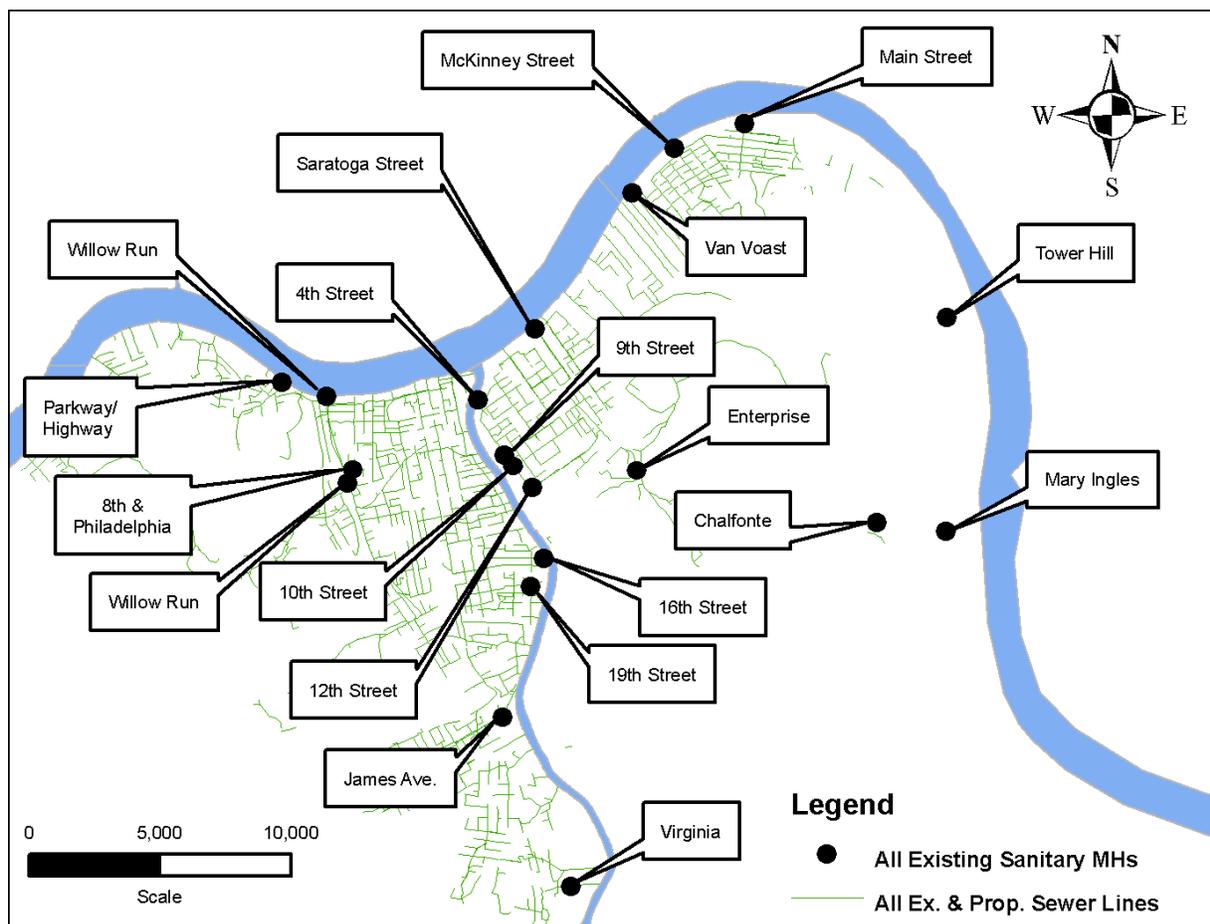
Figure 3.2 Locations Proposed for In-Line Storage

In a typical year, system-wide, the static controls are projected to lead to a 132 MG reduction in CSO volume. Additionally, SD1 will continue to evaluate in-line storage as opportunities through ongoing asset management activities and as opportunities to partner with developers arise.

Included in the 21 locations noted above, are the two in-line storage locations at the Main Street and McKinney Street diversions that were created as part of SD1’s efforts to identify opportunities for collection system upgrades in concert with new development. Efforts are currently underway to replace 8,000 ft of the existing 27-inch Ohio River Interceptor with approximately 6,600 linear feet of 84-inch and 1,300 linear feet of 110-inch diameter pipe to provide 2.2 million gallons (MG) of in-line storage. (See Section 2 for the current status of this project.)

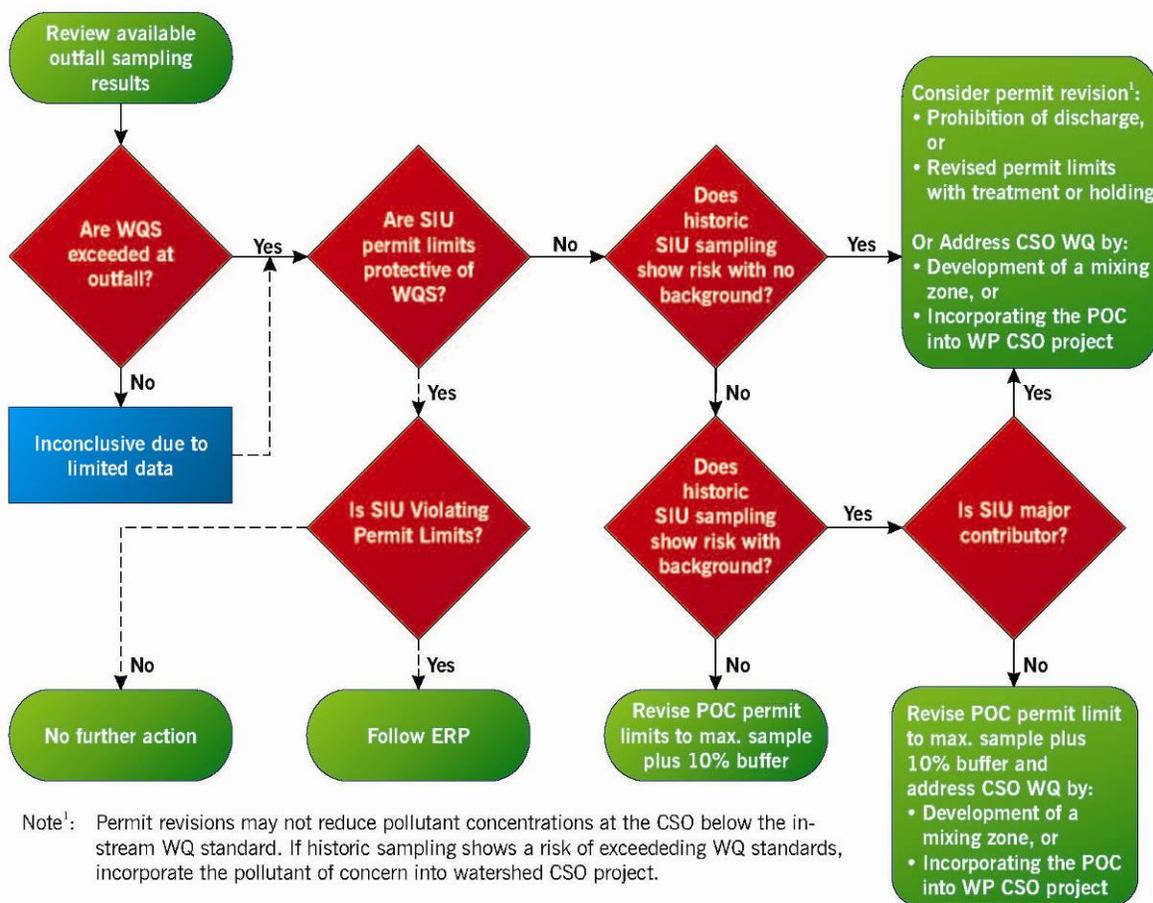
Figure 3.3 Analysis Process to Determine Potential for Water Quality Impacts Due to SIUs in the CSS

originally used for this purpose as well as the outfall sampling that was completed as part of the synoptic sampling (see Section 3.9.1). The data showed that there were high levels of some pollutants in the CSOs. Further analysis was then conducted to determine if the SIU permit limits are protective of water quality. A flow chart outlining this analysis process is shown in Figure 3.3.

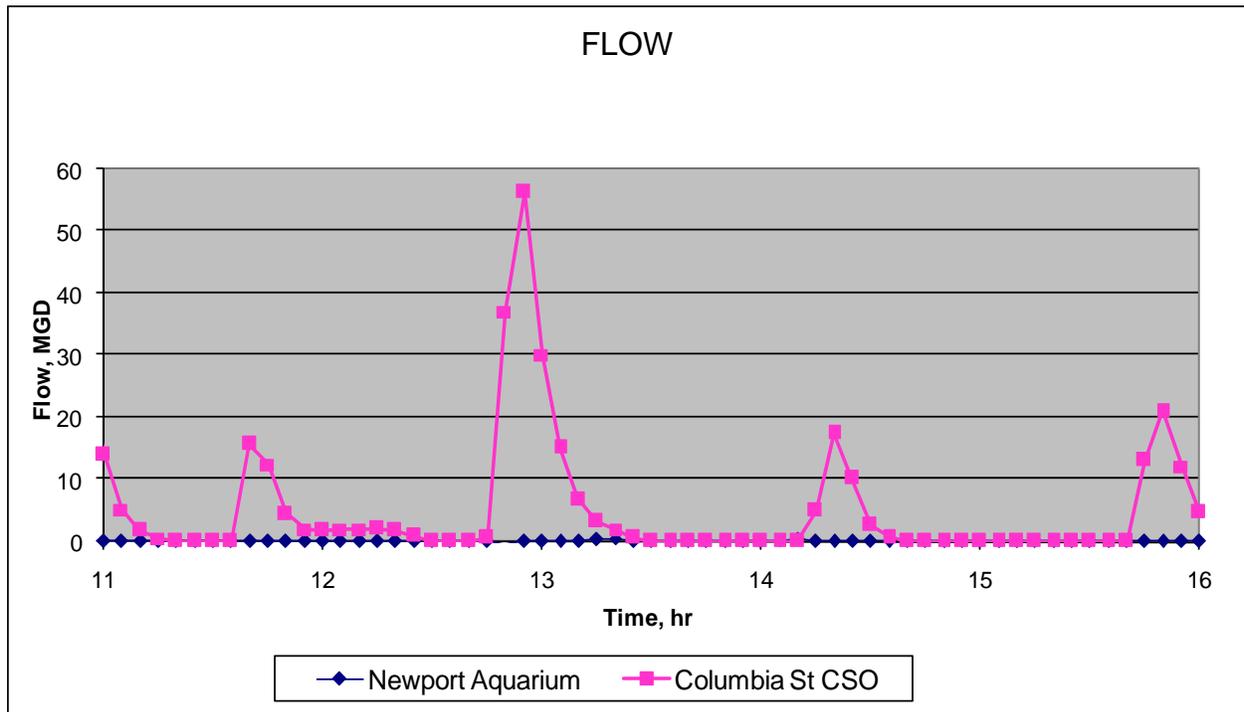
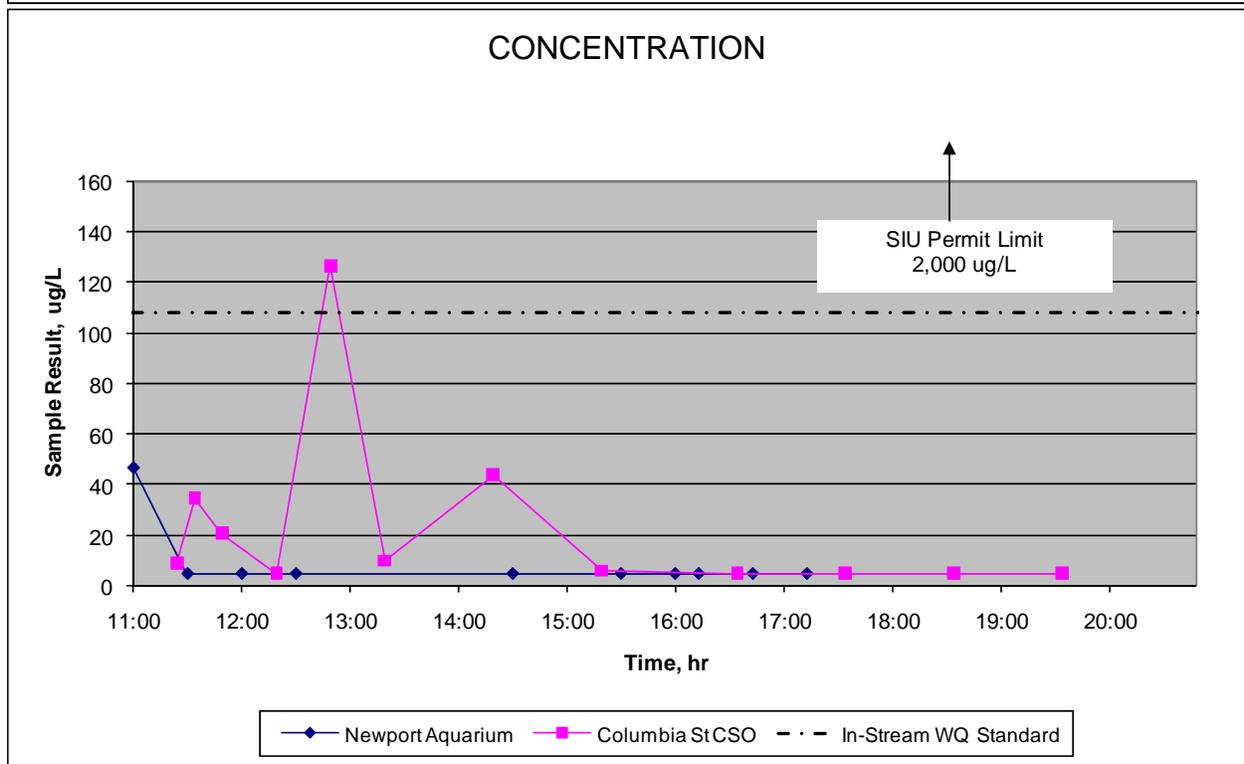
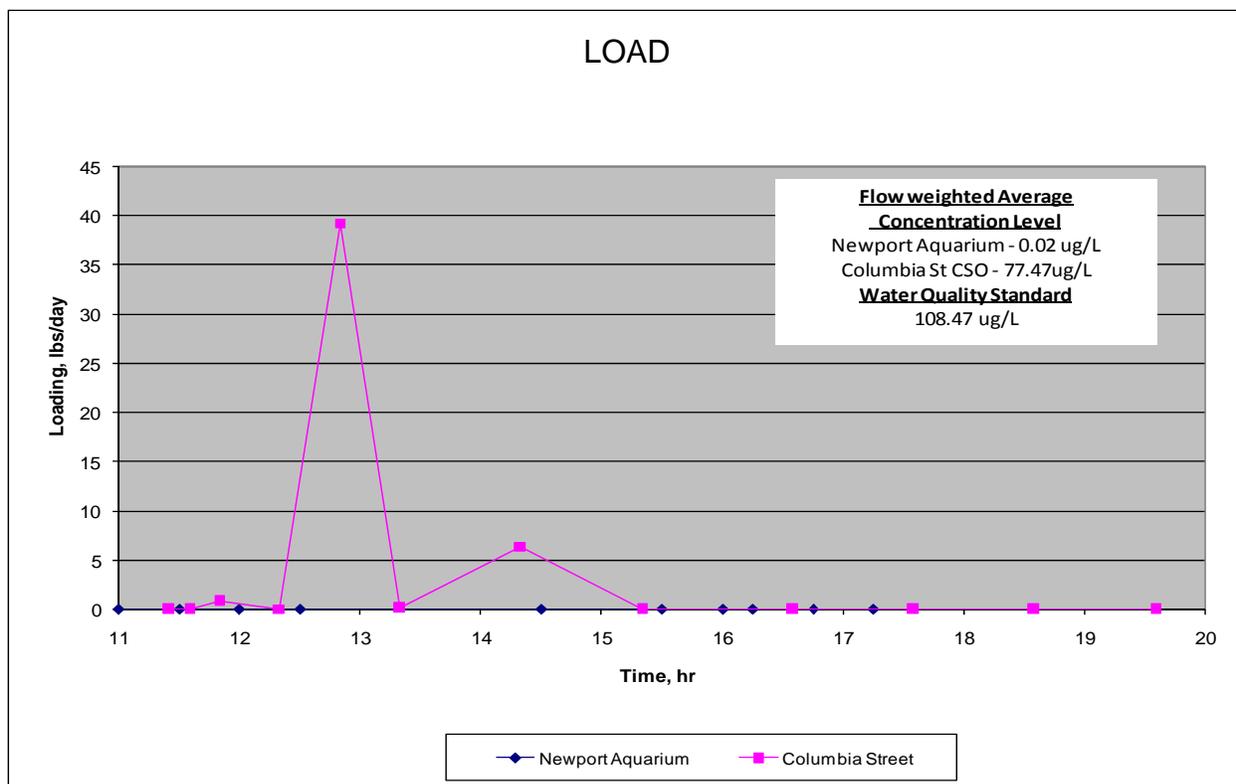
Figure 3.4 Newport Aquarium and Columbia Street CSO Flow, Lead Concentration and Lead Load Graphs for Event 7 (6/3/2008)

Monitored flows, and sampled pollutant concentrations collected as part of the synoptic sampling program were utilized to develop pollutant loads from the industry and at the outfall. Figure 3.4 shows graphs prepared for Newport Aquarium and the Columbia Street CSO for lead during synoptic sampling event number seven. In this example, the flow graph shows that flow from the CSO is much greater than the discharge from Newport Aquarium. The concentration graph shows that the concentration of lead in the SIU discharge is above 40 micrograms per liter before the CSO event starts, but drops to less than 10 micrograms per liter for the duration of the event. Because of the combination of lower flow and concentration, the load graph shows that the load from the SIU is much less than the load at the outfall. Additionally, even during a CSO event, only a portion of the flow from the industry is discharged with the CSO.

The remainder is diverted to the interceptor and conveyed to the treatment plant for additional treatment. Similar evaluations were completed for each industry where synoptic sampling results showed the concentration of a particular pollutant in the CSO was above the in-stream water quality standards. In every case, it was found that the SIU was not a significant contributor to the concentration of a particular pollutant at the outfall.

This analysis resulted in recommendations for particular SIUs and pollutants that are currently being implemented. As described above, the permit for the Northern Kentucky Water District was amended during 2008 so that there will be no wet weather discharges to the CSS unless permission is granted, under extreme conditions, by SD1. Individual pollutant permit limits have been evaluated for each of the remaining three SIUs, and where necessary, permit limits may be revised to minimize the potential for these SIUs to contribute to CSO impacts. Additional measures to address high levels of some pollutants in the CSOs are now being evaluated as part of SD1’s Watershed Planning process.

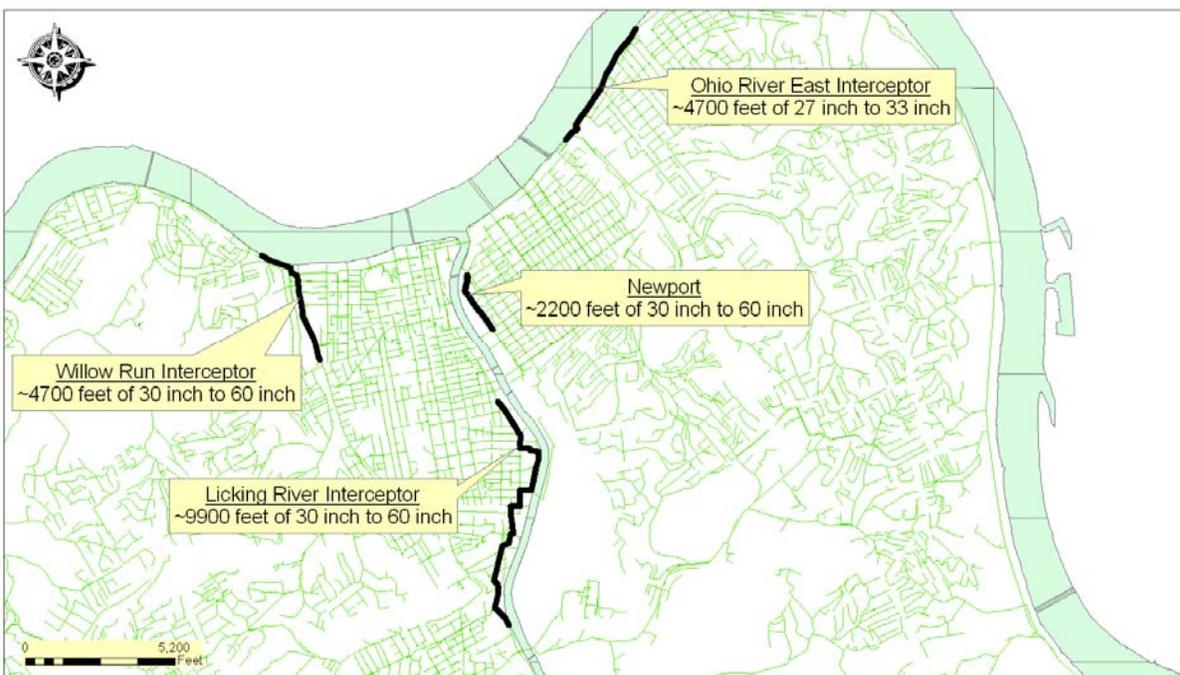
Figure 3.5 Targeted Sewer Cleaning Program Vicinity Map

In September 2007, SD1 conducted an evaluation and assessment of its interceptor sewers using an integrated closed circuit television and Sonar inspection. The results of this investigation found that large amounts of grit, rock and debris were significantly reducing the capacity and proper operation of the Willow Run, Ohio River East, Licking River, and Newport interceptors. In an effort to re-gain the capacity and reduce CSOs, these interceptors were selected for cleaning as part of SD1's Targeted Sewer Cleaning Program, as shown on the map in Figure 3.5.

In July 2008, SD1 awarded a contract to Doetsch Industrial Services to clean and televise approximately 21,500 linear feet of pipe in these specified areas and to gather defect data to be used for post cleaning rehabilitation analysis and planning.

Work began in September 2008 and continued until inclement weather conditions and elevated river levels occurred in December. Continued work is scheduled to commence once weather conditions improve and is anticipated to begin again in early summer of 2009. Included in Appendix E is a collection of photos that highlight the following progress made through December of 2008:

- Willow Run interceptor
 - 308 tons of debris removed
 - 4,000 feet cleaned and inspected
- Licking River interceptor
 - 452 tons of debris removed
 - 7,792 feet cleaned
 - 5,480 feet inspected
- Newport interceptor
 - Began removing heavy material by hand from the 66" pipes

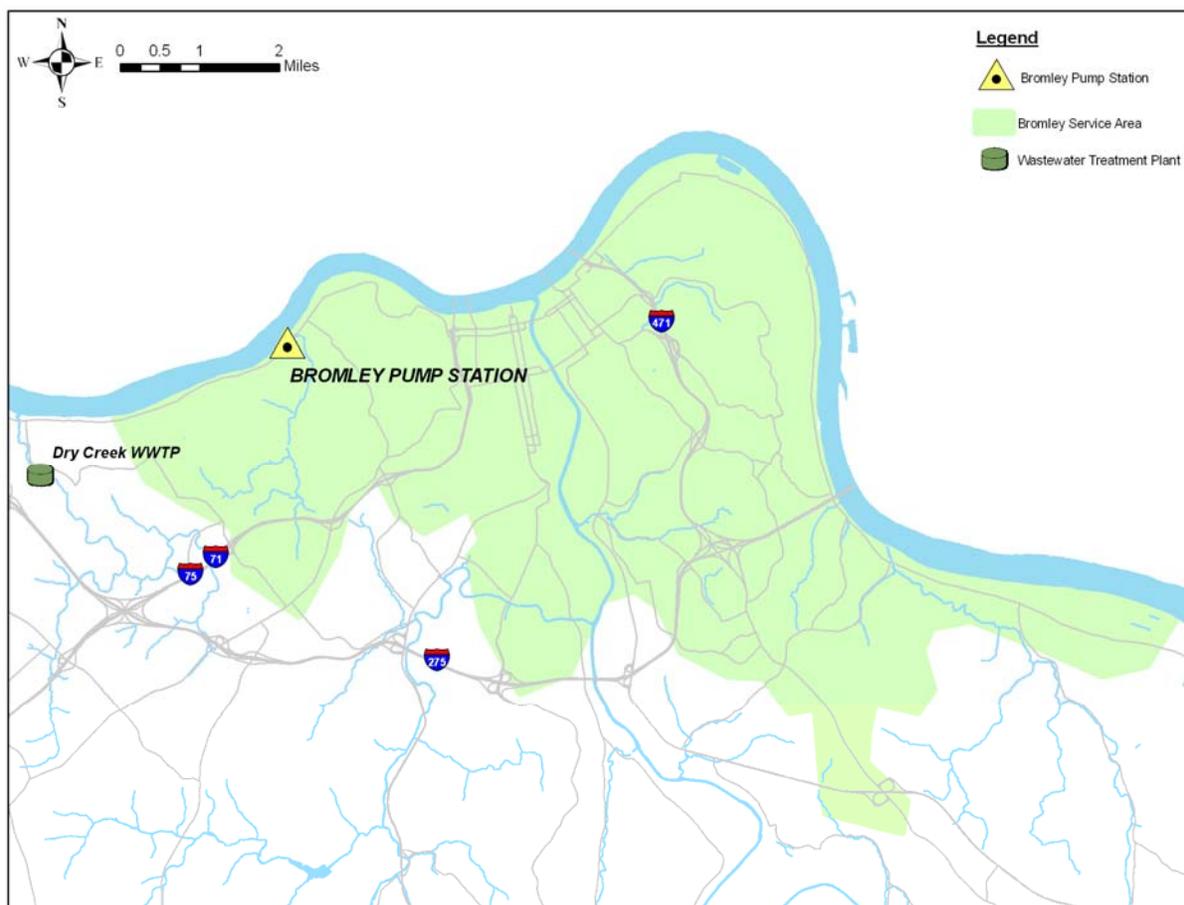
Figure 3.6 Bromley Pump Station Service Area

The Bromley Pump Station is the largest pump station that SD1 operates and conveys all flows tributary to the CSS directly to the Dry Creek Waste Water Treatment Plant. Figure 3.6 shows the outline of the area serviced by the Bromley Pump Station.

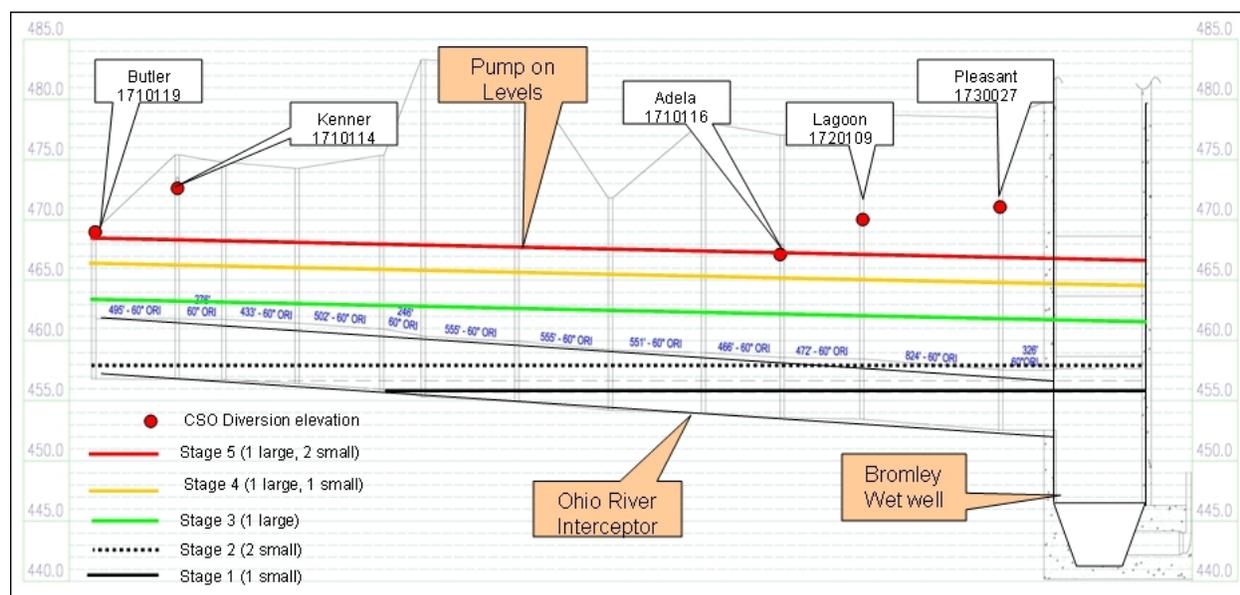
Figure 3.7 Bromley Pump Station Wet Well Settings

With the current wet well settings at Bromley pump station, the hydraulic grade line in the upstream interceptor is above the crown of the pipe before the first small pump turns on. Additionally, the wet well level required to operate one large pump is higher than several upstream diversions. During higher wet weather flows the hydraulic gradeline backs up in the interceptor and causes overflows to occur due to backflow through the CSO diversions. Figure 3.7 shows the relationship between the wet well settings for pump operation, the interceptor, and the upstream diversion elevations. The Figure shows that the CSOs are already overflowing from the interceptor before the remaining pumps turn on at the Bromley Pump Station.

These current wet well settings were developed to reduce the potential for excessive vibration and cavitation in the pumps. This occurs because these pumps require a significant amount of “suction head”. Suction head occurs on the suction side of a pump, where the pump action creates a low pressure zone. In some cases, the pressure can drop low enough that the vapor pressure of the fluid can be reached at the ambient temperature, thus resulting in boiling (bubble formation) of the fluid. Boiling in turn leads to reduced efficiency of the pumps and can cause pump cavitation and damage.

An evaluation was then conducted to assess the potential benefit and feasibility of lowering the settings to pump more flow at lower water levels. The evaluation included assessments of:

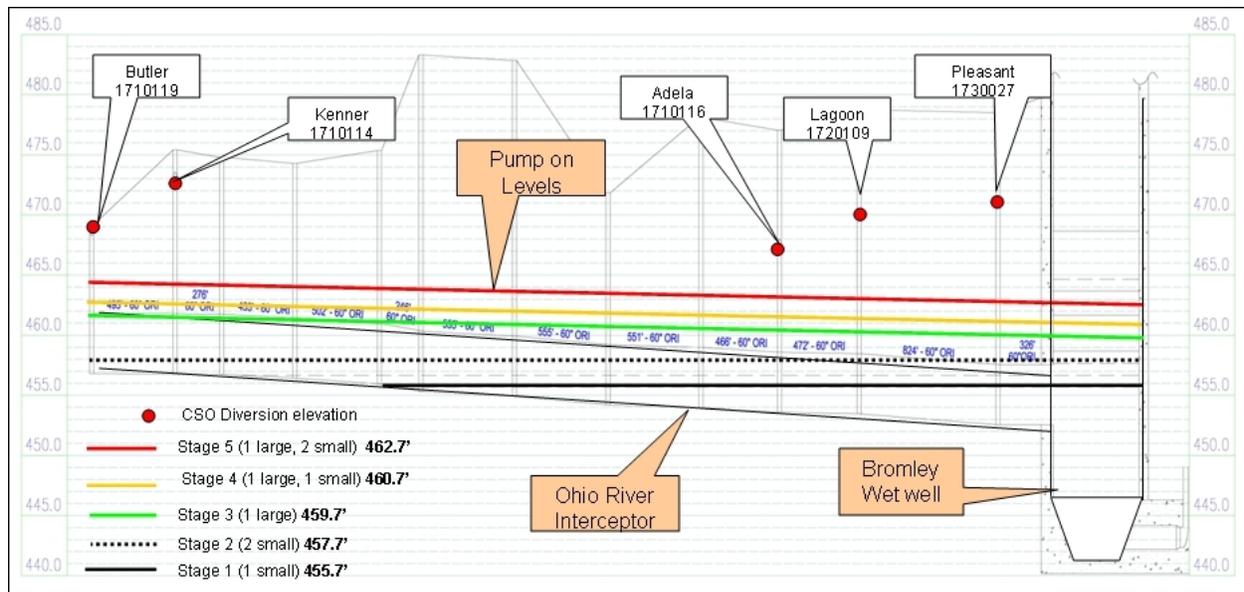
Figure 3.8 New “On” Settings for the Bromley Pump Station

- Potential cavitation due to Net Positive Suction Head or NPSH
- Potential for inlet vortexing
- Bar screen limitations
- Cycling issues

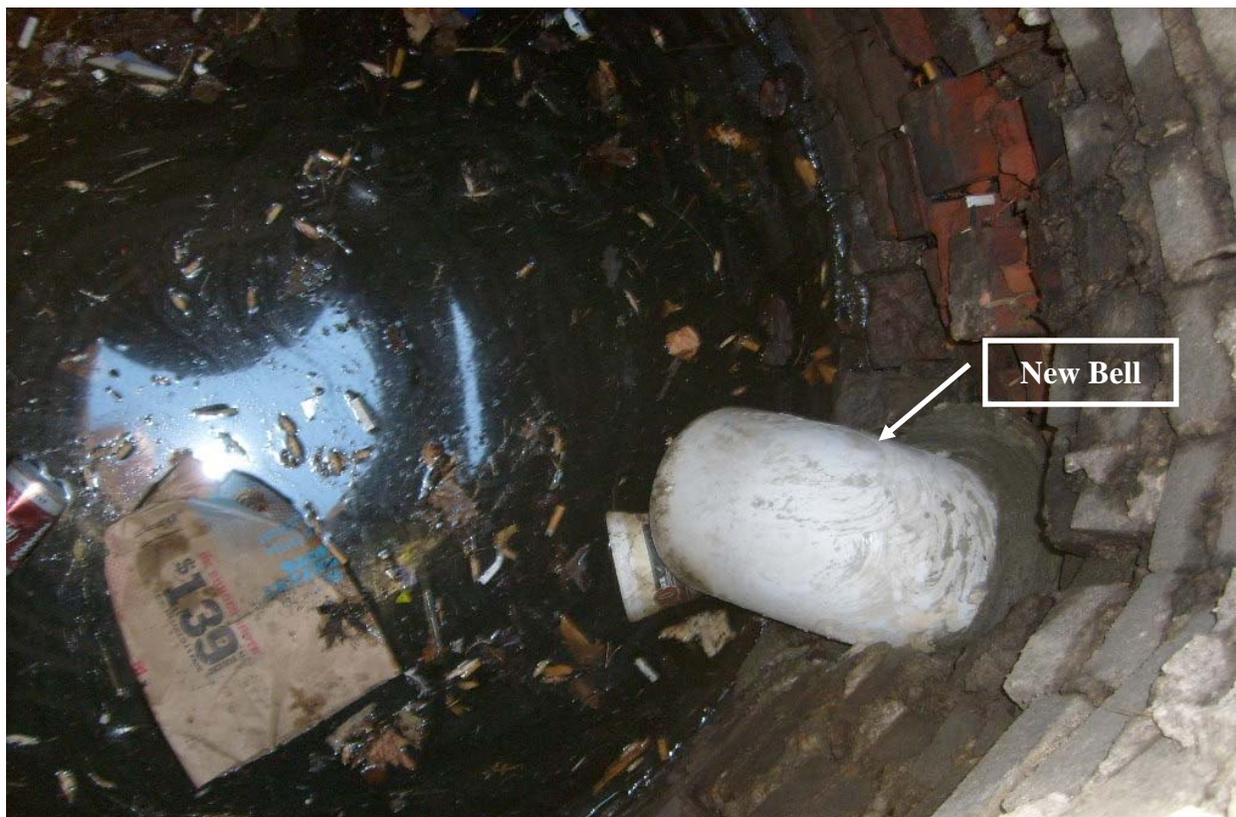
Figure 3.10 Example of a Retrofitted Catch Basin with Bell to Trap S&F

SD1 began retrofitting catch basins with bells and grated inlets as a method of reducing the amount of S&F entering the CSS. Catch basin rehabilitation and replacement work, including these modifications, are currently being scheduled based on established priority areas upstream of recurring DWOs. Crews focus on completing the projects in the highest priority area before moving onto projects in the next priority area. The following methodology is used to determine which modification is appropriate:

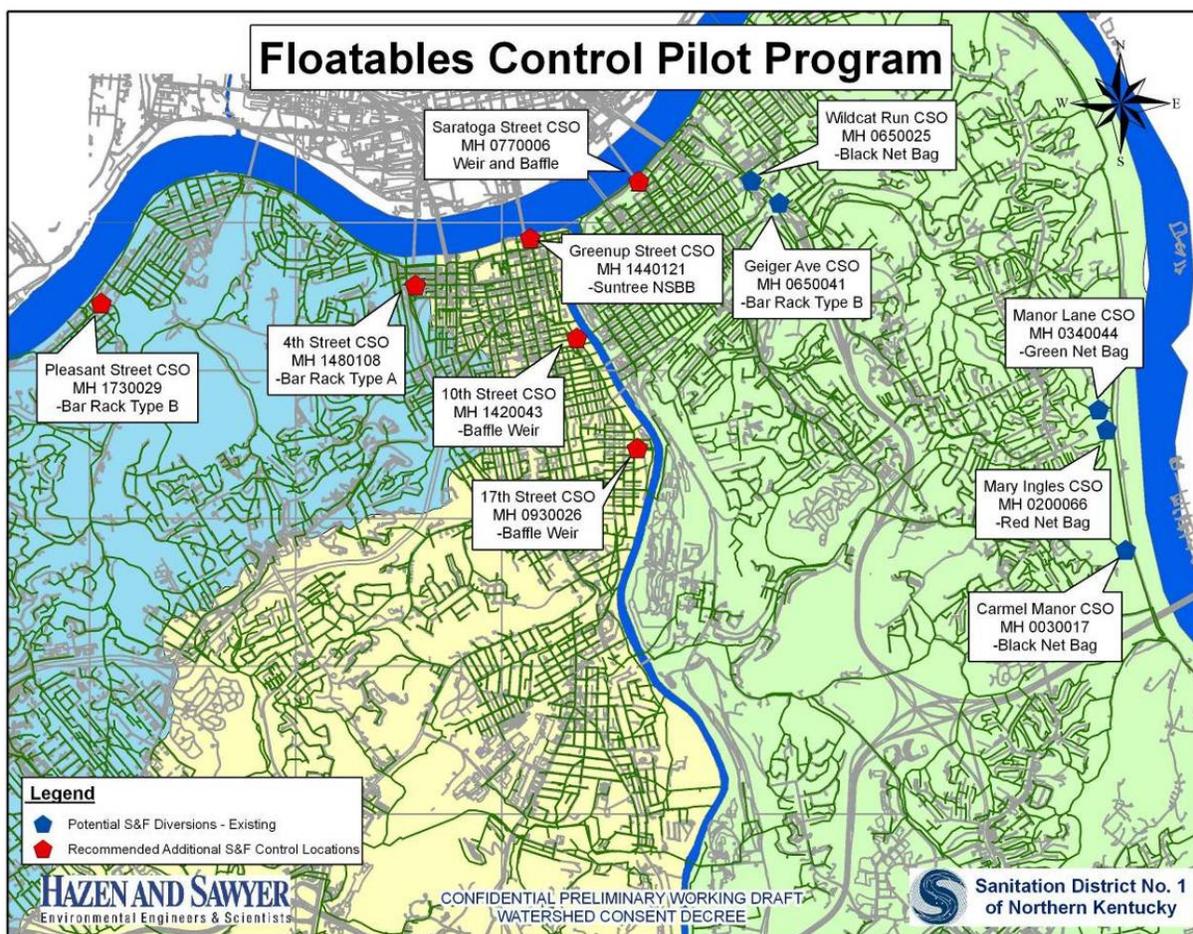
Figure 3.11 Pilot Simple S&F Control Locations

A key part of the NMC effort was the implementation of the pilot simple S&F program. The goal of the program was to assess the benefits and risks associated with implementing simple controls at diversions and outfalls to control the release of S&F through the outfall. An analysis was done to select the initial locations for the installation of various control technologies. These included weirs, baffles, and end of pipe netting. Figure 3.11 shows the locations of these pilot locations.

The types of simple S&F controls that were installed are discussed in SD1’s NMC Compliance Report. The pilot monitoring of the installed controls began in December 2007 and the installed controls were observed during 10 separate storm events through June 2008. Findings from the observations are described below for each technology. In addition, examples of the pilot program observations and the data collected are included in Appendix G.

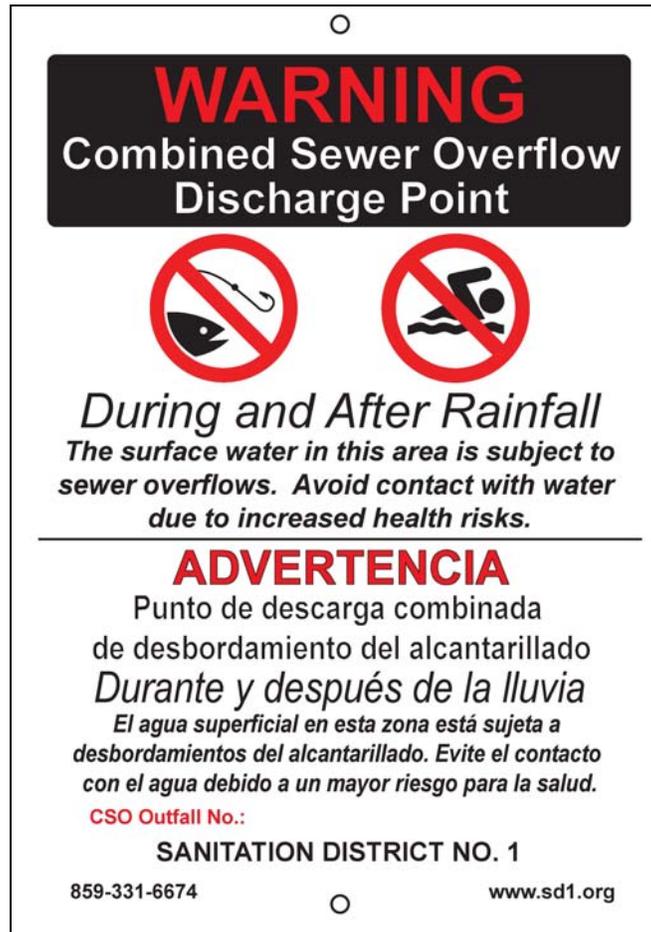
Figure 3.13 New CSO Warning Sign

SD1 has updated and replaced all warning signage posted near CSO outfalls (Figure 3.13), and has developed and installed new public education signs to put in locations near public access to water to warn about unsafe conditions during and after rainfall events (Figure 3.14). The new warning signs posted at the CSO outfalls are written in English and Spanish, provide improved graphics, and display SD1's web address. The new public education signs are designed to catch your attention, provide warning language, a history of CSOs in the area, discussion on solutions, and provide SD1's contact phone number and website. The map in Figure 3.15 indicates the locations throughout the service area where CSO signage is posted.

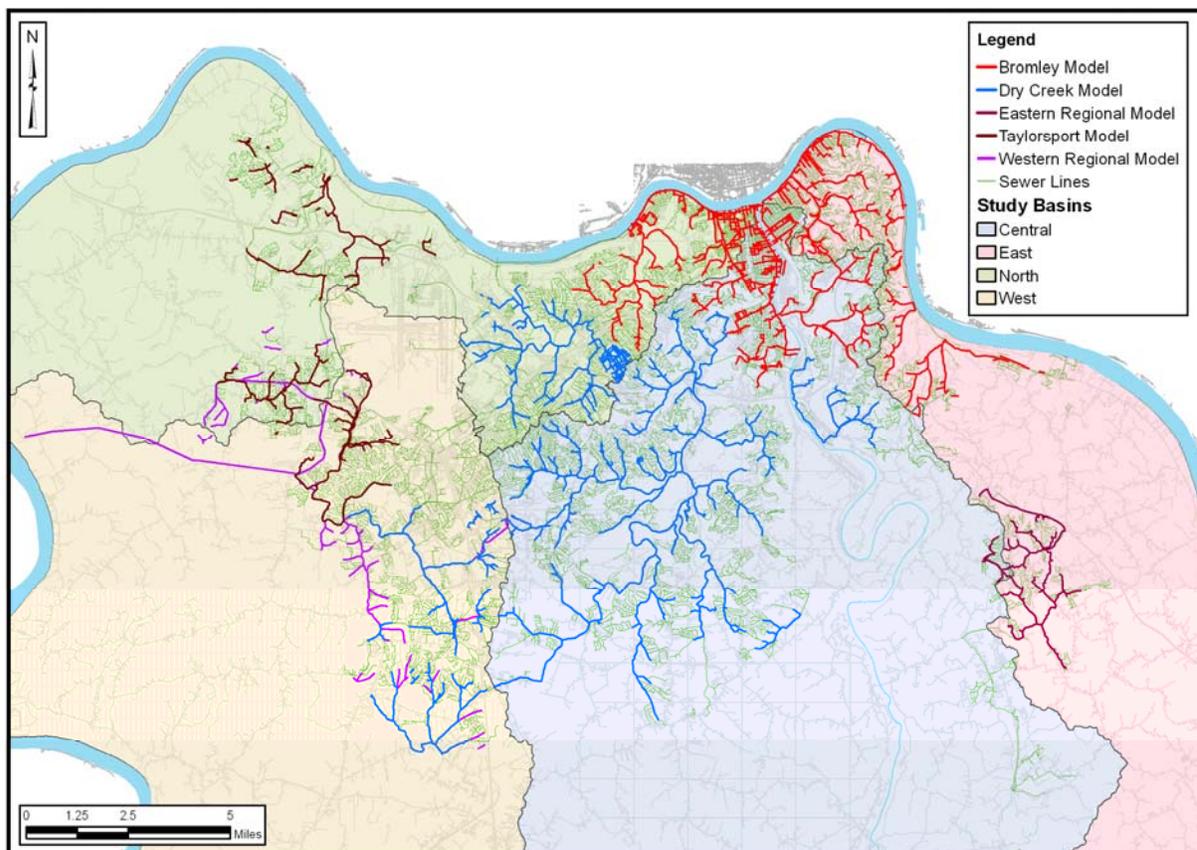
Figure 3.16 Extent and Location of SD1's Hydraulic Model

SD1 completed a year-long flow monitoring program in 2008, consisting of more than 245 flow meters and 45 rain gauges installed throughout the combined and separate sewer systems, that was utilized to update the calibration and validation of the system-wide hydraulic models. This calibration was undertaken to provide a model network that could confidently be used as a planning level tool in preparing SD1's Watershed Plans. In addition to the use of the models for planning future capital improvements, the models are also being used to provide information about the current performance of SD1's system. Based on the results of the model calibration and verification, SD1 has developed a highly calibrated and verified hydraulic model that provides an accurate representation of the sewer system. SD1 made these investments so that the models can be used to accurately understand how CSOs respond during rain events, when CSOs begin and end, and to calculate the frequencies and overflow volumes that occur. This tool allows SD1 to have confidence in the results of the overflow volumes from the sewer system and to provide estimates of the overflow locations within the system for reporting purposes. The models are intended to take the place of maintaining a system-wide, real-time alarm system to record when overflows begin and end. The same data can be accurately provided and understood through the calibrated models. Flow meters and rain gauges will be installed periodically as improvements and changes are made to the collection system to collect data that will be used to update the hydraulic models. This will ensure that the models remain an accurate tool for planning and reporting. This

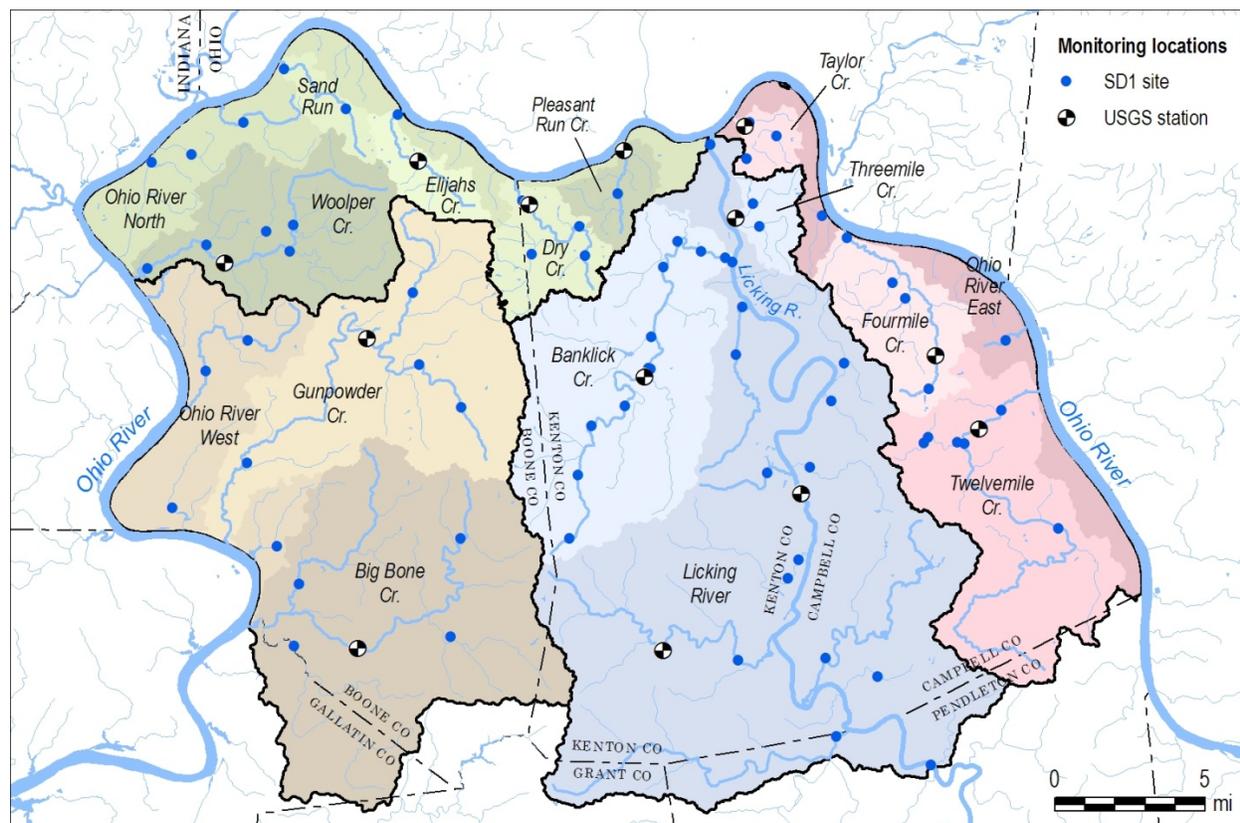
Figure 3.19 Monitoring Locations

SD1 intends to continue the monitoring program so that the resulting data can be used to identify trends in water quality and provide feedback on the effectiveness of pollutant controls and other actions to improve water quality.

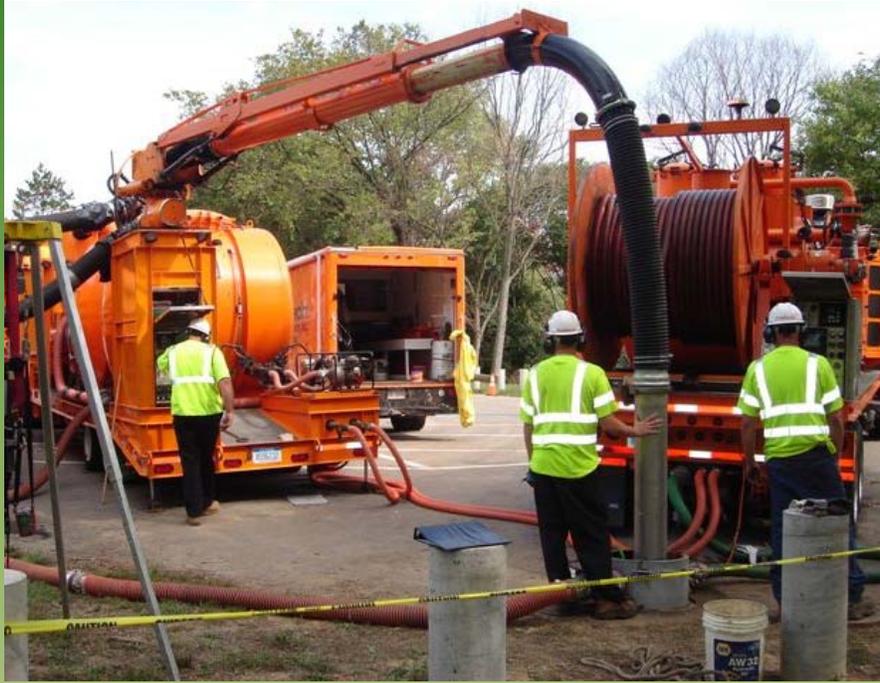
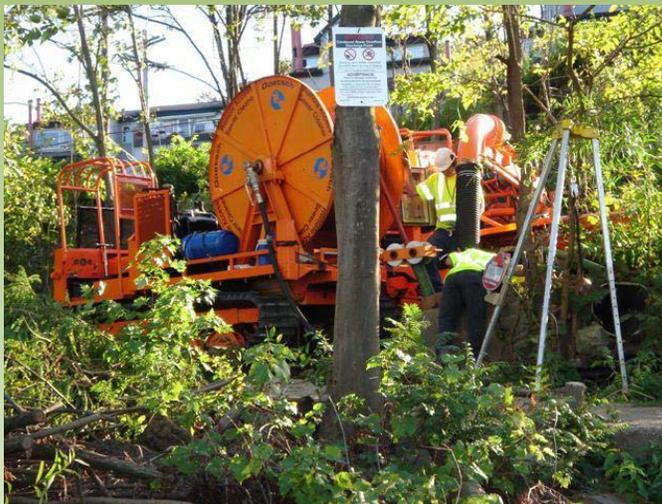
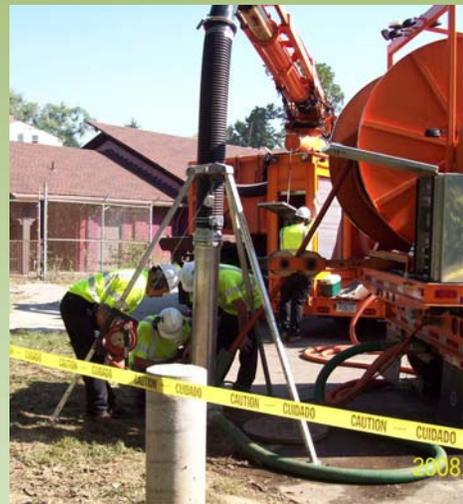
2008 Targeted Sewer Cleaning Program

Licking River Interceptor

452 Tons of Debris Removed
7,792 Feet Cleaned / 5, 480 Feet Inspected

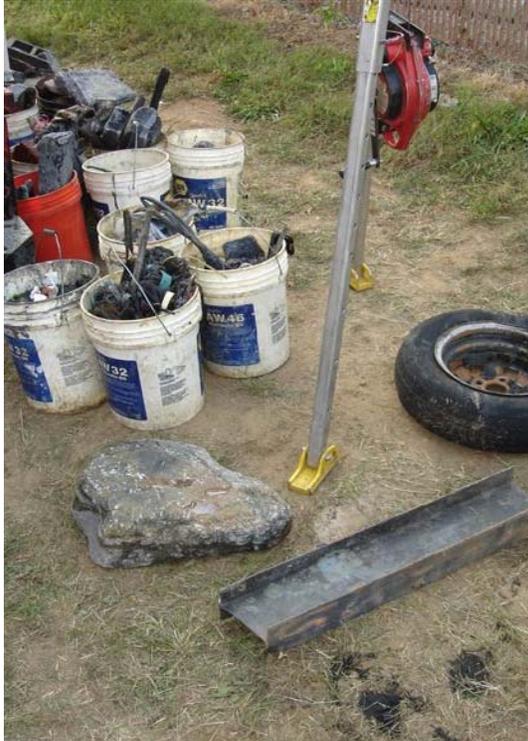
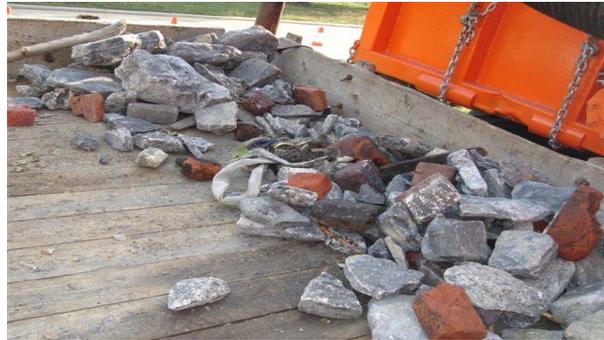
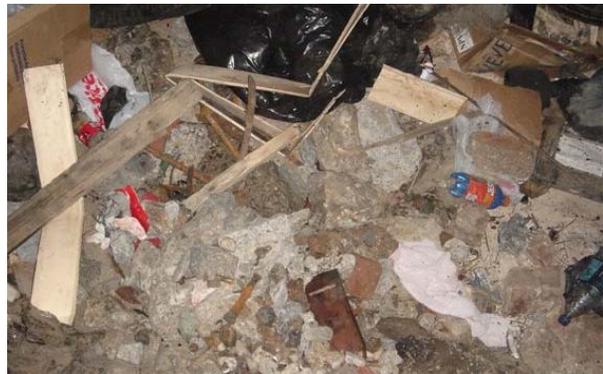
Willow Run Interceptor

308 Tons of Debris Removed
4,000 Feet of Line Cleaned and Inspected

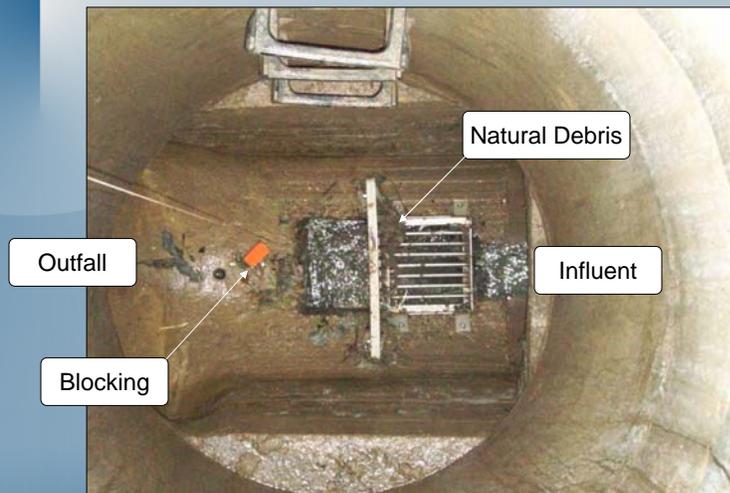
- Pleasant Street
- Bar rack type B
- June 3, 2008 rain event
 - Rainfall duration: 8.58 hrs
 - Event rainfall depth: 1.23 in
 - 15 min. depth return interval: 3 month
 - Total depth return interval: 6 month
 - Modeled overflow: 225,000 gallons

- Pleasant Street – Prior to Rain Event

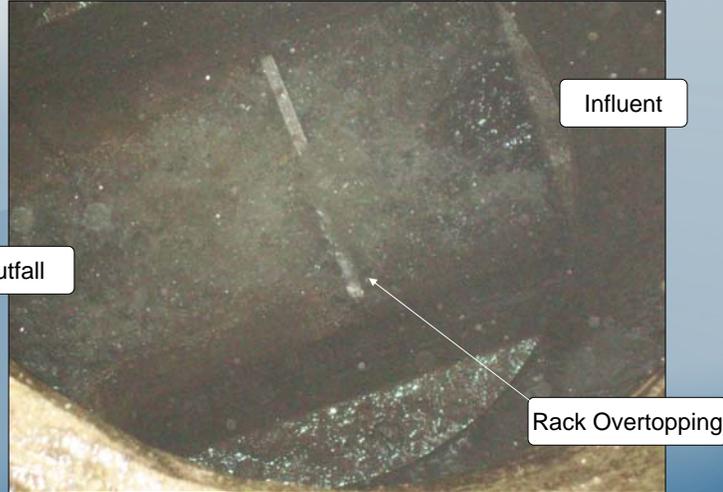
- Pleasant Street – During Rain Event

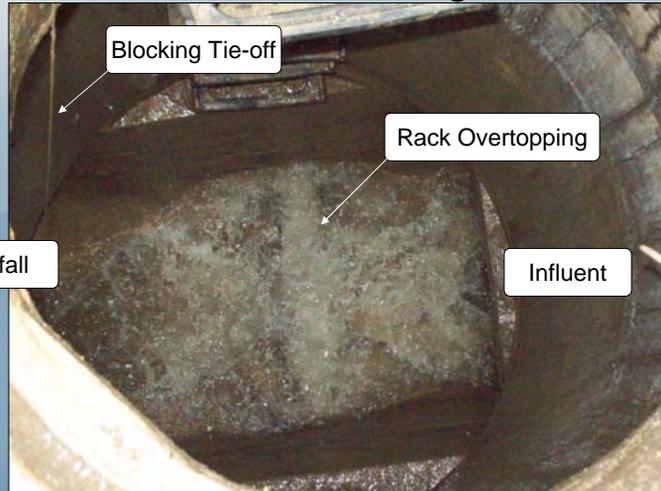
- Pleasant Street – During Rain Event

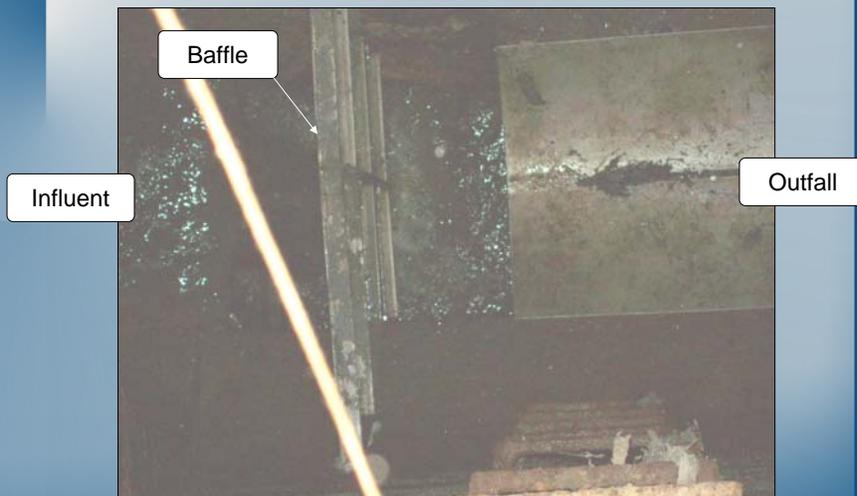
- 17th Street
- Baffle
- June 3, 2008 rain event
 - Rainfall duration: 8.58 hrs
 - Event rainfall depth: 1.69 in
 - 15 min. depth return interval: 3 month
 - Total depth return interval: 6 month
 - Modeled overflow: 68,000 gallons

- 17th Street – Before Rain Event

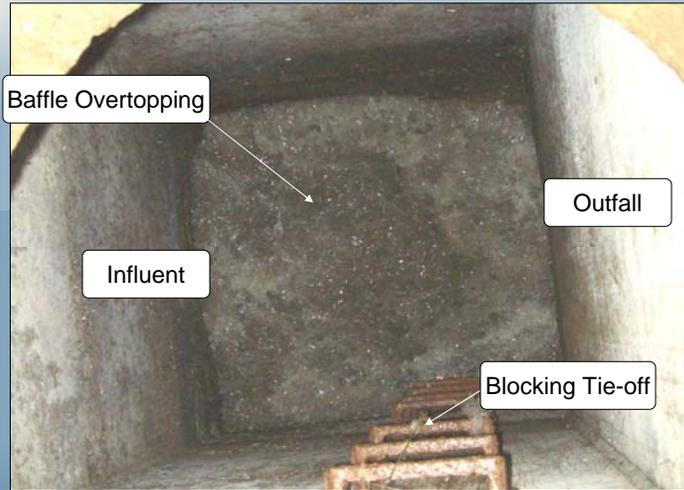
- 17th Street – During Rain Event

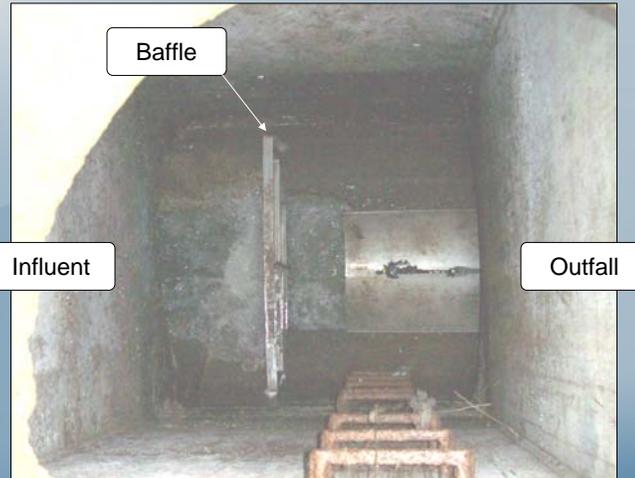
- 17th Street – After Rain Event
