Pleasant Run Creek Watershed Characterization Report

Prepared for: Sanitation District No. 1 of Northern Kentucky

January 2009

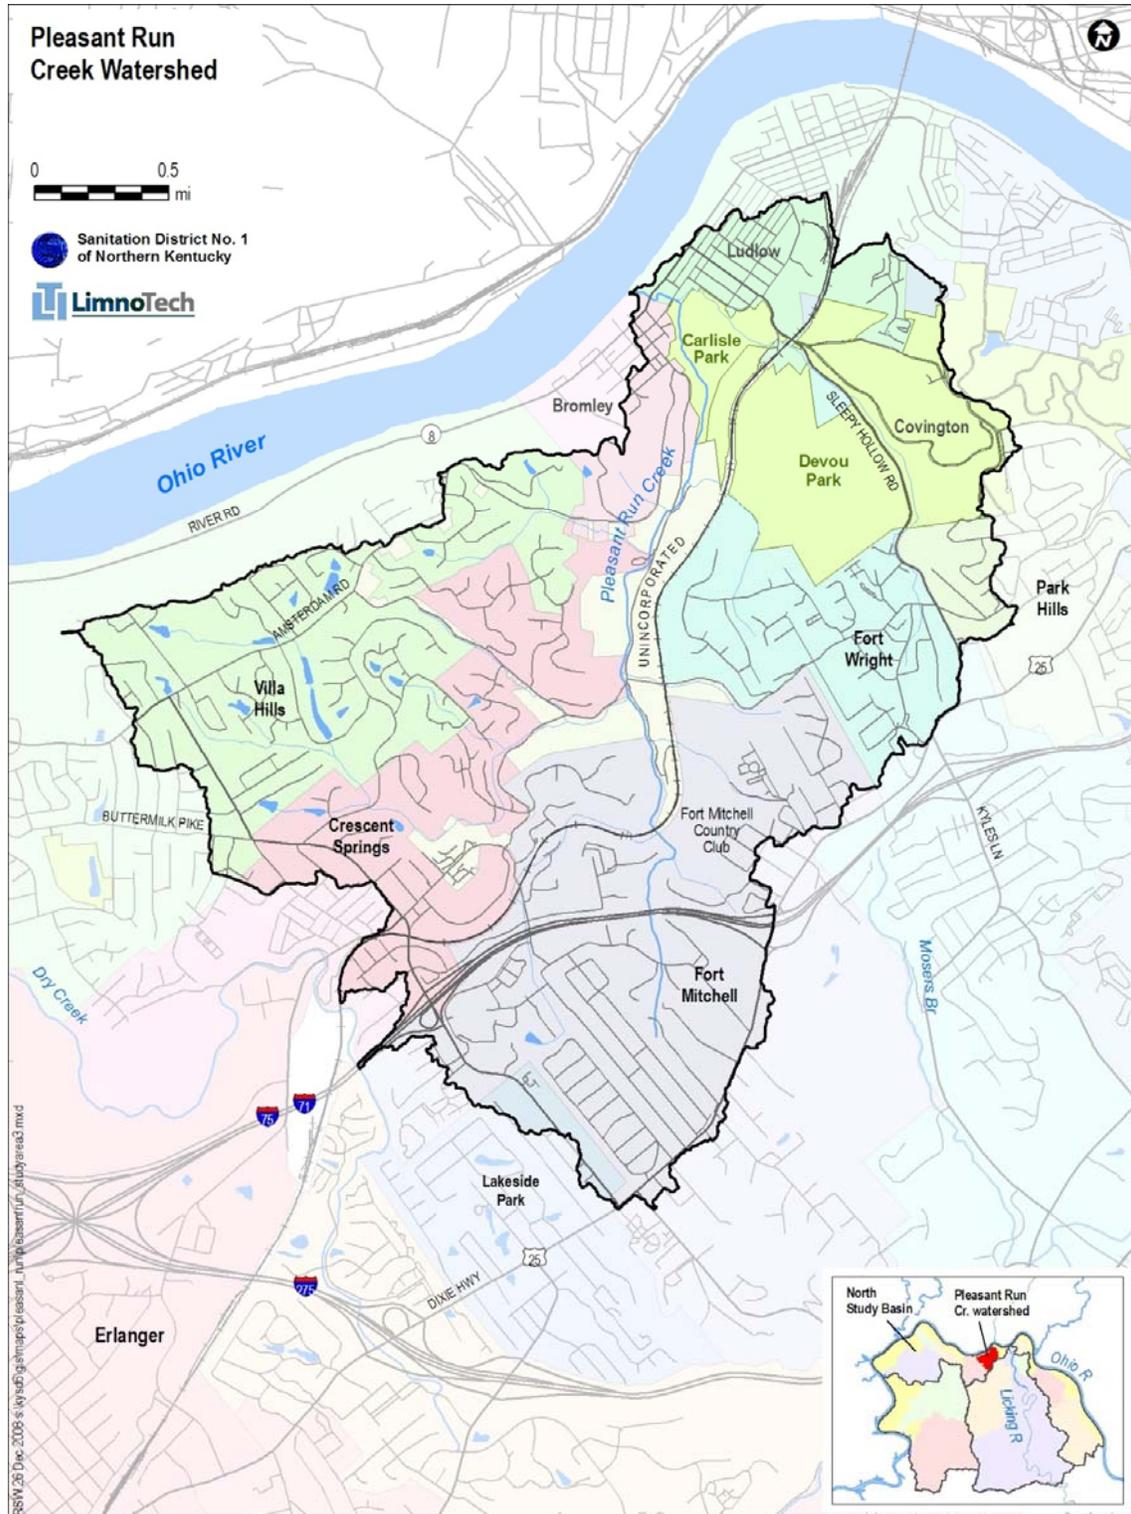
Figure 1. Pleasant Run Creek Watershed

The Pleasant Run Creek watershed is located within Kenton County in the North Study Basin (Figure 1). This creek originates north of Fort Mitchell and flows northward to the Ohio River, draining a predominantly developed watershed.

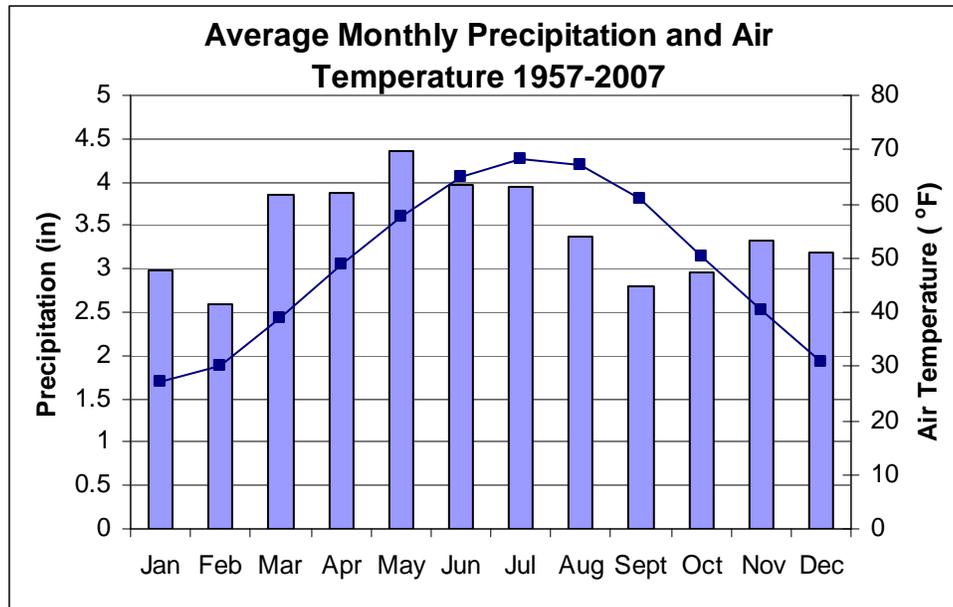
Figure 2. Average Monthly Precipitation and Air Temperature at the Cincinnati Northern Kentucky Airport (1957-2007)

The temperatures in this area are generally lowest in January and highest in July. Precipitation averages 41.2 inches annually, with the wettest months observed between March and July. Minimum precipitation is recorded in the fall and late winter as shown in Figure 2 (NCDC, 2008).

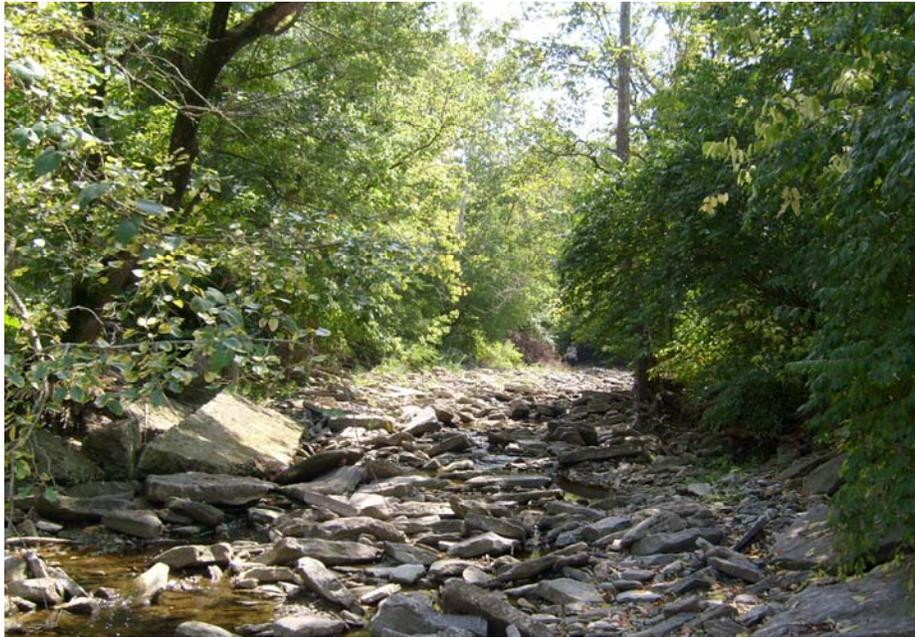
Figure 3. Pleasant Run Creek at Bromley Crescent Springs Road (RM 2.0)

A 2007 visit to the area showed that in most places, the creek is generally low-gradient, less than 1.5 feet deep and has cobble substrate (Figure 3). Near its mouth, Pleasant Run Creek receives backwaters from the Ohio River (Figure 4).

Pleasant Run Creek drains a highly developed watershed. This creek is shallow through most of its length, and during a site visit in January 2007, water depth was observed to range between 0.3 and 1.5 feet downstream of River Mile (RM) 2.0. Backwater effects from the Ohio River have been observed near the mouth of this creek.

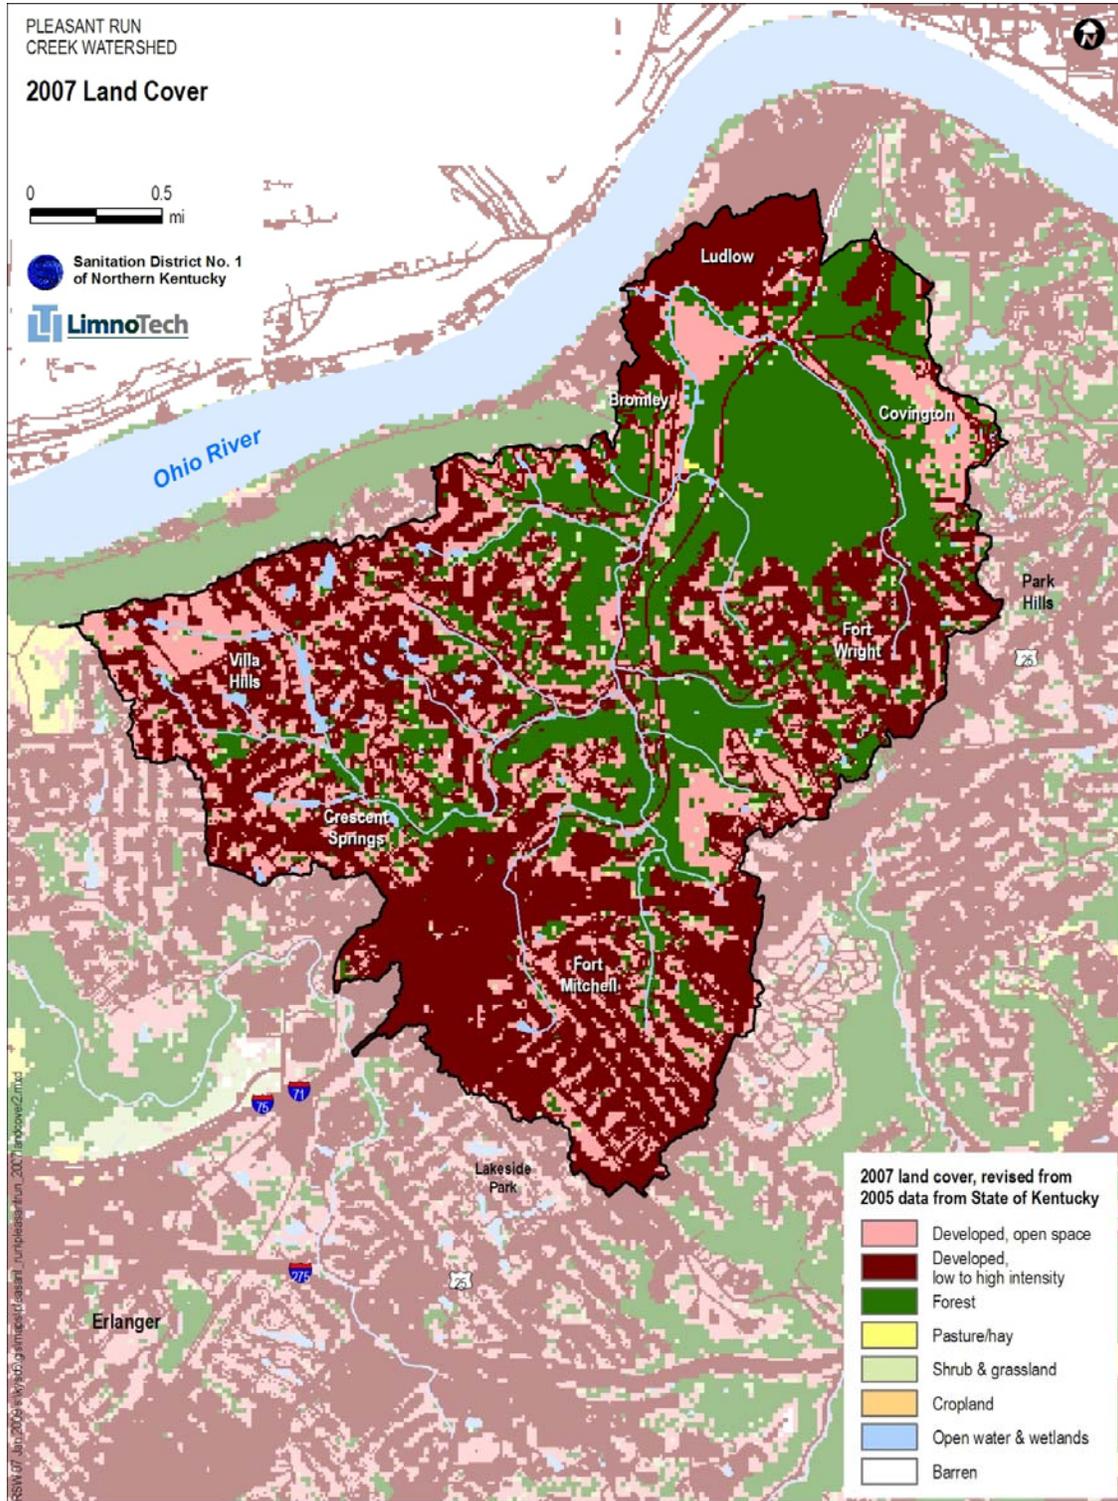
Figure 5. 2007 Land Cover

The Kentucky Division of Geographic Information, Commonwealth Office of Technology provided a GIS dataset showing 2005 Kentucky land cover. This dataset was updated and improved to approximate 2007 land cover conditions (Figure 5) using a variety of other datasets that represent current impervious conditions (roads, parking lots, buildings), open space lands (including parks), and surface waters.

The majority (69%) of the watershed is developed, resulting in an impervious cover of 18%. Aside from forest (28%), other land uses appear in only small amounts.

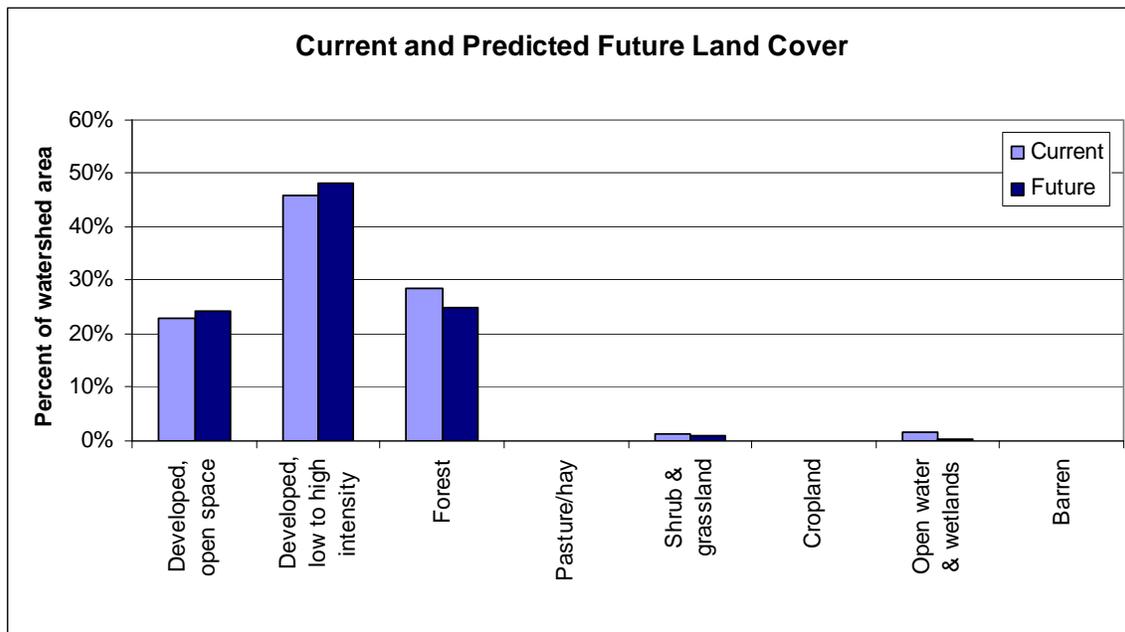
Figure 6. Current and Predicted Future Land Cover

Future land cover was developed by modifying 2007 land cover to reflect potential future conditions (roughly 2030) obtained from SD1 and the Northern Kentucky Area Planning Commission (NKAPC). It is predicted that developed lands will increase from 69% to 72% (Figure 6) and impervious surfaces in the watershed are predicted to increase from 18% to 19%.

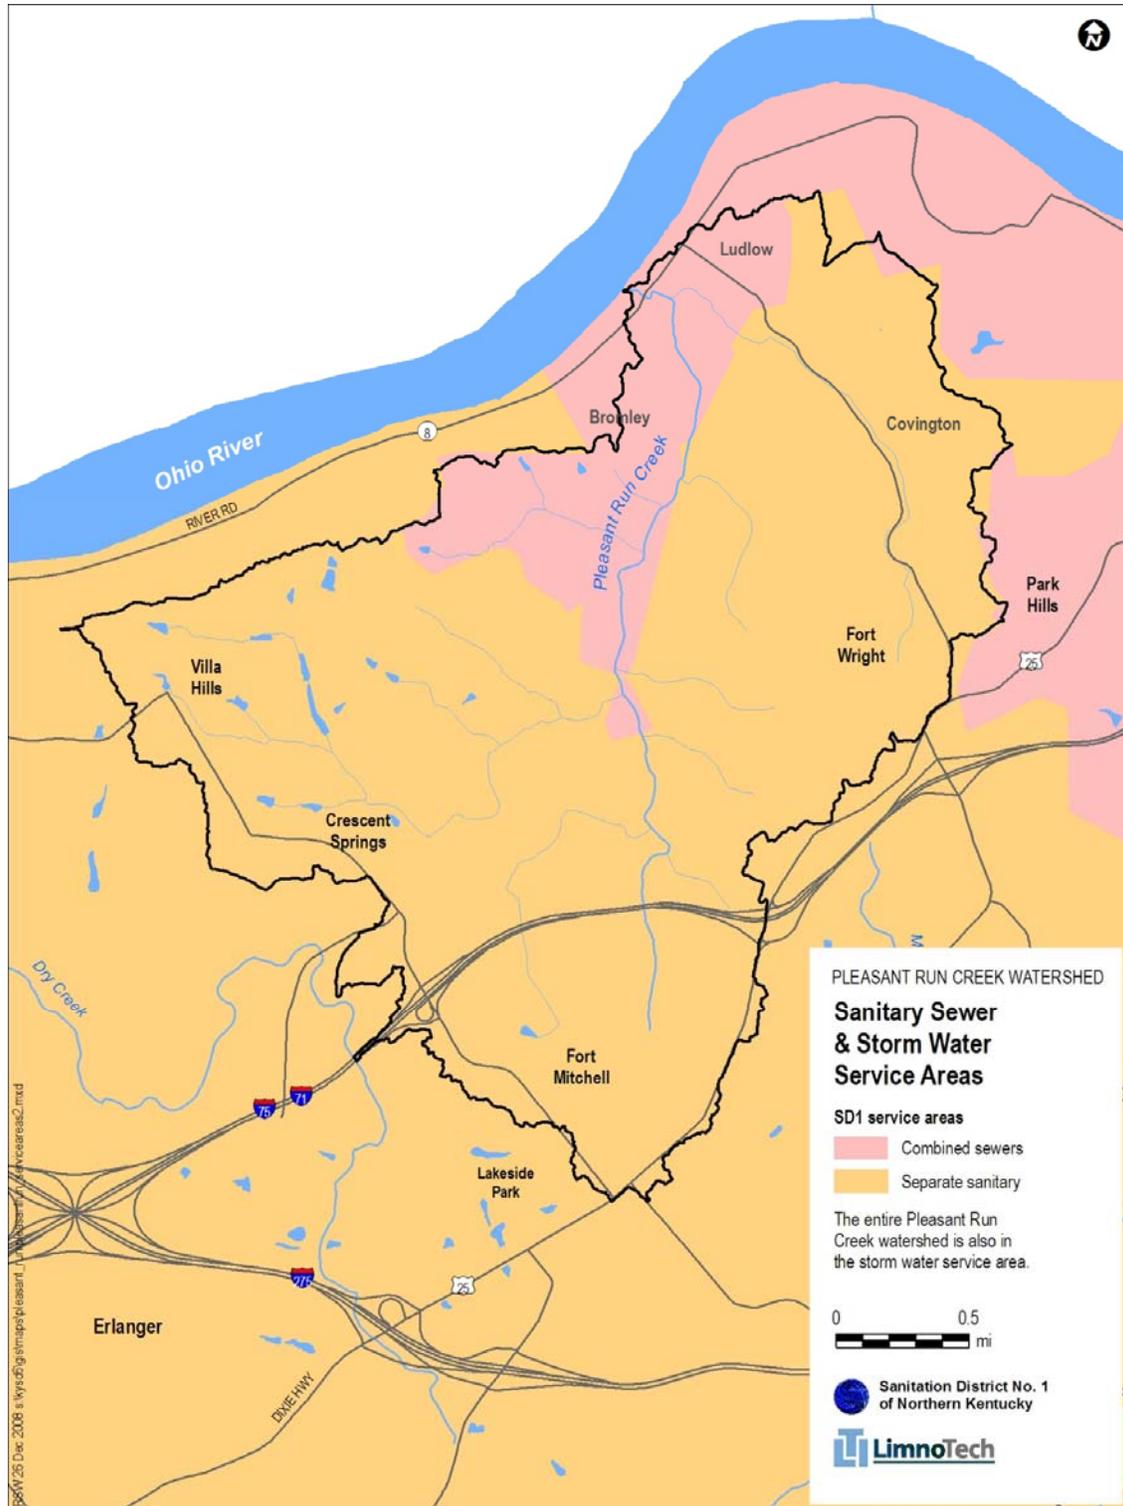
Figure 7. Sanitary Sewer, Combined Sewer and Storm Water Service Areas

Approximately 86% of this watershed is located within SD1's sanitary sewer service area. This area contains approximately 70.6 miles of separate sanitary sewer lines.

Approximately 14% of this watershed is within SD1's combined sewer area. This area contains approximately 12.5 miles of combined sanitary sewers lines.

The entire Pleasant Run Creek watershed lies within SD1's storm water service area. The storm water system is comprised of approximately 51.8 miles of streams and channels and approximately 44.8 miles of pipes.

The extent of the sanitary sewer, combined sewer and storm water service area in this watershed is shown in Figure 7.

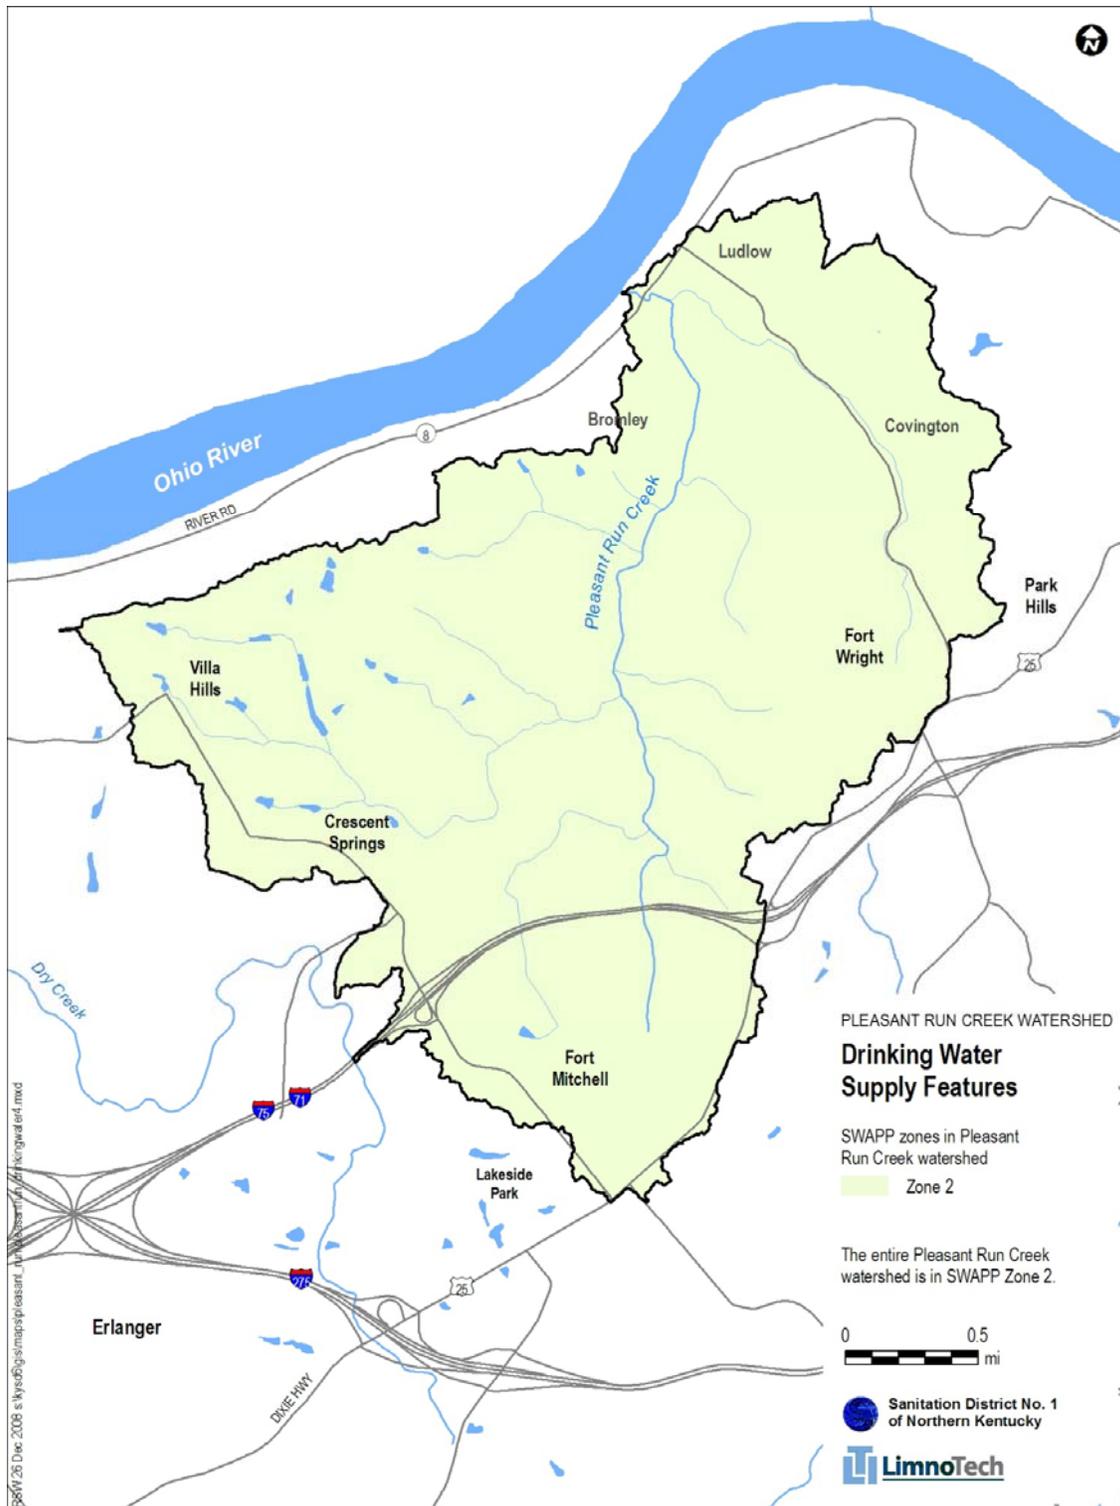
Figure 8. Water Supply Features

Source Water Assessment and Protection (SWAPP) zones for the Ohio River intakes are determined by the Ohio River Valley Water Sanitation Commission (ORSANCO). SWAPP zones are not used in a regulatory sense, but are delineated to identify potential contaminants upstream of water intakes and are used to support identification of sources potentially impacting the intakes. ORSANCO has determined that this entire watershed lies within SWAPP Zone 2, reflecting the fact that this watershed is more than 25 miles upstream of the Louisville intake.

Drinking water supply features are shown in Figure 8.

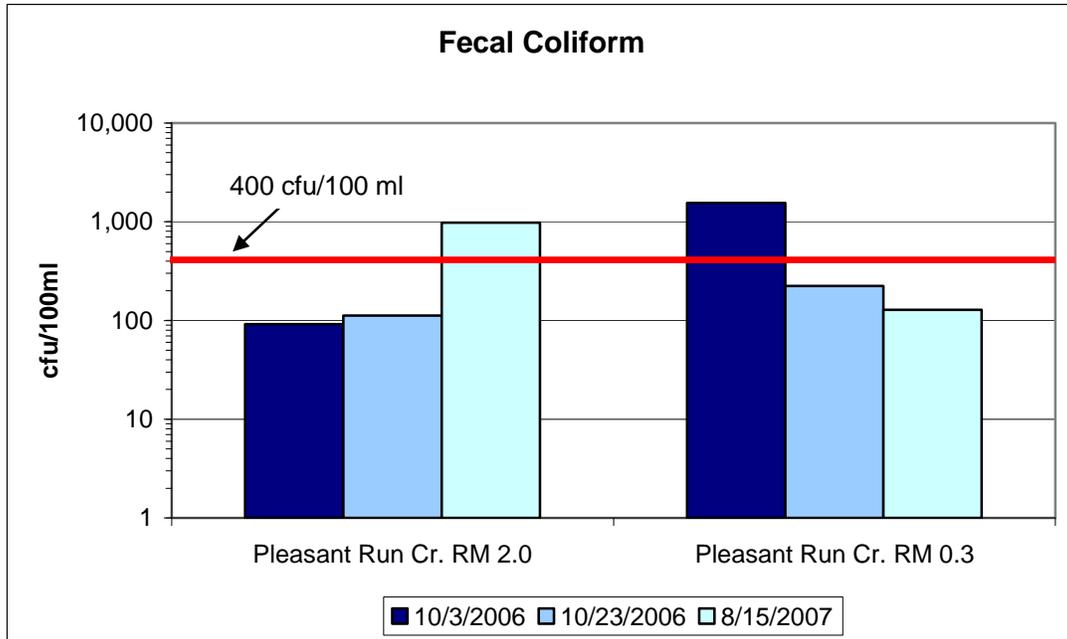
Figure 9. 2006-2007 Base Flow Fecal Coliform Results Compared to the 400 cfu/100ml Criterion

Bacteria sampling was conducted in the Pleasant Run Creek watershed by SD1 during three baseline surveys in 2006-2007. All bacteria samples were collected during base flow conditions. As shown in Figure 9, elevated base flow concentrations of fecal coliform were observed in two of the six Pleasant Run Creek samples. The maximum base flow fecal coliform concentration of 1,550 cfu/100 ml was recorded in Pleasant Run Creek at RM 0.3. As shown in Figure 10, a similar pattern was observed for *E. coli*, with elevated levels in two of the six base flow samples. The maximum *E. coli* concentration, 1,302 cfu/100 ml was recorded at River Mile 2.0.

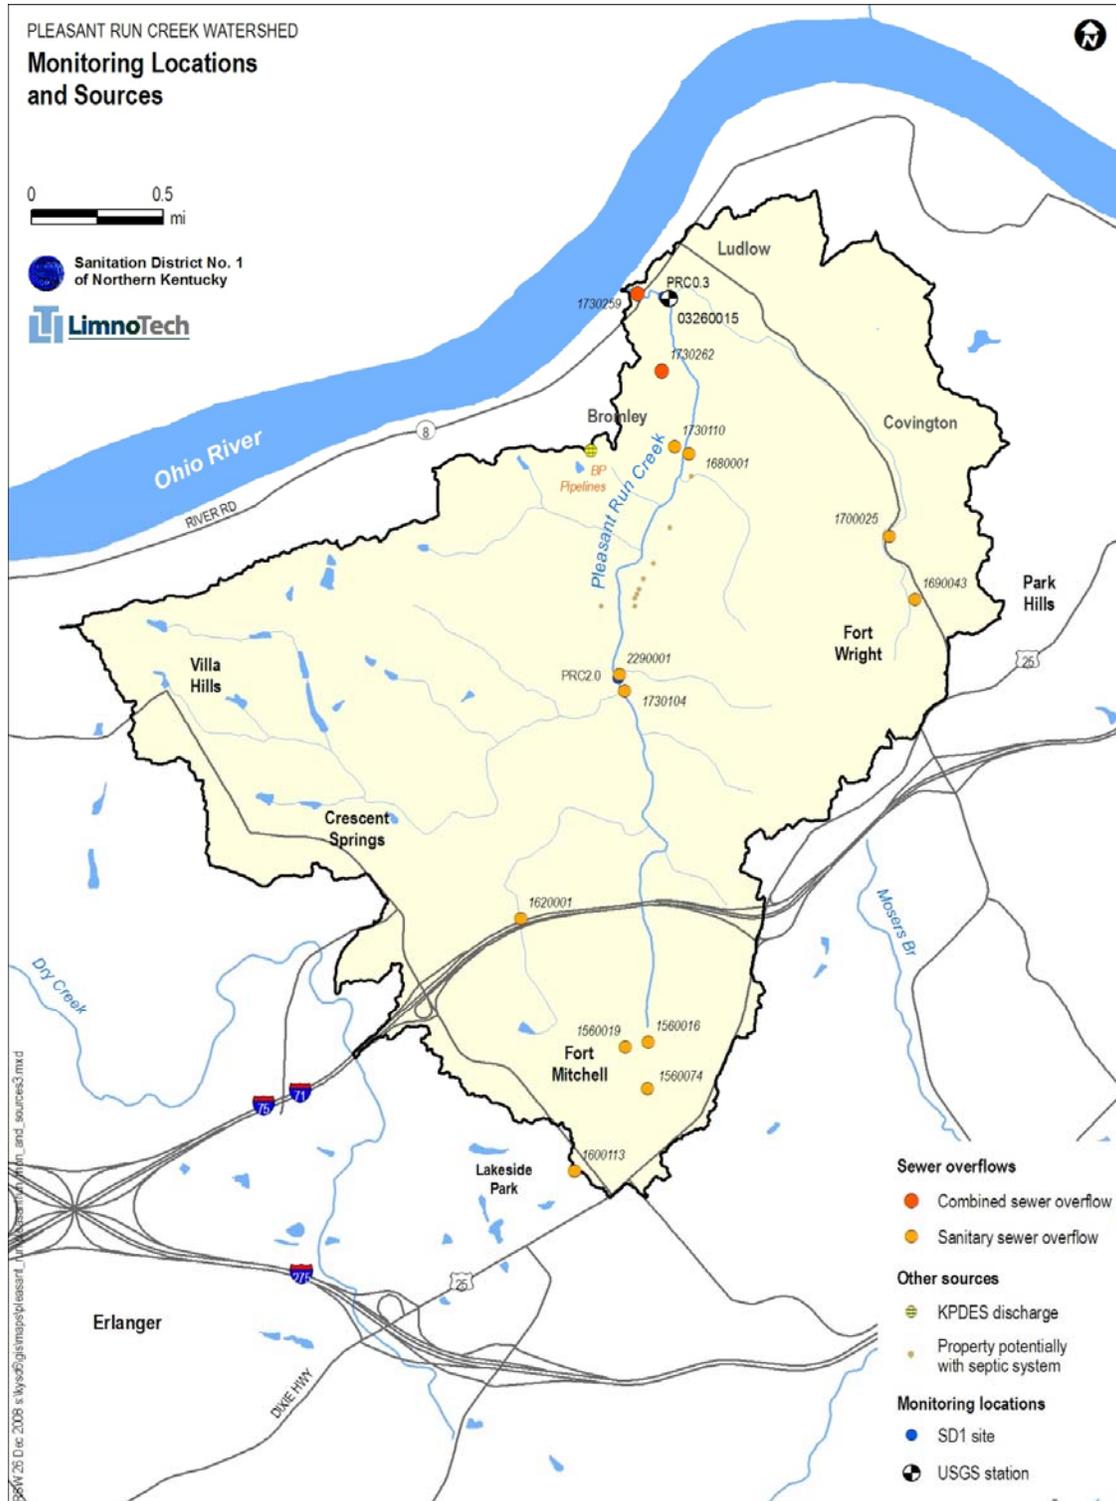
Figure 11. Monitoring Locations and Sources

Potential sources of bacteria were identified within the Pleasant Run Creek watershed. These sources are summarized in Table 9 and their locations are shown in Figure 11. Although all of the recent exceedances were observed during base flow conditions, all potential sources are included in this summary.

Pleasant Run Creek
Recent observed impairment=>	Bacteria
SSO ^a	11
CSOs ^a	2
KPDES storm water outfall ^b	1
Septic systems	Very few
Storm water runoff	Urban
Watershed improvements	Riverwatch pump station planned for elimination in 2008. Stream restoration and bank stabilization projects planned in Devou Park

SD1 plans to continue monitoring this watershed during base flow conditions with at least one survey per year. The three sampling locations are: Pleasant Run Creek at RM 0.3, 2.0 and RM 0.8 of an unnamed tributary to Pleasant Run Creek, which enters at RM 0.4. Typical analyses will include bacteria, nutrients, solids, oxygen-demanding constituents and physical parameters.

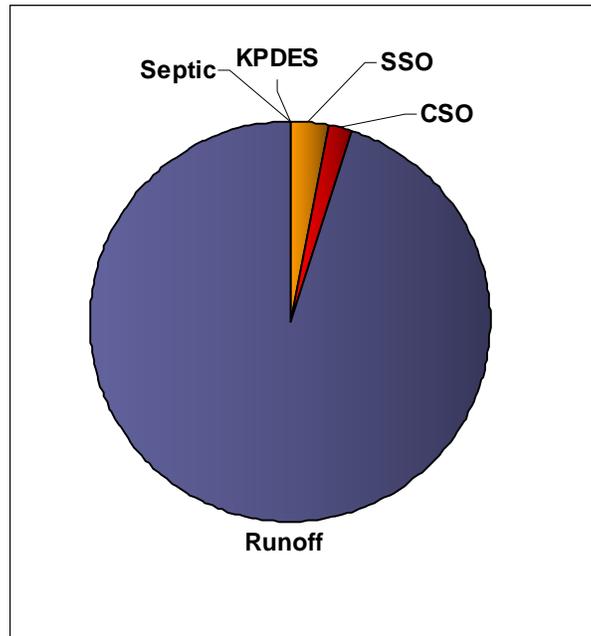
Figure 12. Initial Year-Round WAT! Results for Fecal Coliform

The relative fecal coliform load generated by source is shown in Figure 12. These WAT! results incorporate predicted sewer overflow volumes from infrastructure model simulations for 1992-1996 climatological conditions⁹. Flow estimates are available for one of the CSOs and six of the SSOs in this watershed.

Under year-round conditions, the largest source of fecal coliform bacteria is storm water runoff. Septic systems are not a significant contributor to the total annual bacteria load; however, during base flow conditions they are estimated to contribute the majority of the fecal coliform load.

WAT! is still under development. All results presented here are for illustrative purposes only. The results are subject to change and should therefore not be relied on or considered definitive.
