# Sand Run

## Watershed Characterization Report

Prepared for: Sanitation District No. 1 of Northern Kentucky

January 2009

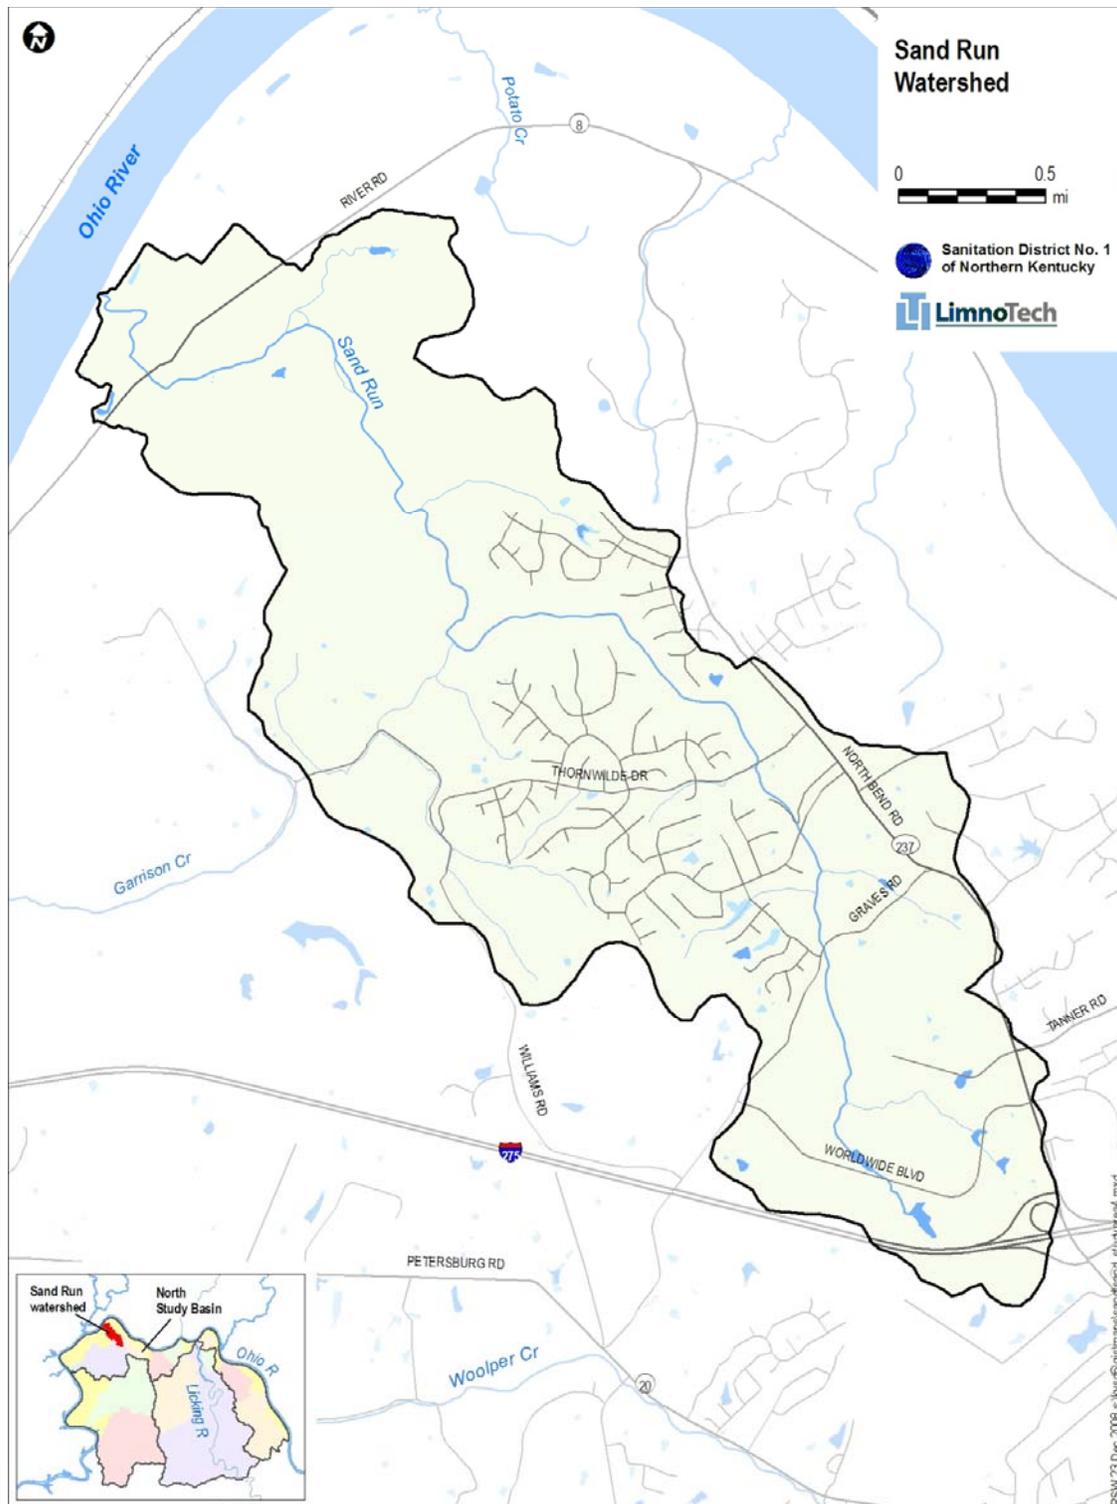
Figure 1. Sand Run Watershed

The Sand Run watershed is located in Boone County in the North Study Basin and is one of the smallest Northern Kentucky watersheds (Figure 1). This watershed has seen rapid development, especially in the headwaters. Currently, forest and developed lands comprise the dominant land cover.

Sand Run is located entirely in Boone County, Kentucky, and the watershed area for this creek is 5 square miles. Sand Run originates in northern Boone County near I-275 and North Bend Road, and flows northwest for 5.7 miles to the Ohio River.

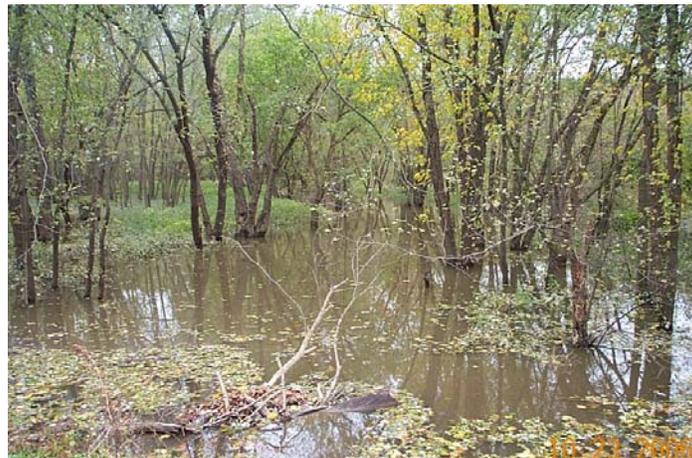
**Figure 2. Sand Run near RM 0.5**

The 100-year floodplain extends from the mouth of Sand Run upstream to approximately RM 1.5, and is roughly 1,000 feet across. According to the Boone County Comprehensive Plan, flooding has not been a problem in Sand Run in the past, however due to urban and suburban development, it has more recently become a problem in this creek (BCPC, 2005).

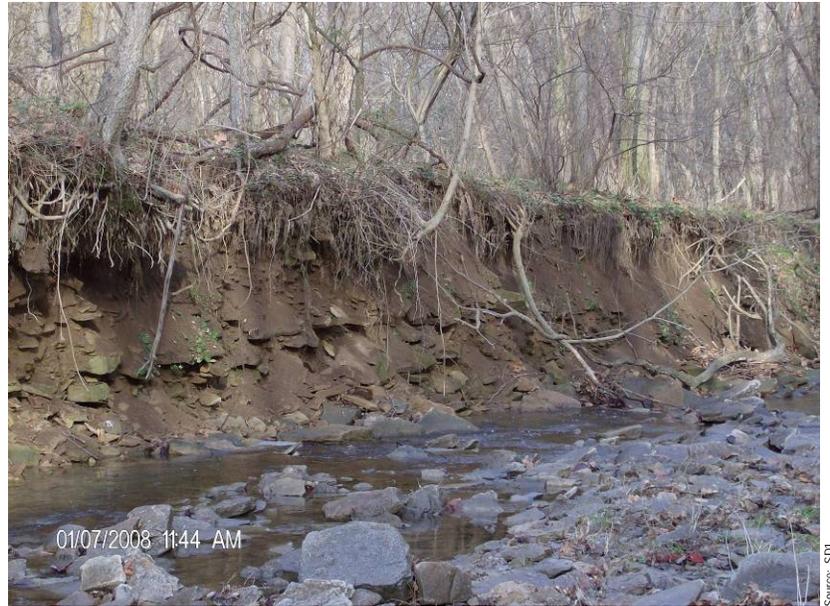
**Figure 3. Sand Run Erosion**

Most of the soils in the watershed are ranked as either “highly erodible” (83%) or “fairly erodible” (13%) as indicated by an index for erodibility (NRCS, 2006). The erodibility of soils is important when soils are disturbed through activities such as land clearing for new development. Portions of this watershed are developing rapidly and this development is anticipated to continue in the future (Section 2.2). Some areas of severe erosion have been observed within this watershed (Figure 3).

Several small areas of severe streambank erosion were also noted near the downstream portion of the watershed, where the creek enters the floodplain (NKU-ERMC, 1999).

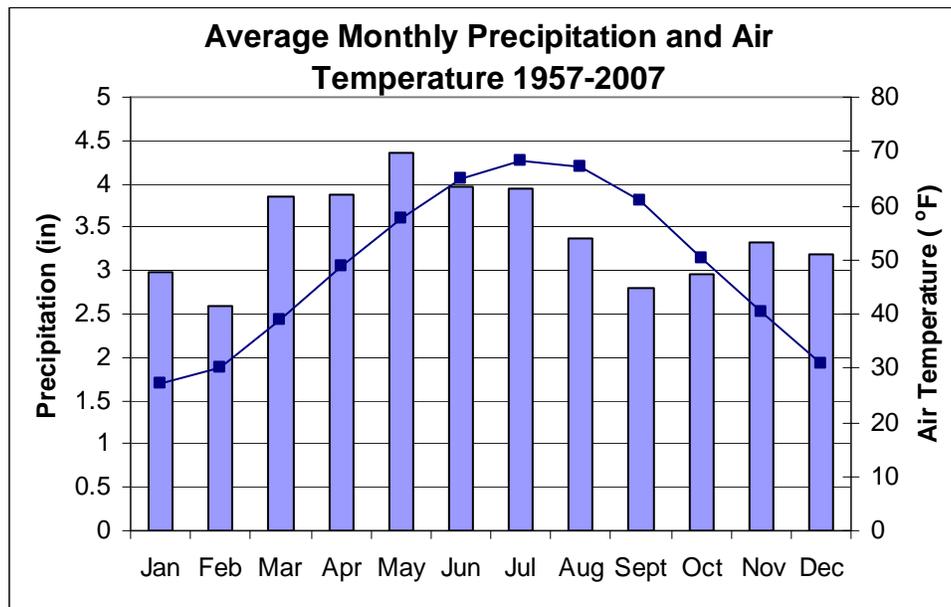
**Figure 4. Average Monthly Precipitation and Air Temperature at the Cincinnati Northern Kentucky Airport (1957-2007)**

The temperatures in this area are generally lowest in January and highest in July. Precipitation averages 41.2 inches annually, with the wettest months observed between March and July. Minimum precipitation is recorded in the fall and late winter as shown in Figure 4 (NCDC, 2008).

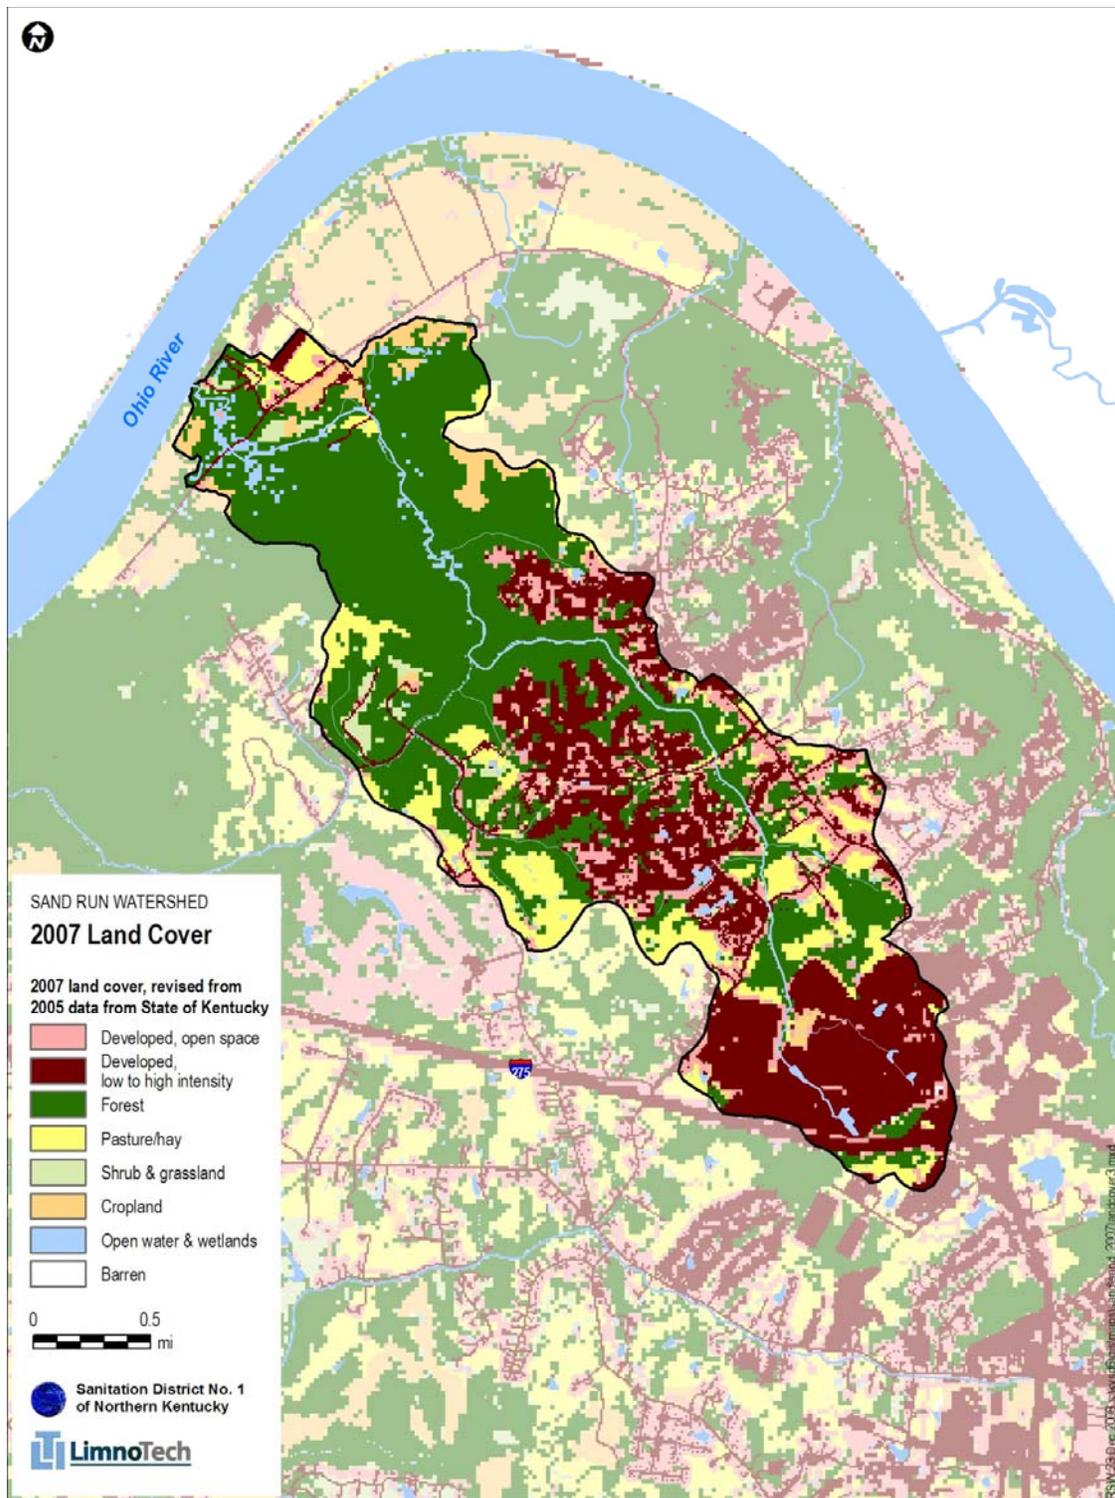
Figure 5. 2007 Land Cover

The Kentucky Division of Geographic Information, Commonwealth Office of Technology provided a GIS dataset showing 2005 Kentucky land cover. This dataset was updated and improved to approximate 2007 land cover conditions (Figure 5) using a variety of other datasets that represent current impervious conditions (roads, parking lots, buildings), open space lands (including parks), and surface waters.

Forest and developed lands are the dominant land covers in the watershed. 12% of this watershed is covered with impervious surfaces. Interstate 275 crosses the southernmost tip of the watershed and development in this watershed is currently focused in the upstream portion of the watershed and is concentrated on hilltops. None of the land in this watershed is incorporated. Many of the subdivisions appear to have storm water

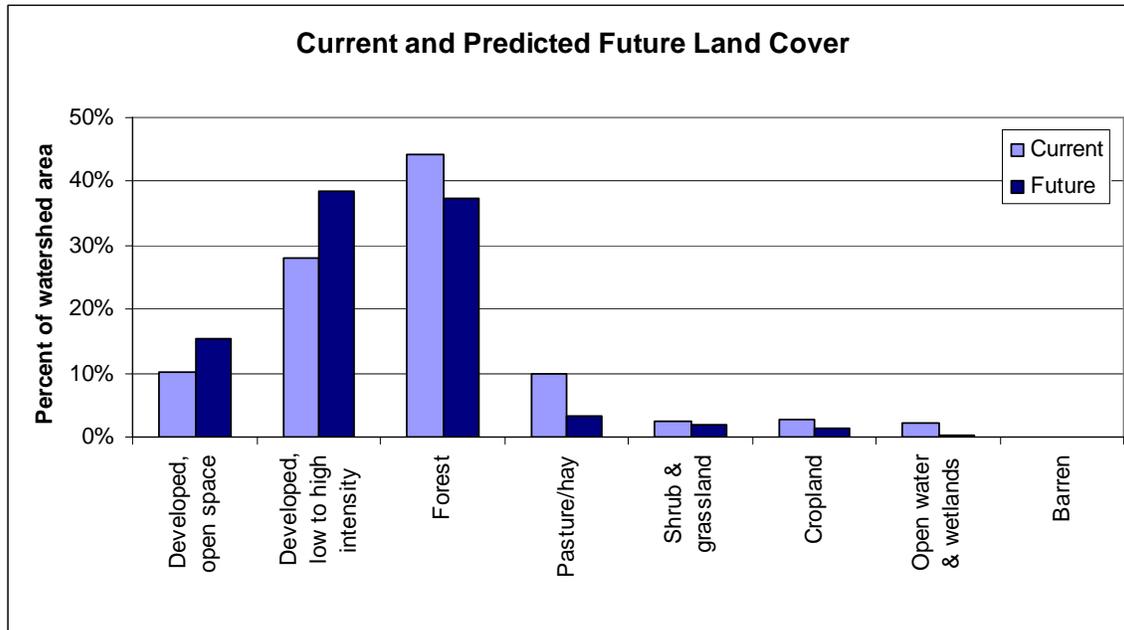
Figure 6. Current and Predicted Future Land Cover

It is predicted that development will primarily replace forest and pasture lands (Figure 6). Developed lands are predicted to increase from 38% to 54% and impervious surfaces in the watershed are predicted to increase from 12% to 16%.

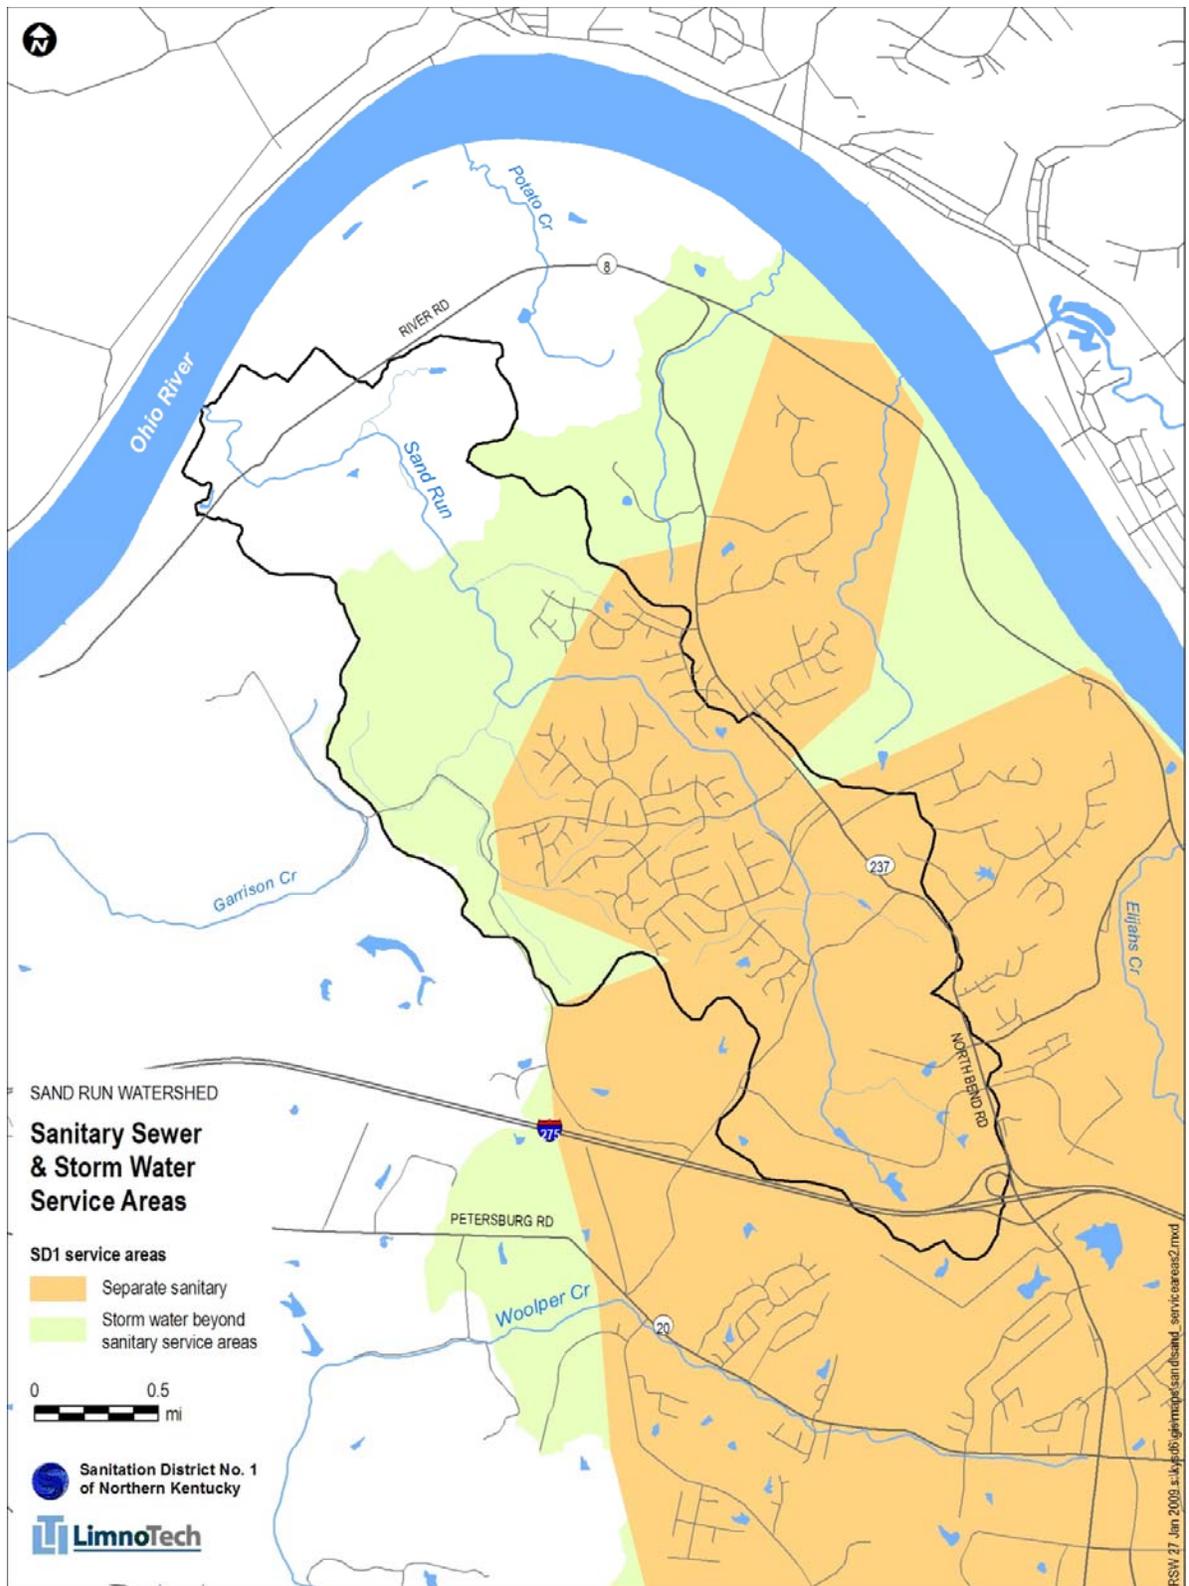
Figure 7. Sanitary Sewer and Storm Water Service Areas

Approximately 56% of this watershed is located within SD1's sanitary sewer service area. This area contains approximately 26.1 miles of separate sanitary sewer lines and is primarily located in the upstream portion of the watershed.

Approximately 81% of this watershed lies within SD1's storm water service area. Within the service area, the storm water system is comprised of approximately 39.8 miles of streams and channels and approximately 18.2 miles of pipes.

The extent of the sanitary sewer and storm water service area in this watershed is shown in Figure 7.

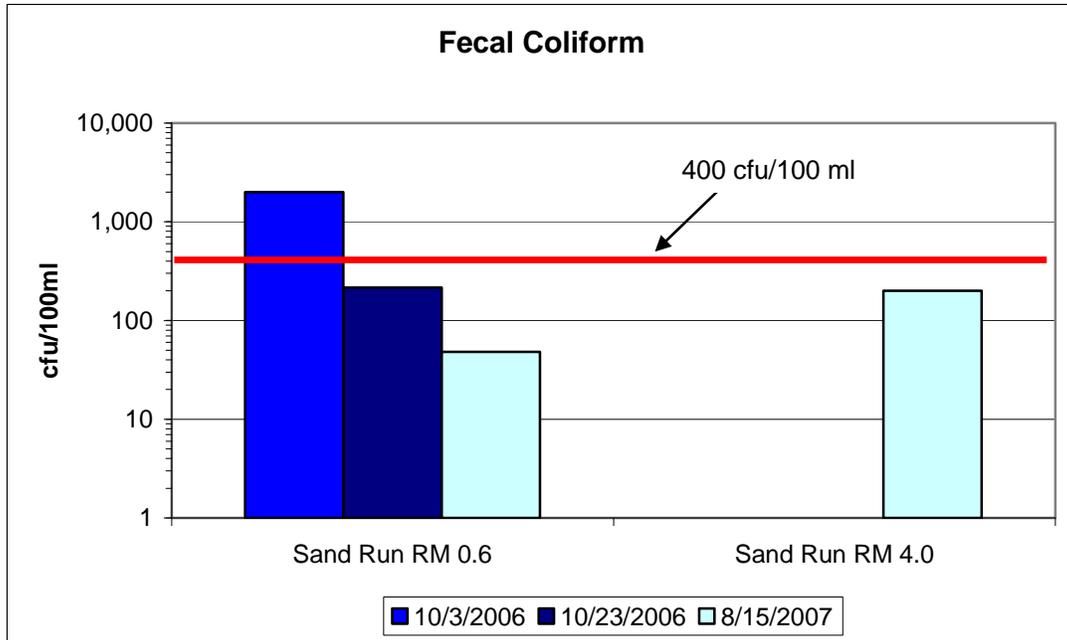
**Figure 9. 2006-2007 Base Flow Fecal Coliform Results Compared to the 400 cfu/100ml Criterion**

SD1 collected four base flow fecal coliform measurements in 2006 and 2007 at Sand Run RM 0.6 and 4.0 and one of the four fecal coliform samples exceeded the recreation season standard of 400 cfu/100ml (Figure 9). A fecal coliform concentration of 2,000 cfu/100 ml was measured at River Mile 0.6 in October 2006.

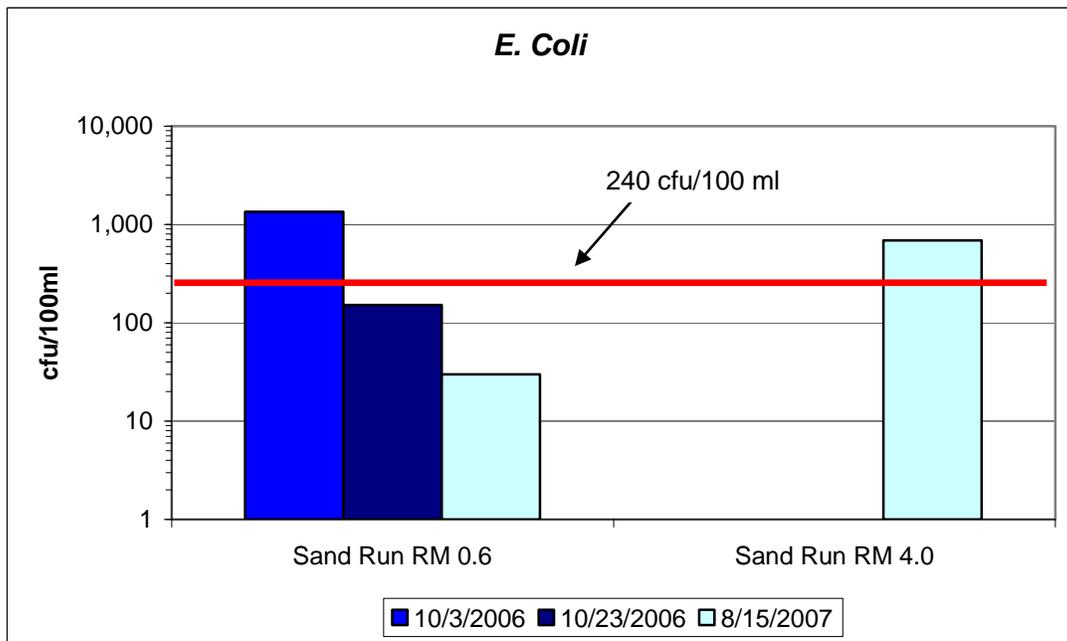
**Figure 10. 2006-2007 Base Flow *E. Coli* Results Compared to the 240 cfu/100ml Criterion**

SD1 collected four base flow *E. coli* measurements in 2006 and 2007, at Sand Run RM 0.6 and 4.0; and two of the four *E. coli* samples exceeded the recreation season standard of 240 cfu/100ml (Figure 10). The maximum *E. coli* measurement of 1,350 cfu/100 ml was observed at River Mile 0.6 in October 2006.

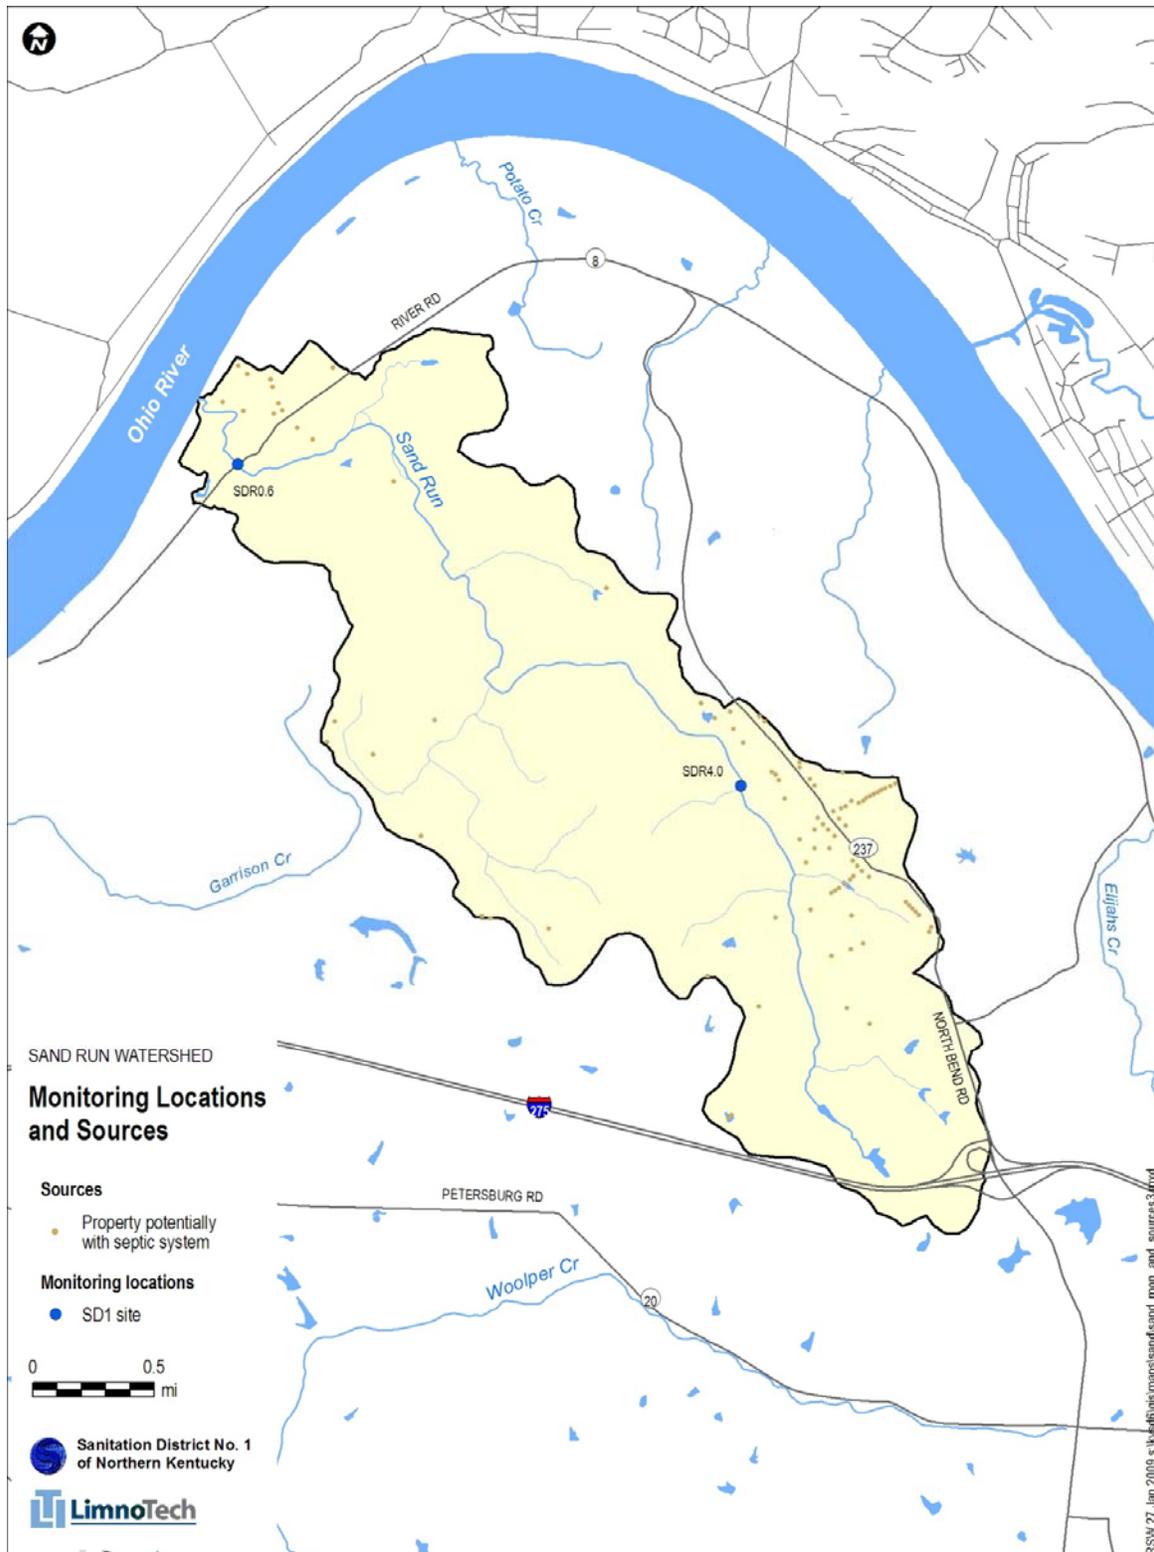
Figure 11. Monitoring Locations and Sources

SD1 estimates that approximately 6% of all parcels in the Sand Run watershed are potentially serviced by septic systems (Figure 11). Properties potentially served by septic systems are found near the mouth of the creek and in the western portion of the watershed near Kentucky 237.

SD1 plans to continue monitoring in Sand Run at RM 0.6 and 4.0 during base flow conditions with at least one survey per year. Typical analyses will include bacteria, nutrients, solids, oxygen-demanding constituents and physical parameters.

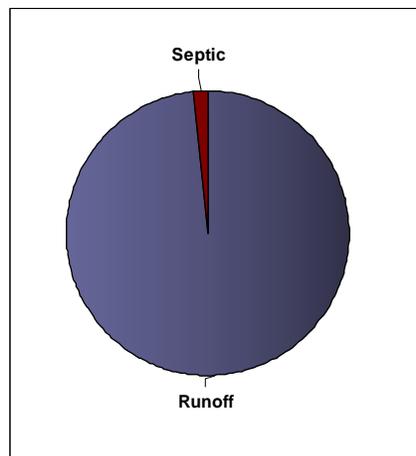
**Figure 12. Initial Year-Round WAT! Results for Fecal Coliform**

The relative fecal coliform load generated by source is shown in Figure 12. These WAT! results incorporate predicted sewer overflow volumes from infrastructure model simulations for 1992-1996 climatological conditions<sup>7</sup>. Neither CSOs nor SSOs were a factor in the WAT! results, as none occur in the watershed.

Under year-round conditions, the largest source of fecal coliform bacteria is storm water runoff. Septic systems are not a significant contributor to the total annual bacteria load; however, during base flow conditions they are estimated to contribute the majority of the fecal coliform load.
