Ohio River West Tributaries Watershed Characterization Report

Prepared for: Sanitation District No. 1 of Northern Kentucky

January 2009

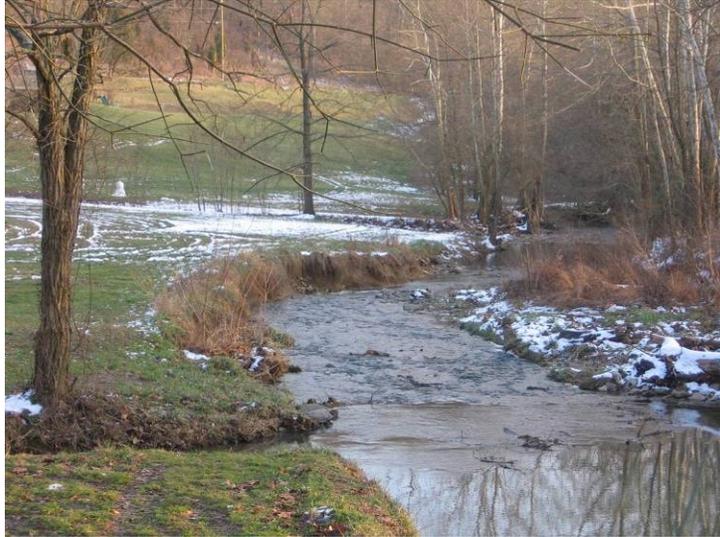
Figure 3. Middle Creek near McVile

In 2007, erosion problems were evident in some of the streams (Figure 3). The turbid waters, bank erosion and reduced riparian areas shown in this figure are characteristics of several reaches of Middle Creek, although other portions of this creek appear to be in very good condition (Figure 4). According to the Conservation District, Lick Creek is in good condition and could be used as a reference stream (BCKCD, 2007).
