Taylor Creek Watershed Characterization Report

Prepared for: Sanitation District No. 1 of Northern Kentucky

January 2009

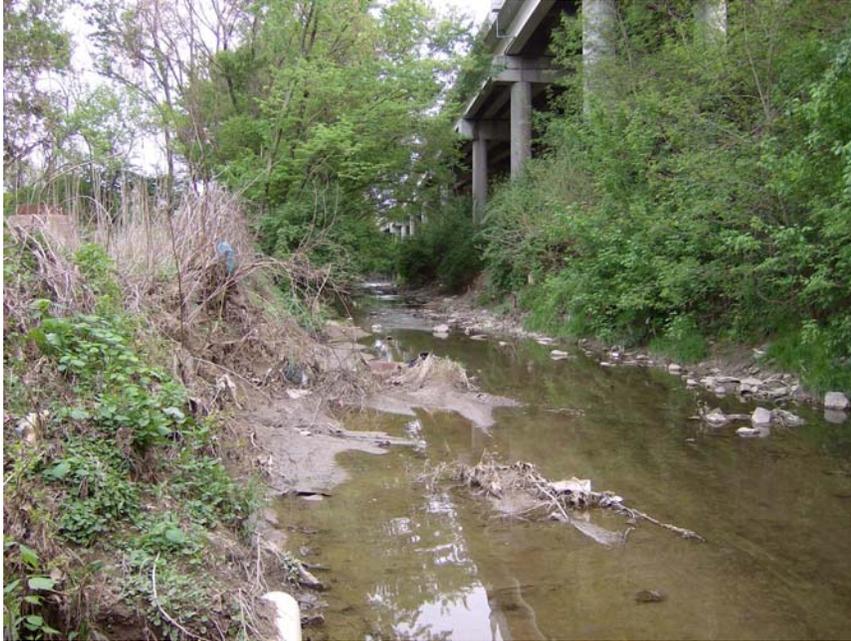
Figure 3. Taylor Creek upstream from RM 0.7

cobble substrate (Figure 3). However, in some areas of the watershed, streams also have limestone bedrock substrate (Figure 4). Throughout the watershed, streams have been channelized and generally have small sparse and narrow (0 to 30 feet) riparian zones⁶ containing mostly hardwood trees (Figure 3 and Figure 4). Aquatic habitats in the Taylor Creek watershed are limited by the impacts of urbanization in the watershed. Evidence of sedimentation and eutrophication, channel straightening and reduced habitat heterogeneity is observed throughout the watershed (Figures 3 and 4).
