# Threemile Creek Watershed Characterization Report

Prepared for: Sanitation District No. 1 of Northern Kentucky

January 2009

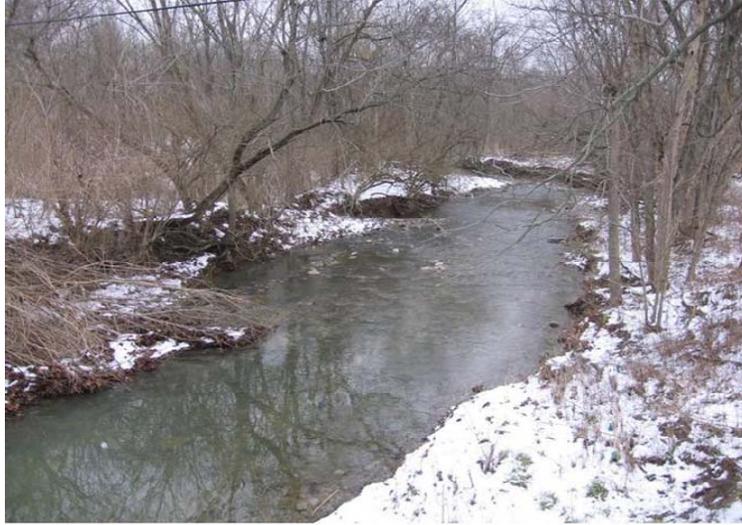
**Figure 2. Threemile Creek RM 0.7, at Threemile Road**

The headwaters of Threemile Creek originate in the rolling hills of the Grant Lake Limestone/Fairview formation. This creek also traverses the erodible shale of the Kope formation, and then unconsolidated alluvial sediments near the Licking River. A visit to the area revealed erosion problems along Threemile Creek (Figure 2) and North Branch (Figure 3).

Threemile Creek flows through a primarily urban-suburban watershed that is highly developed. The creek is enclosed in underground pipes at two locations where it flows under Interstates I-471 and I-275. During a site visit in January 2007, the water at river mile (RM) 0.7 was light brown in color and flowing over a cobble substrate. Water was less than 1 foot deep. At the confluence with the Licking River, the water was pooled in backwater, and the creek was observed to be brown and silty. Signs of erosion were apparent at both locations.

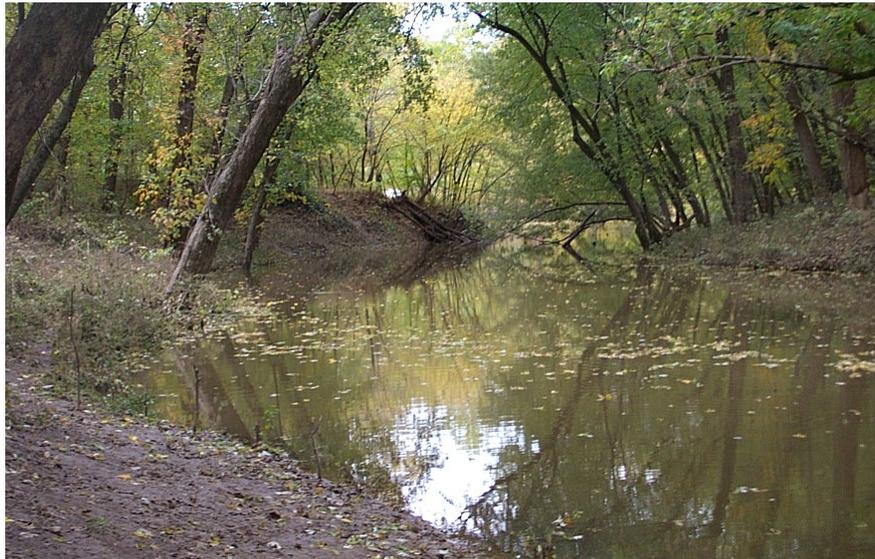
KDOW assessed instream habitat<sup>6</sup> at four locations in this watershed. All sites were rated as not supporting of aquatic habitats (Table 1). Riparian zones<sup>7</sup> along much of Threemile Creek and North Branch were observed to be narrow, but riparian areas widen near its confluence with the Licking River, where it also experiences impacts from backwater from the larger river (Figure 5).

**Figure 5. Threemile Creek near its confluence with the Licking River**

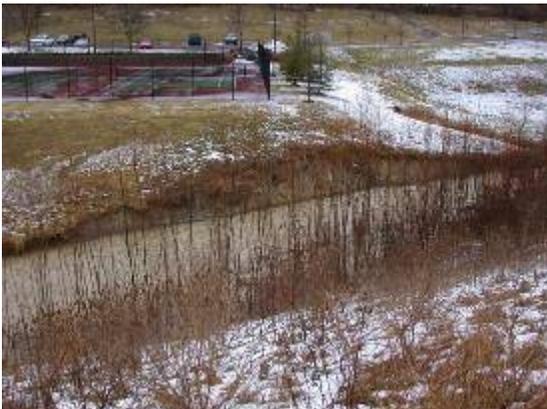
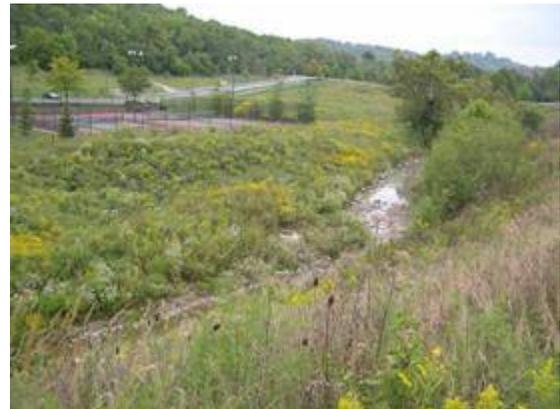
**Figure 9. Bentwood Hills Stream Restoration Site on North Branch**

*Photos show before (left) and after (right).*

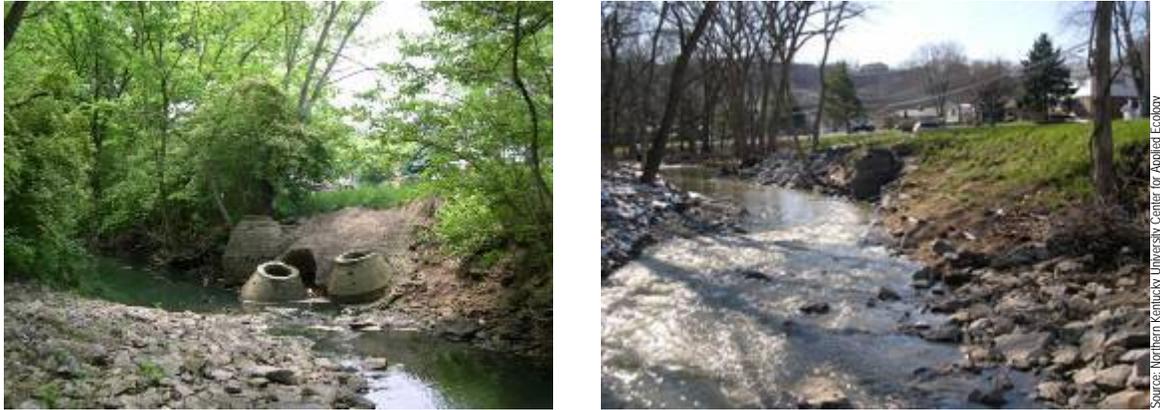
- Stream corridor restoration has been conducted along approximately 3,700 feet of North Branch, located on the Woodland Hills Condominium property, in the City of Southgate. This stream flows immediately into the Bentwood Hills Stream Restoration site (above). This project involved fish passage enhancement, aquatic habitat enhancement, streambank stabilization, and restoration and enhancement of 10 acres of riparian forest (Figure 10).

**Figure 10. Woodland Hills Stream Restoration Site on North Branch**

*Photos show before (left) and after (right).*
