# Northern Kentucky Watersheds – A Summary

Prepared for: Sanitation District No. 1 of Northern Kentucky

June 2009

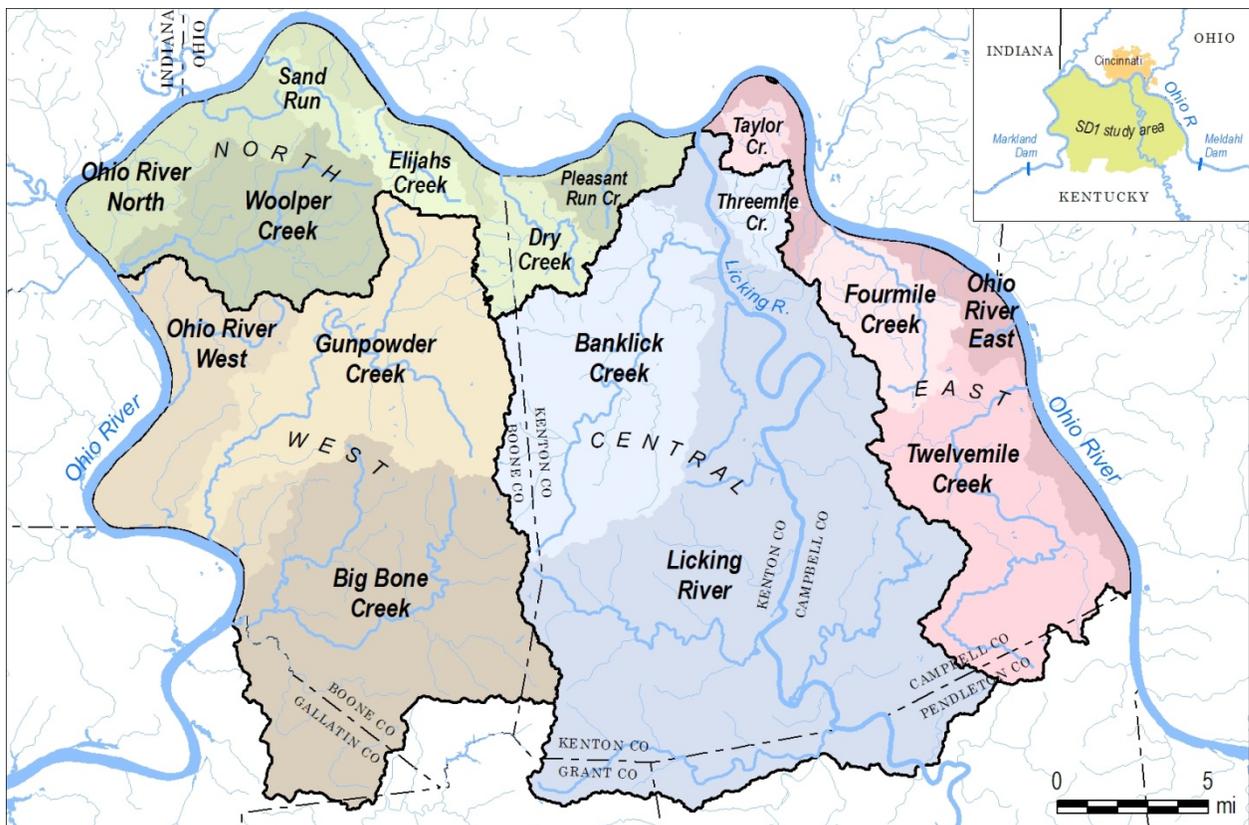
**Figure 1. Study Area Map**

The Consent Decree describes four study basins (East, Central, North and West), which encompass the area's sixteen watersheds (Figure 1). This summary report describes SD1's efforts to characterize and improve conditions within this 592 square mile area, and provides an overview of study area features. The unique characteristics of each of the study area watersheds are highlighted in individual fact sheets (Appendix A). These characteristics will be considered in prioritizing watersheds, identifying specific sources for improvement, and identifying data gaps to be addressed in subsequent updates to the Watershed Plans. Additional details can be found in the sixteen Watershed Characterization Reports which are available at <http://www.sd1.org/projects/wcr.asp>.

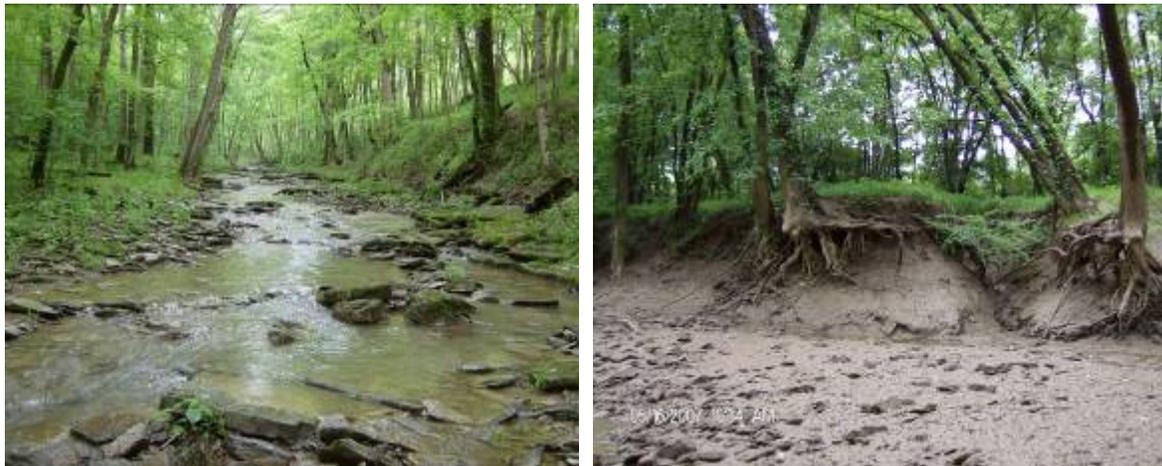
**Figure 2. Double Lick Creek (left) and Fourmile Creek (right)**

The land cover in a watershed is an important characteristic because it affects the amount and quality of runoff. Figure 2 contrasts two study area streams that drain watersheds with different levels of development. Double Lick Creek in the Woolper Creek watershed drains a primarily undeveloped watershed, and has been identified as an exceptional water by the State. Fourmile Creek, in contrast, drains a more highly developed watershed and is identified on State's 303(d) list as being impaired.

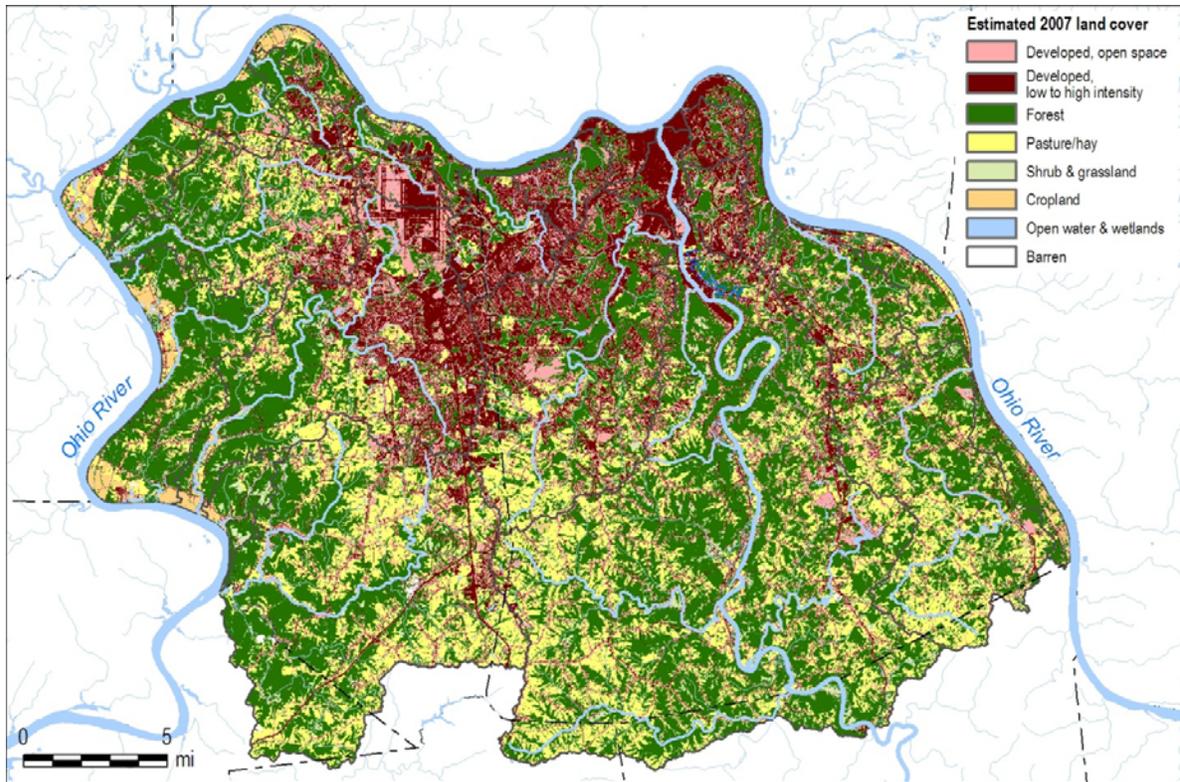
**Figure 3. Current (2007) Land Cover**

Current (2007) land cover within the study area is shown in Figure 3. Developed areas currently comprise approximately 29% of the study area and the percent imperviousness is roughly 6.5%. Future land cover was developed by modifying the 2007 land cover to reflect potential future conditions (roughly 2030). In the future, 39% of the study area is predicted to be developed and the percent imperviousness is anticipated to increase to 9.3%. Growth is anticipated primarily within the boundary indicated on Figure 4 (predicted extent of future development). New development can increase storm water runoff and pollutant loads, and introduce additional challenges for protecting and improving stream condition.

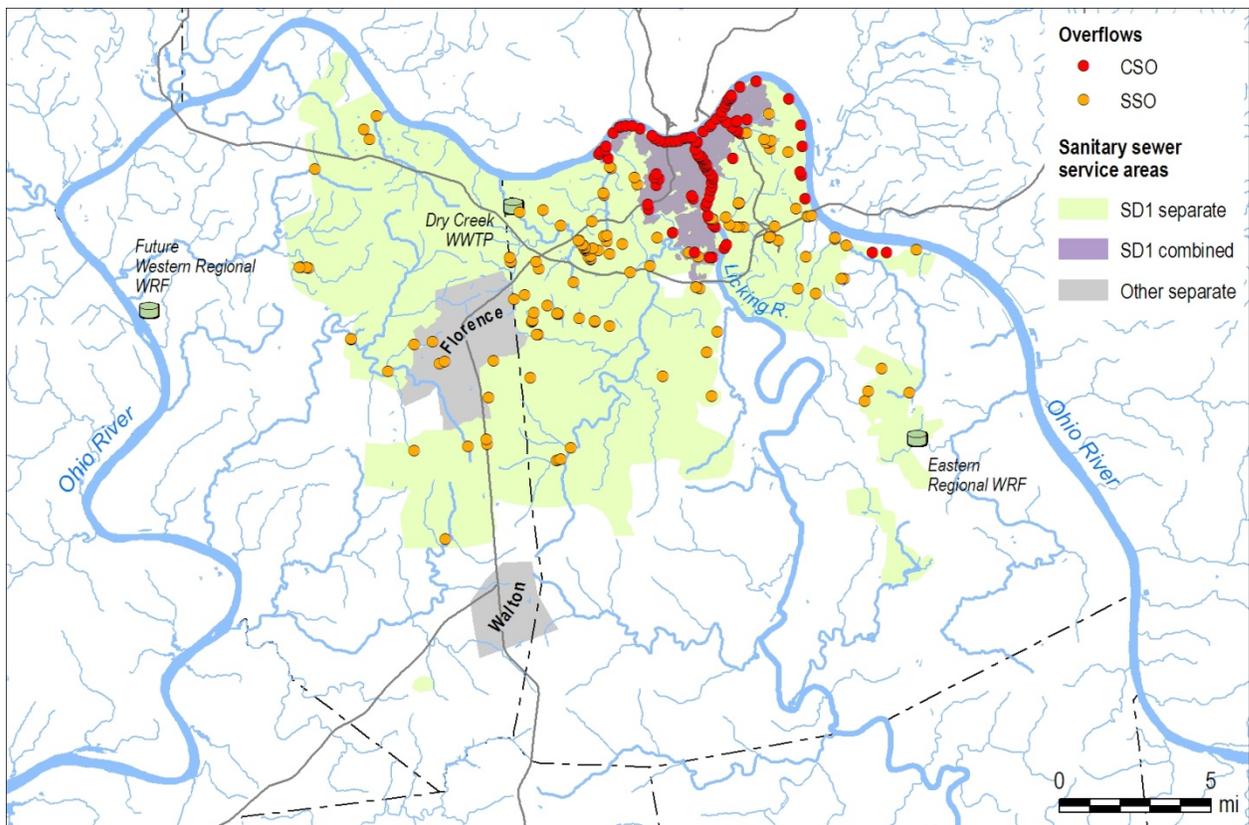
**Figure 5. Sewer Overflows and Sanitary Service Area**

Pollutant sources in the study area include CSOs, SSOs, other KPDES<sup>1</sup>-permitted discharges, storm water runoff and septic systems<sup>2</sup>. The distribution of these sources in the study area is shown on Figures 5 and 6, along with the boundaries for the sanitary (wastewater) sewer and storm water service area. Florence and Walton are shown separately, because these communities are responsible for their own wastewater and storm water.

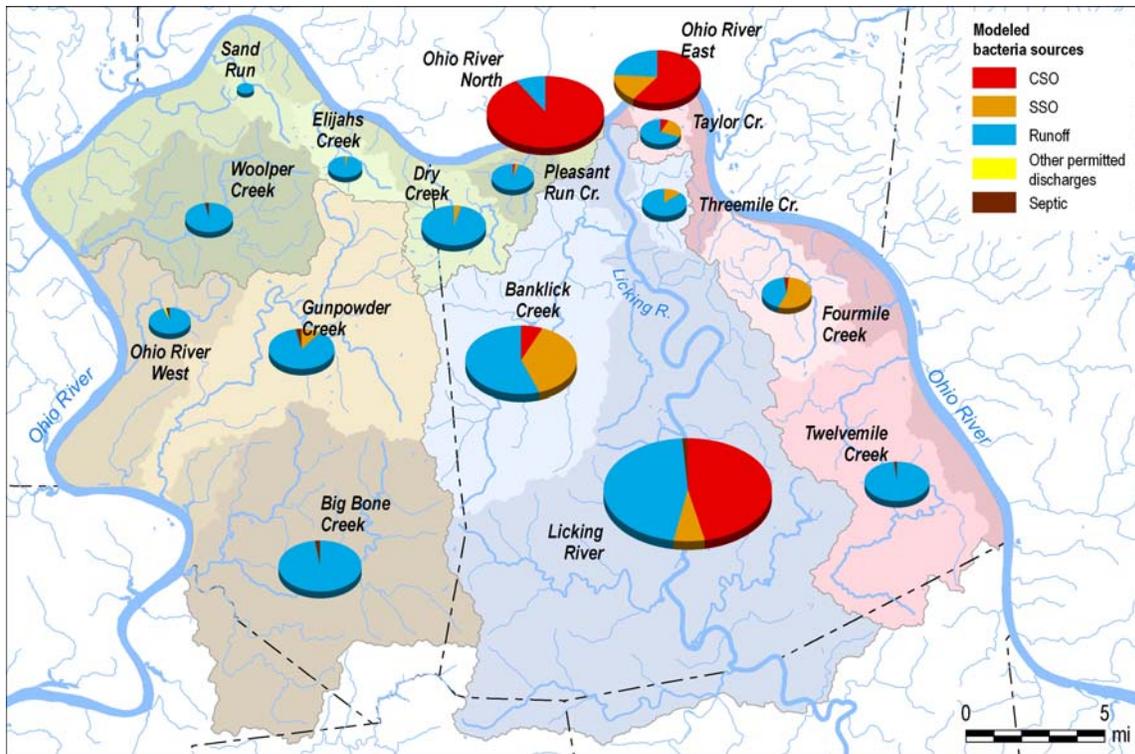
**Figure 7. WAT! Loading Potential Results for Fecal Coliform**

The pie charts shown in Figure 7 are sized to reflect the potential for each watershed to generate fecal coliform bacteria, for year-round conditions, relative to the other study area watersheds. A larger pie chart indicates that a watershed has a higher potential to generate bacteria loads. The pie slices reflect the loading potential by source. In most watersheds, storm water runoff (e.g., runoff from agricultural, developed and forested lands) is the source with the highest potential to generate bacteria.

*The Licking River pie chart does not include results from sources outside the study area or from Banklick Creek and Threemile Creek, which are presented separately.*

The potential for these sources to generate fecal coliform bacteria loads over a year-round period has been assessed using WAT!. These WAT! results also incorporate predicted sewer overflow volumes from infrastructure model simulations.<sup>3</sup>

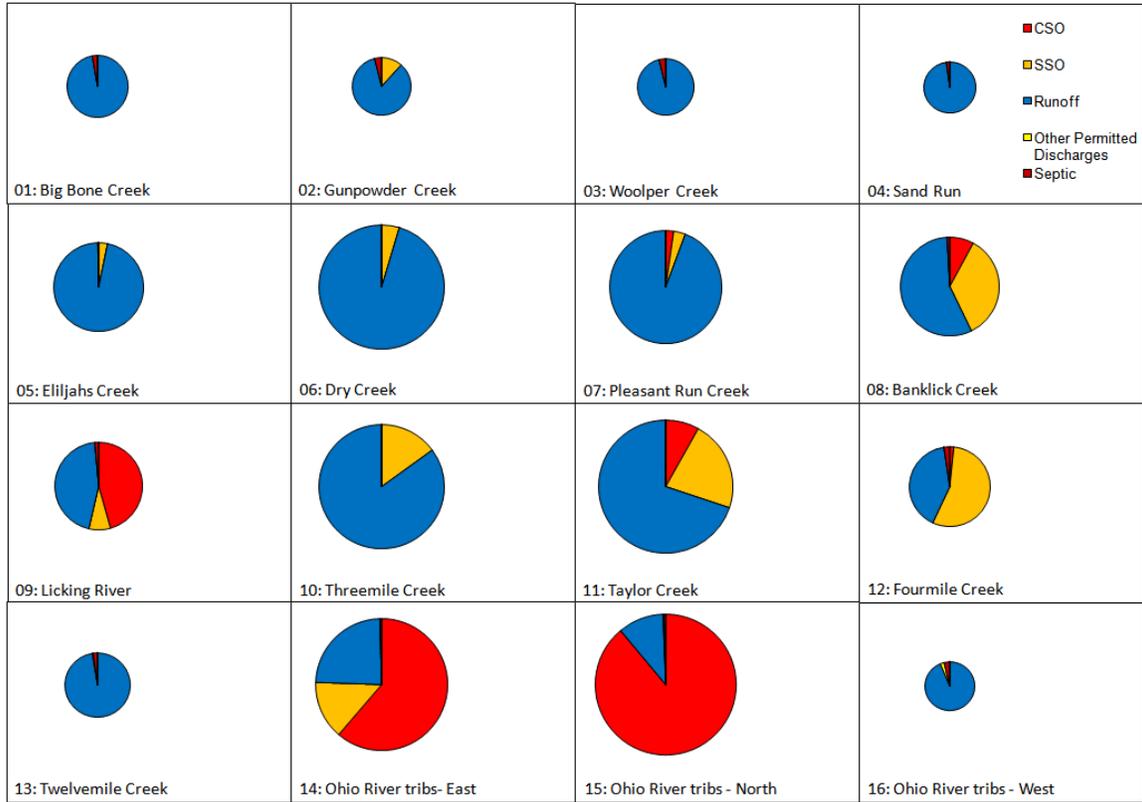
**Figure 8. WAT! Area-Normalized Results Indicating Fecal Coliform Impact**

Figure 8 shows the area-normalized results for each watershed, where the size of each pie reflects what can be viewed as loading potential per acre. For example, both the larger rural Ohio River West watershed (with a 33.0 square mile drainage area) and much smaller, urban Pleasant Run Creek watershed (with a 6.5 square mile drainage area) have similar bacteria loading potentials, as shown in Figure 7. When normalized by watershed area, as shown in Figure 8, it can be seen that, on average, land in the Pleasant Run Creek watershed has a higher bacteria loading potential than land in the Ohio River West watershed.

WAT! can also be applied to assess the potential that each watershed has to impact water quality. This potential impact can be calculated in WAT!, by normalizing the bacteria loading potential of each watershed by the watershed's drainage area (e.g., by dividing the loading potential shown in Figure 7, by the area of each watershed). The area-normalized results for each watershed can then be ranked for year-round or dry weather conditions to inform prioritization of pollutant source investigations and controls.

Table 1 shows the rankings for the sixteen watersheds based on their respective area-normalized results, for both year-round and dry weather conditions. Dry weather conditions were assessed separately because bacteria can adversely affect recreational use of the streams and people may be more likely to use the streams when flow conditions are not affected by runoff. A ranking of 1 reflects a larger potential to impact instream water quality and a ranking of 16 reflects a lower potential to impact water quality. As discussed previously, even though the Ohio River West and Pleasant Run Creek watersheds have similar bacteria loading potentials, their watershed rankings based on potential impact (area-normalized results) are quite different.

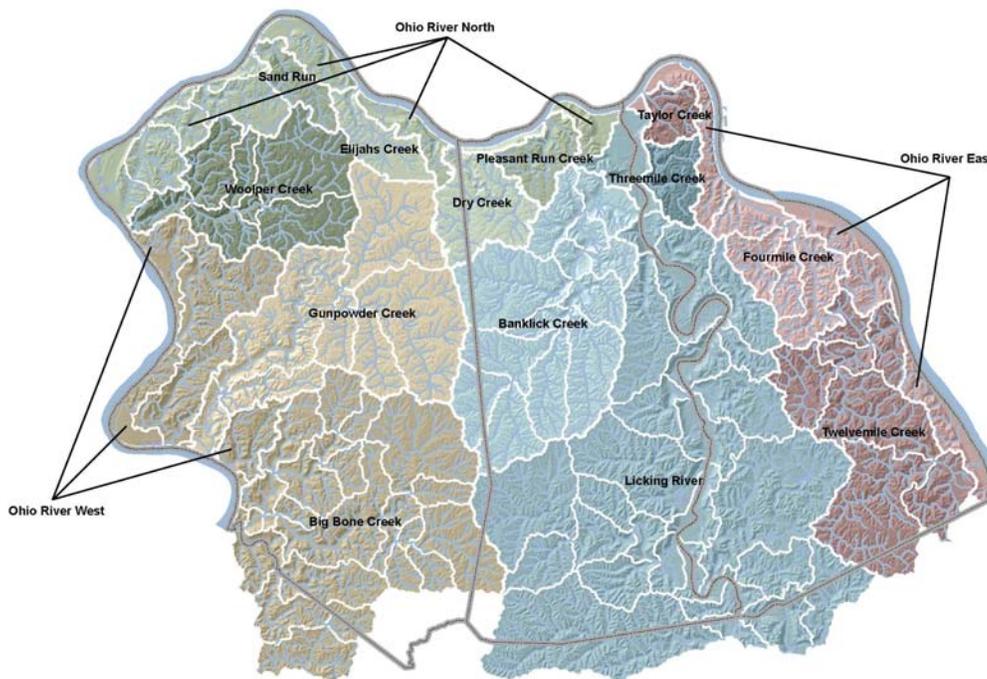
**Figure A-1. Watershed Map**

This appendix contains individual fact sheets that are specific to the study area watersheds (Figure A-1). The fact sheets provide an overview of the study area watersheds, condensed from the more detailed Watershed Characterization Reports<sup>4,5</sup>. Each fact sheet consists of a table of key watershed features and a map showing identified sources within the watershed. The fact sheets primarily describe current watershed conditions and sources, but also include predicted future land cover and percent imperviousness for roughly 2030 conditions. A key to understanding the information described in the fact sheet tables is presented in Table A-1.

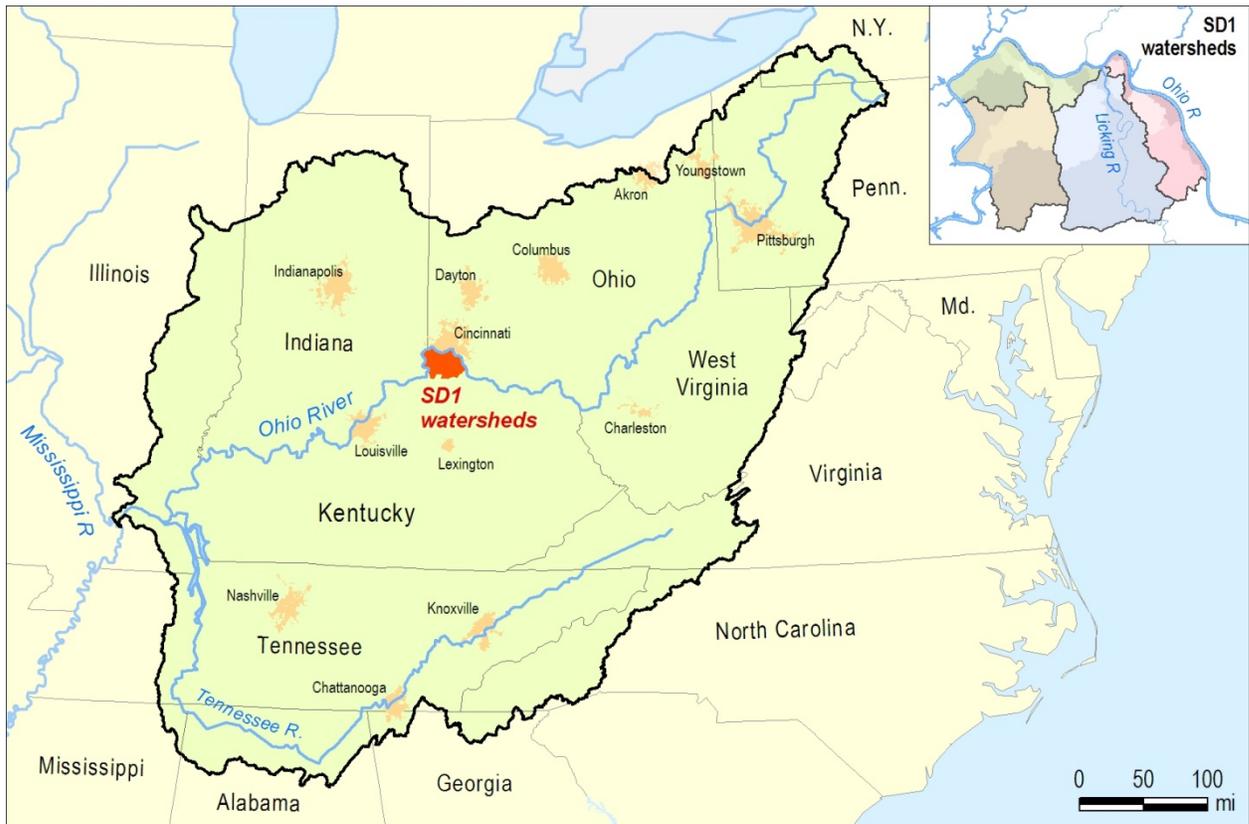
### SD1 Study Area Watersheds within the Ohio River Watershed

The Ohio River is almost 1,000 miles long and its watershed drains over 200,000 square miles and portions of fourteen states. The sixteen study area watersheds have an area of 592 square miles and comprise less than 0.3% of the Ohio River watershed.

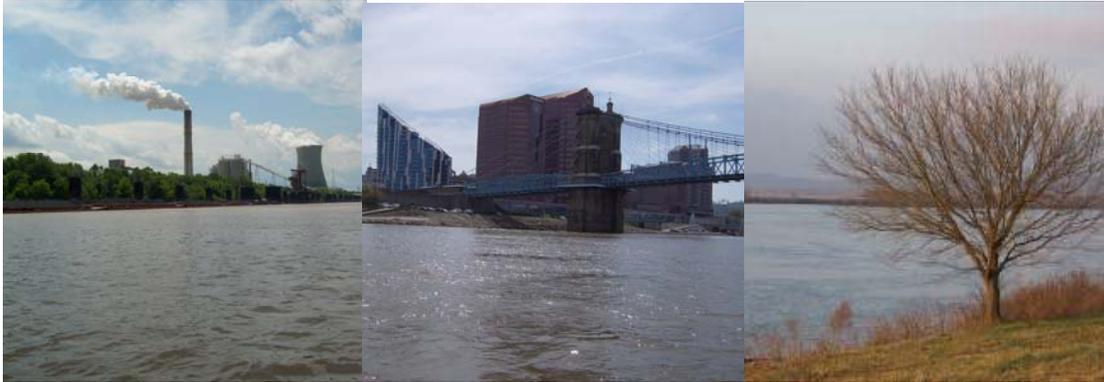
With the exception of two Licking River tributaries (Banklick Creek and Threemile Creek), the study area watersheds drain directly to the Ohio River. The relative potential of each watershed to generate fecal coliform bacteria has been predicted using WAT!. These results are plotted below, in the order (upstream to downstream) that these watersheds drain to the Ohio River. The portion of the Licking River watershed within SDI’s study area is defined as the area draining to the Licking River between the mouth and River Mile 35.6.
