Banklick Creek Watershed Characterization Report

Prepared for: Sanitation District No. 1 of Northern Kentucky

January 2009

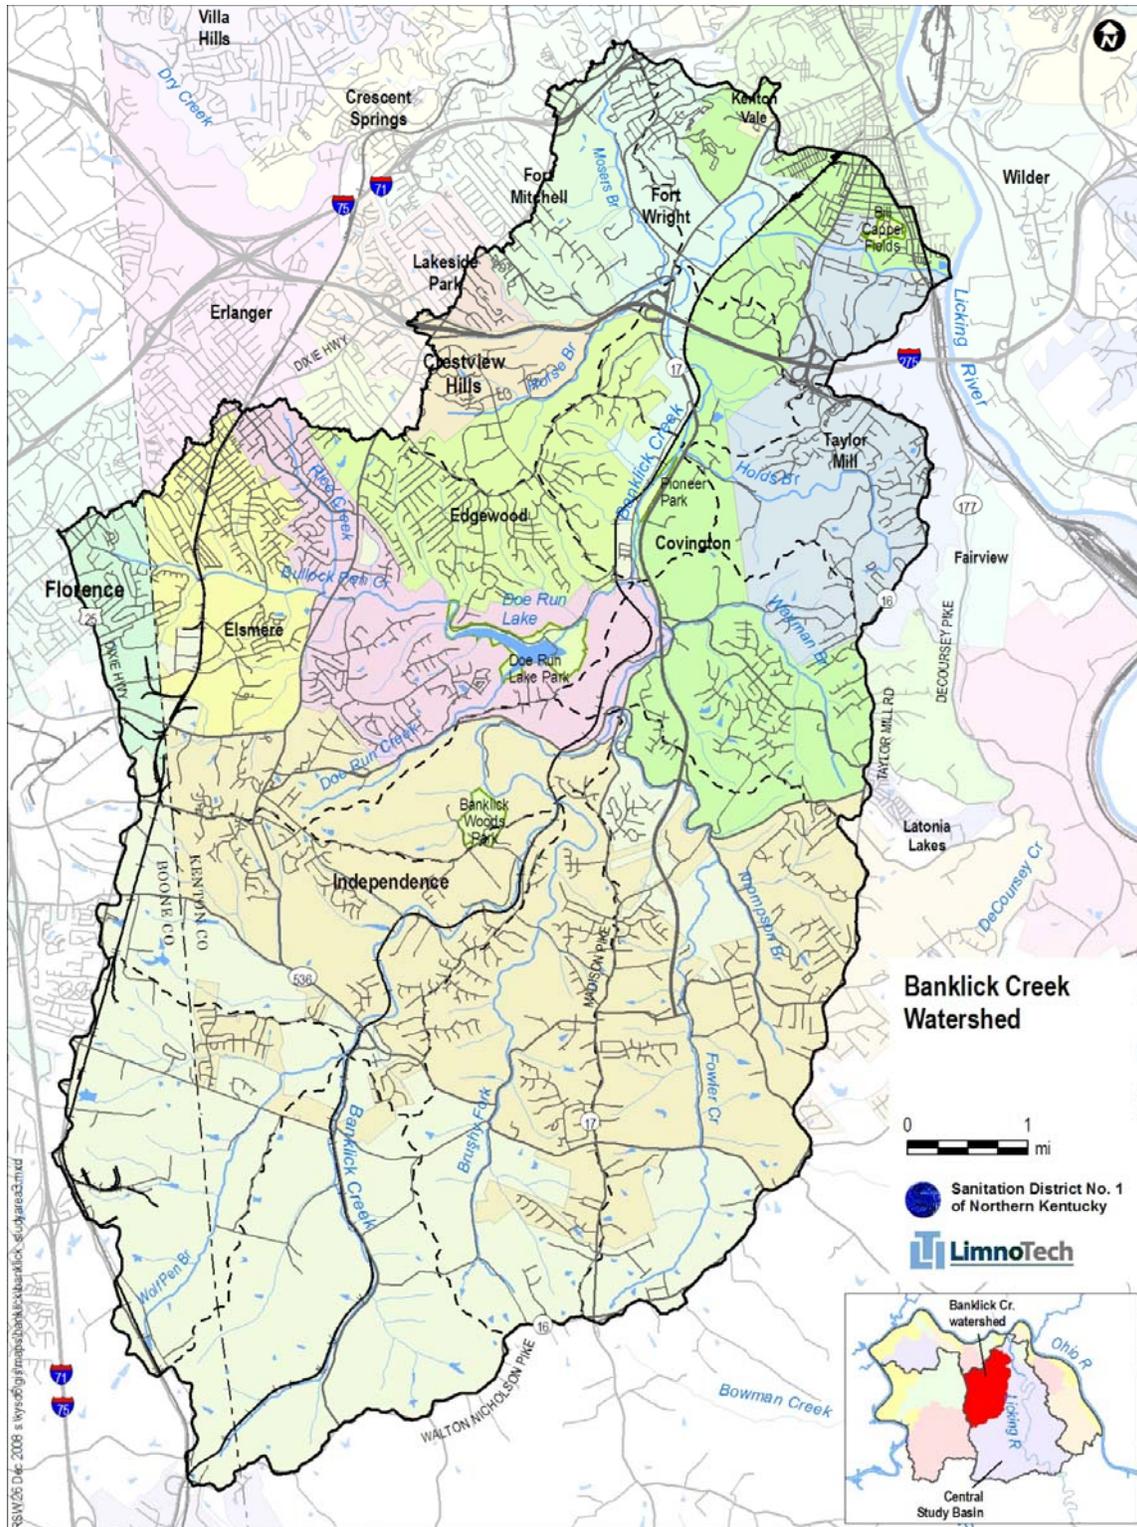
Figure 1. Banklick Creek Watershed

The 58.2-square mile Banklick Creek watershed is located in Kenton and Boone Counties, in the Central Study Basin (Figure 1). Development is found throughout most of this watershed, although the headwaters are currently much less developed. The topography is fairly steep and flooding has been a recurring issue in this watershed. Doe Run Lake, a 51-acre reservoir (normal pool), is located on Bullock Pen Creek. This reservoir was constructed between 1978 and 1982 to help control flooding, but flooding problems persist.

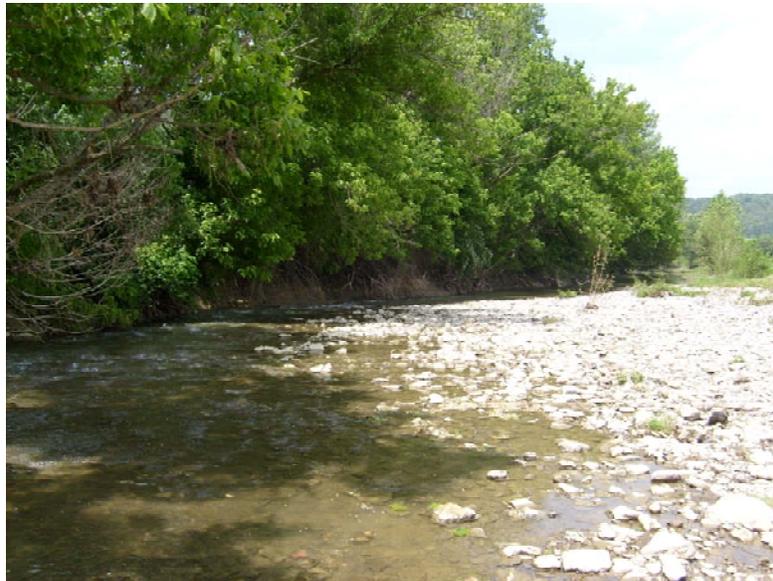
Figure 2. Banklick Creek at RM 5.5

The nature of soils and topography in a watershed play an important role in both the amount of runoff generated and the amount of soil erosion that can occur. Most (93%) of the soils in the Banklick Creek watershed are classified as hydrologic soil group C (NRCS, 2006), meaning they have slow infiltration rates when thoroughly wetted. Roughly 60% of the soils in the watershed are ranked “highly erodible”, and the remaining 40% of the watershed soils are ranked “fairly erodible” as indicated by an index for erodibility (NRCS, 2006). The erodibility of soils is important when soils are disturbed through activities such as land clearing for new development. Portions of the watershed, especially within the City of Independence and near the Banklick Creek headwaters, are undergoing significant development, as discussed in Section 2.2.2, and areas of severe erosion have been observed in this watershed (Figure 2).

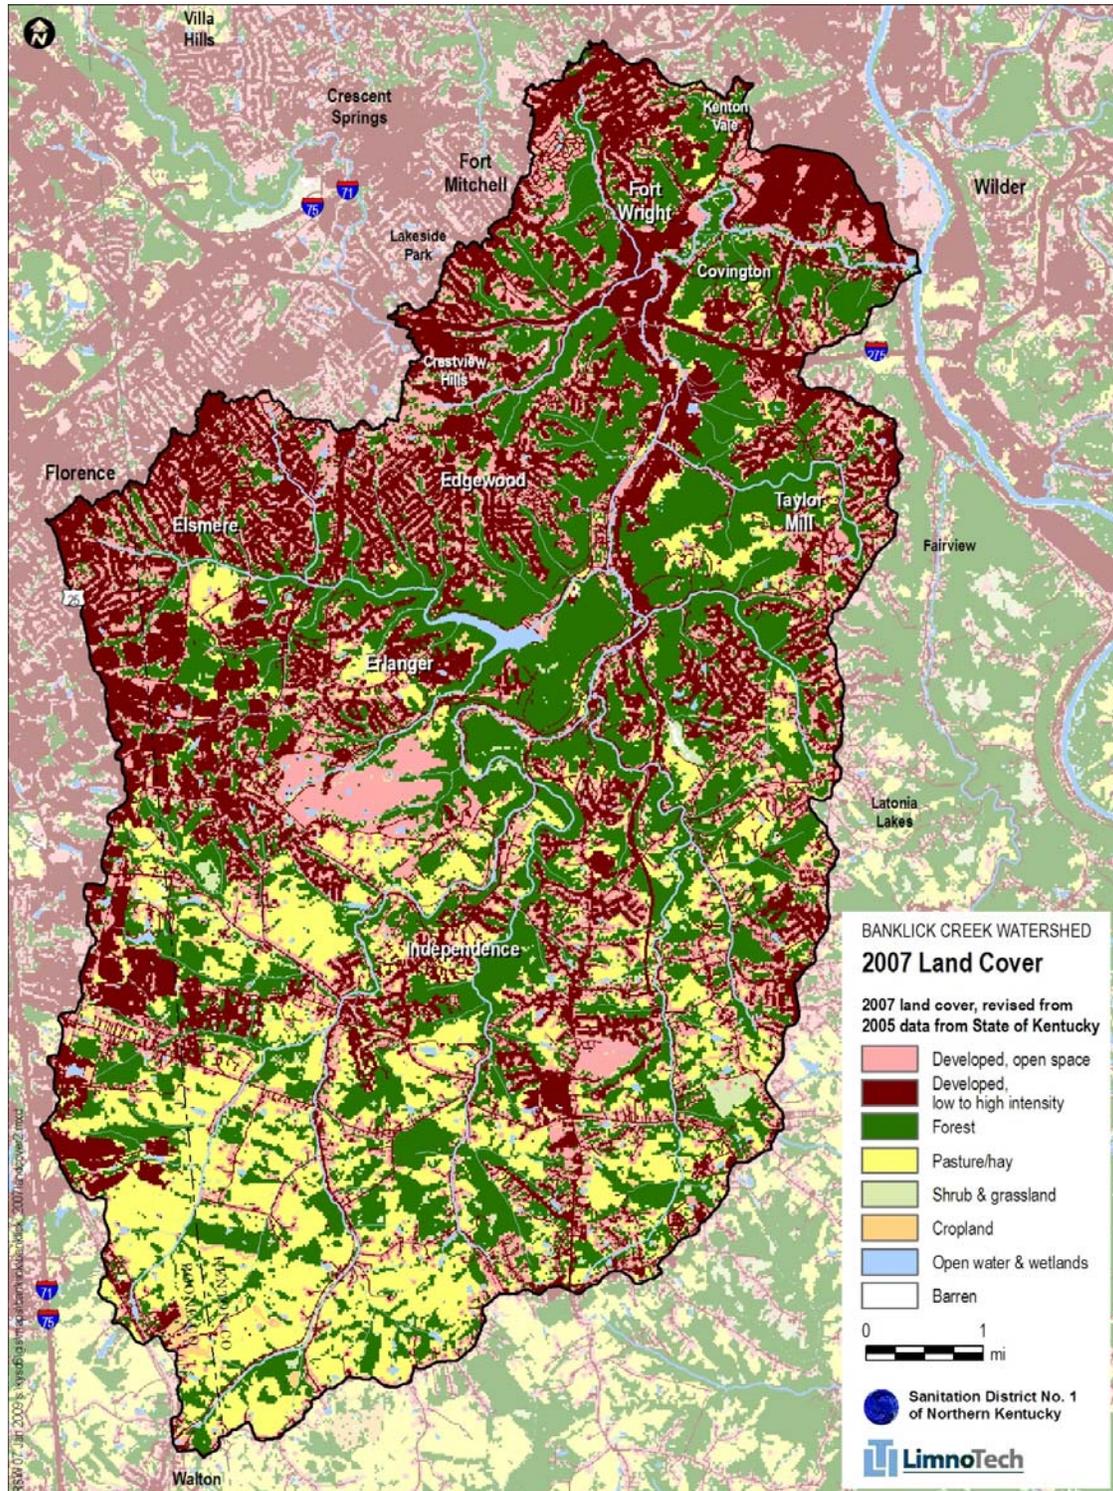
Figure 4. 2007 Land Cover

The Kentucky Division of Geographic Information, Commonwealth Office of Technology provided a GIS dataset showing 2005 Kentucky land cover. This dataset was updated and improved to approximate 2007 land cover conditions (Figure 4) using a variety of other datasets that represent current impervious conditions (roads, parking lots, buildings), open space lands (including parks), and surface waters.

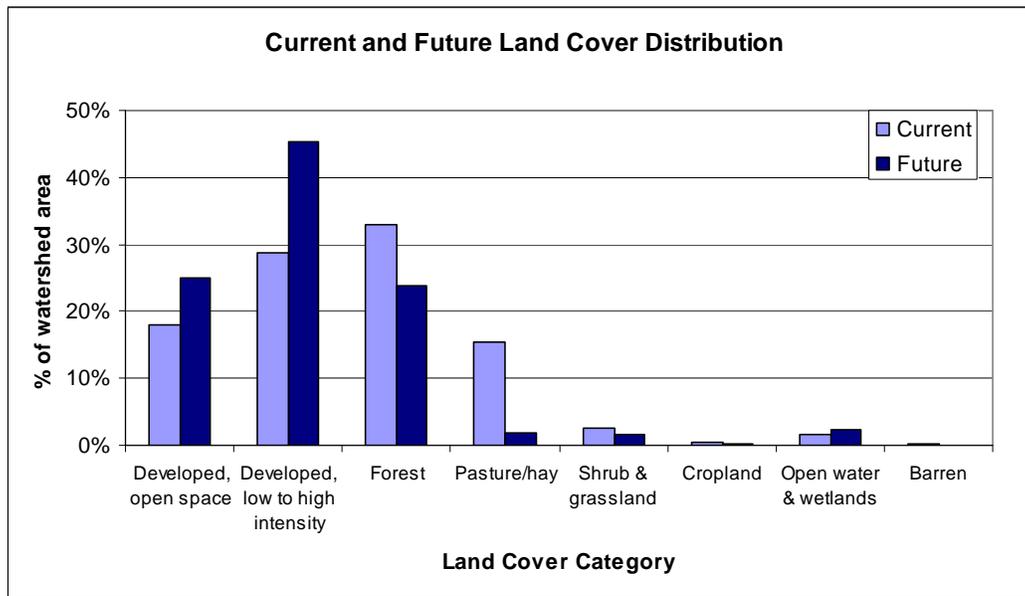
Figure 5. Current and Predicted Future Land Cover

Future land cover was developed by modifying 2007 land cover to reflect potential future conditions (roughly 2030) obtained from SD1 and the Northern Kentucky Area Planning Commission (NKAPC). It is predicted that development will comprise 70% of this watershed, with most development replacing forest and pasture/hay (Figure 5). Imperviousness is predicted to increase from 11% to 17%. Because flat land is becoming scarce, this development is expected to occur more frequently in areas with steep slopes (NKAPC, 2006).

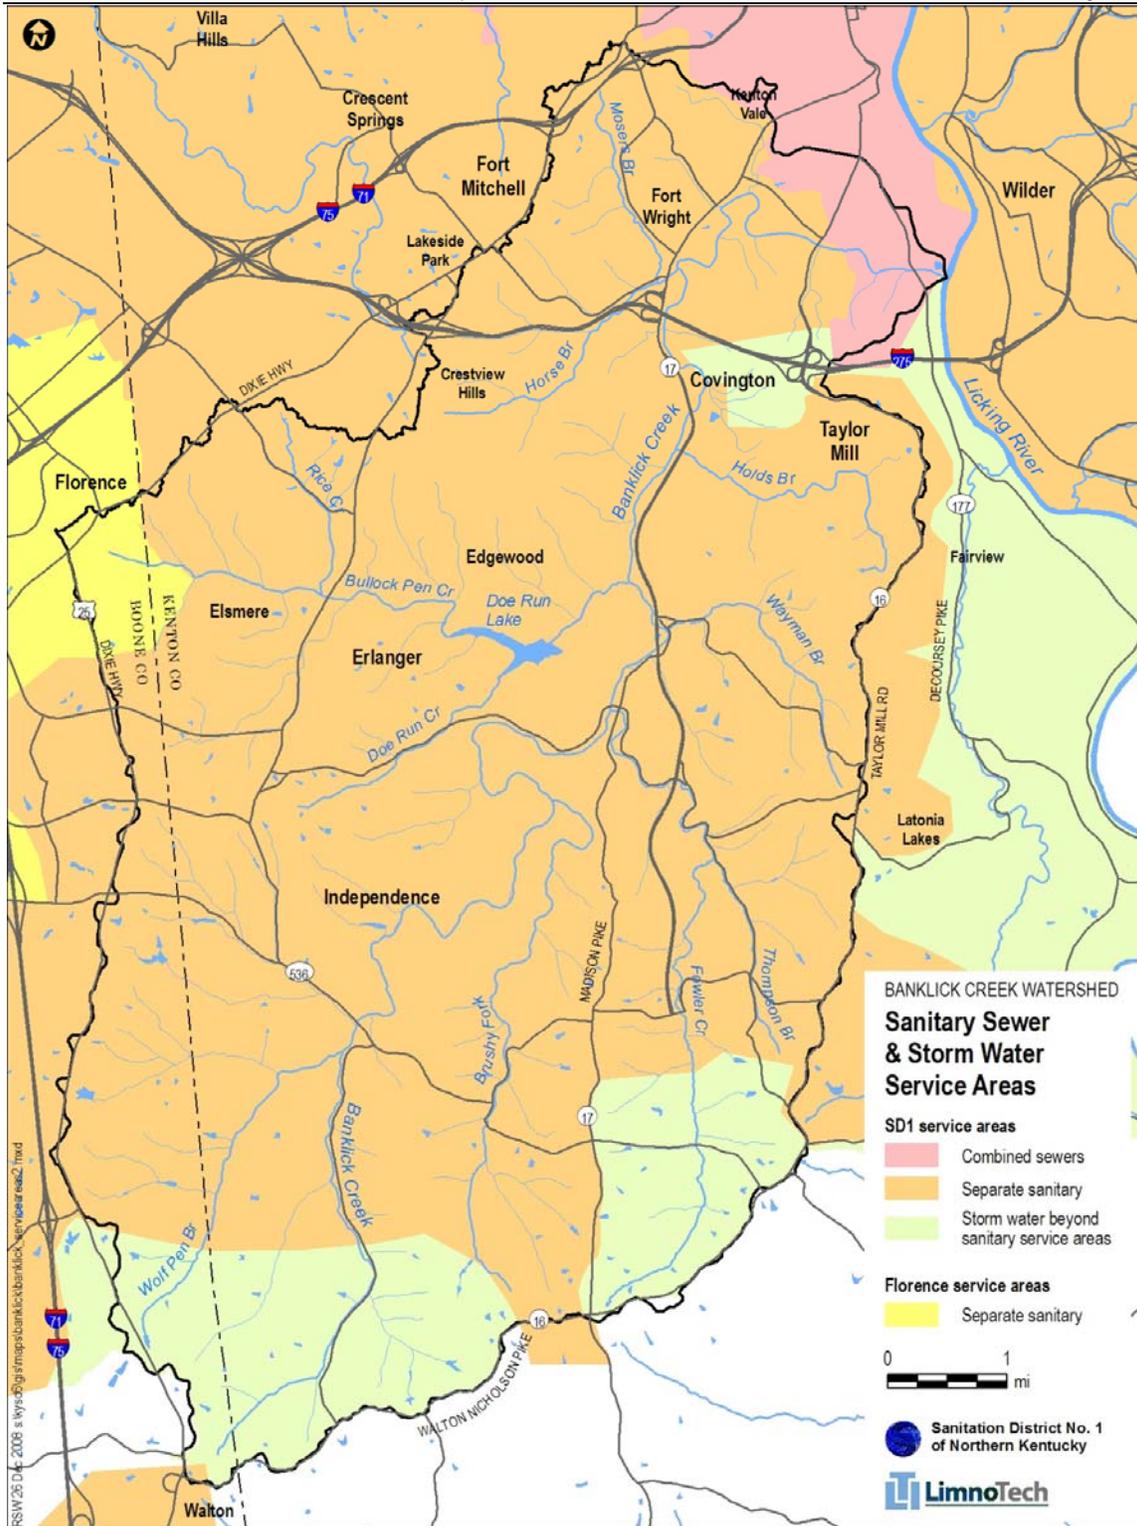
Figure 6. Sanitary Sewer, Combined Sewer and Storm Water Service Areas

The extent of the sanitary sewer, combined sewer and storm water service areas in this watershed is shown in Figure 6.

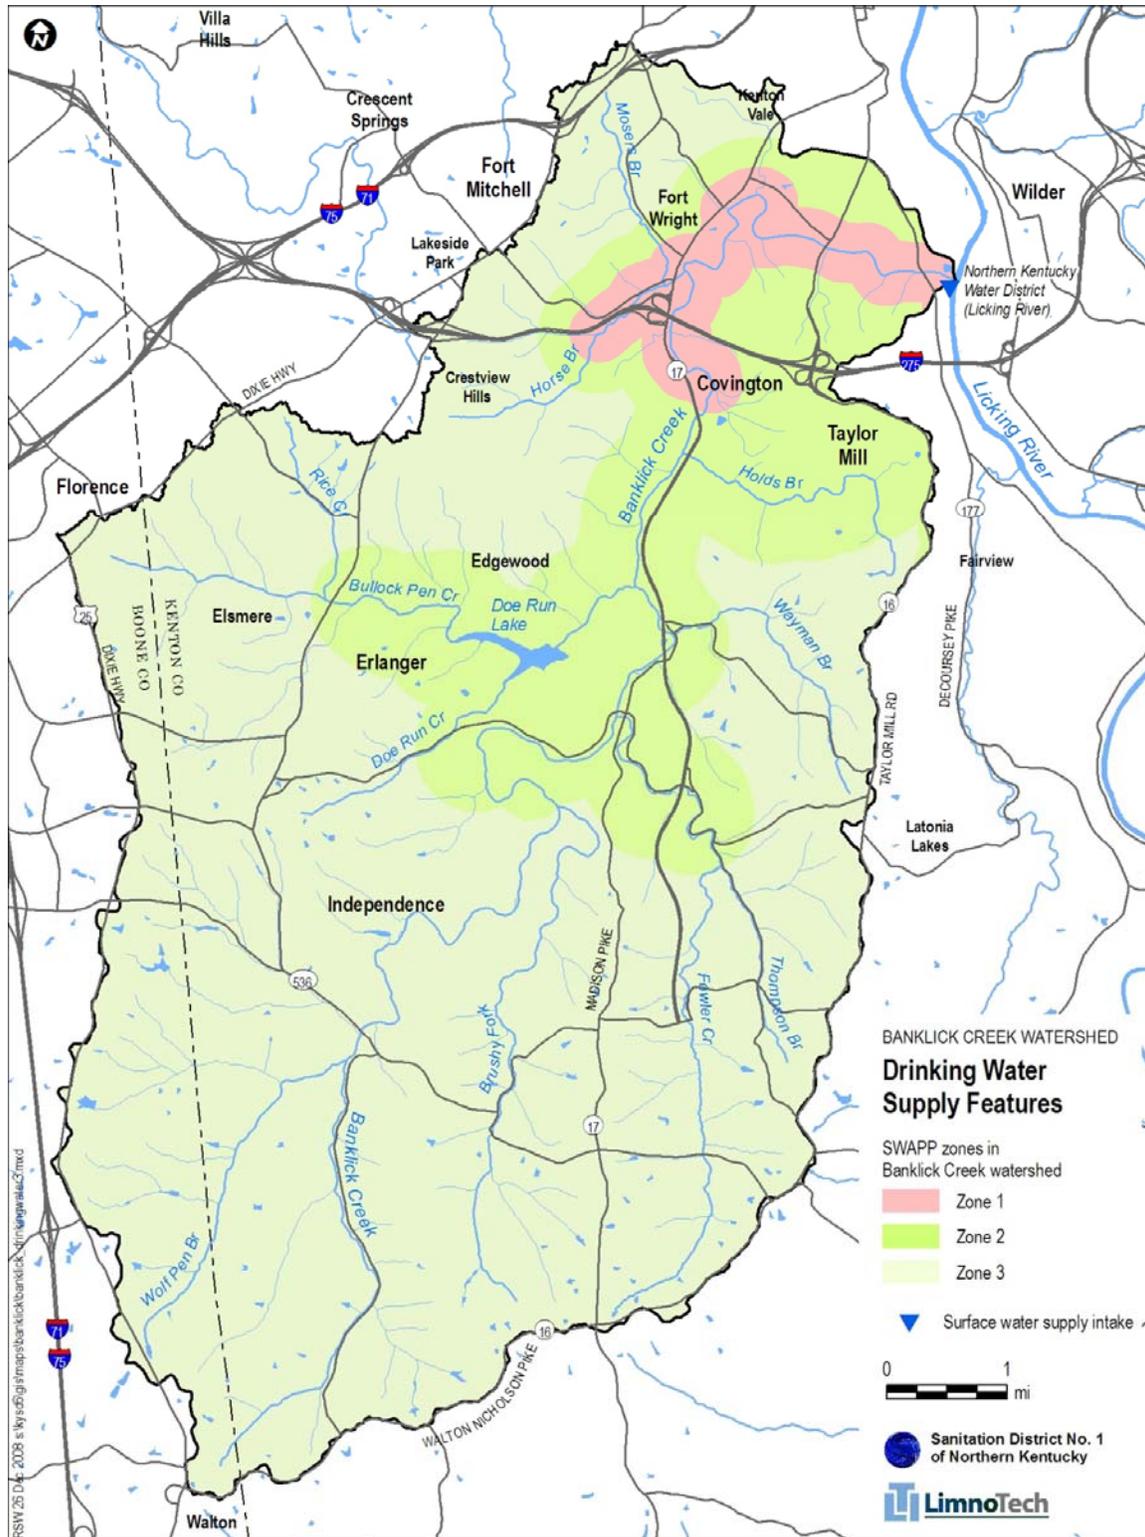
Figure 8. Drinking Water Supply Features

Source Water Assessment and Protection Areas (SWAPPs) for the water intake on the Licking River have been delineated to identify potential contaminants upstream of the water intake. The SWAPP zones are not used in a regulatory sense but are used to support identification of sources potentially impacting the intakes. Due to the location of the NKWD intake, portions of this watershed lie within SWAPP Zone 1, which extends 5 miles upstream on Banklick Creek from the mouth. The remainder of the watershed lies within SWAPP Zones 2 and 3, because they are farther from the intake.

Drinking water supply features are shown in Figure 8.

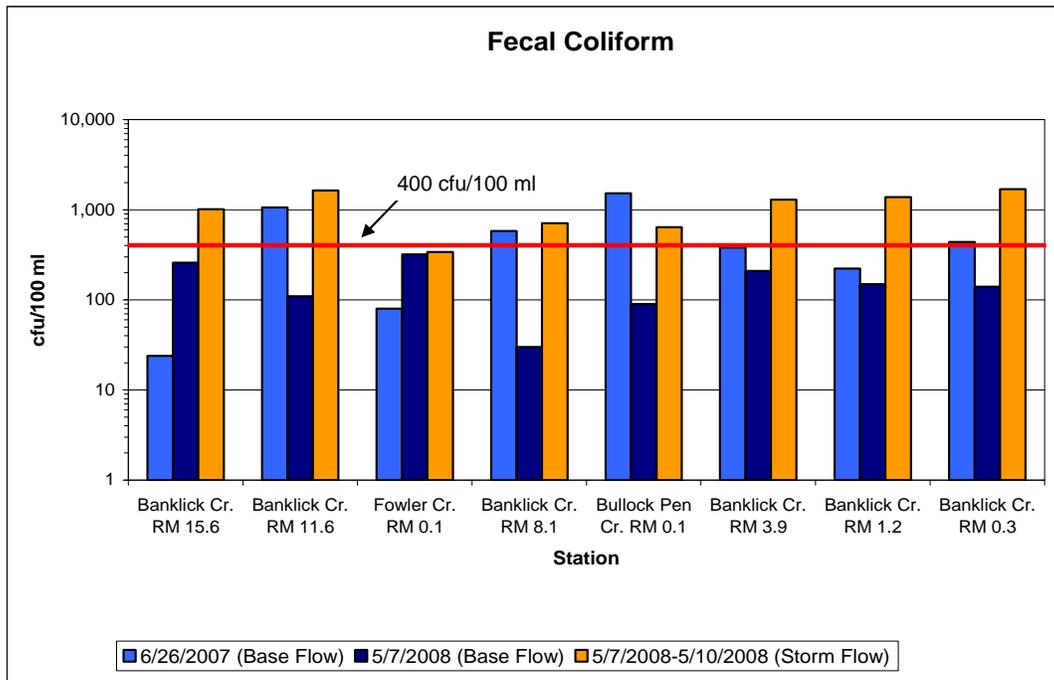
Fecal coliform and *E. coli* data were available for both base flow and storm conditions. Storm flow results for bacteria are presented as an average over the storm event. As shown in Figure 9, fecal coliform concentrations exceeded the applicable criterion in Banklick Creek and Bullock Pen Creek. Four of the 16 base flow samples exceeded the fecal coliform criterion, and storm flow samples exceeded the criterion at every location except Fowler Creek at RM 0.1. The maximum base flow fecal coliform concentration, 1,530 cfu/100 ml, was observed at Bullock Pen Creek RM 0.1, while the maximum storm event concentration, 1,697 cfu/100 ml, was observed at Banklick Creek RM 0.3.

Figure 9. 2006-08 Base Flow and Average Storm Flow Fecal Coliform Concentrations Compared to 400 cfu/100 ml Criterion

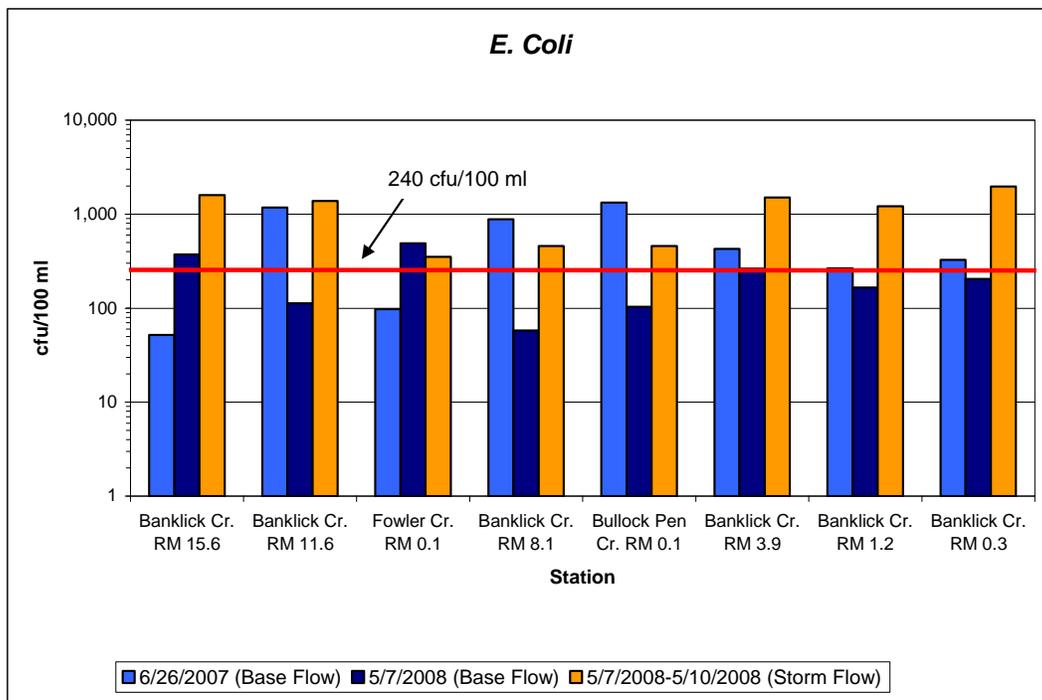
E. coli concentrations exhibited a similar pattern, as shown in Figure 10. Eight of the 16 base flow measurements exceeded the applicable criterion, with exceedances observed at all sampling locations. The maximum base flow *E. coli* concentration, 1,333 cfu/100 ml, was observed at Bullock Pen Creek RM 0.1. Storm flow measurements exceeded the criterion at all locations, with a maximum concentration of 1,972 cfu/100 ml observed at Banklick Creek RM 0.3.

Figure 10. 2006-08 Base Flow and Average Storm Flow E. Coli Concentrations Compared to 240 cfu/100 ml Criterion

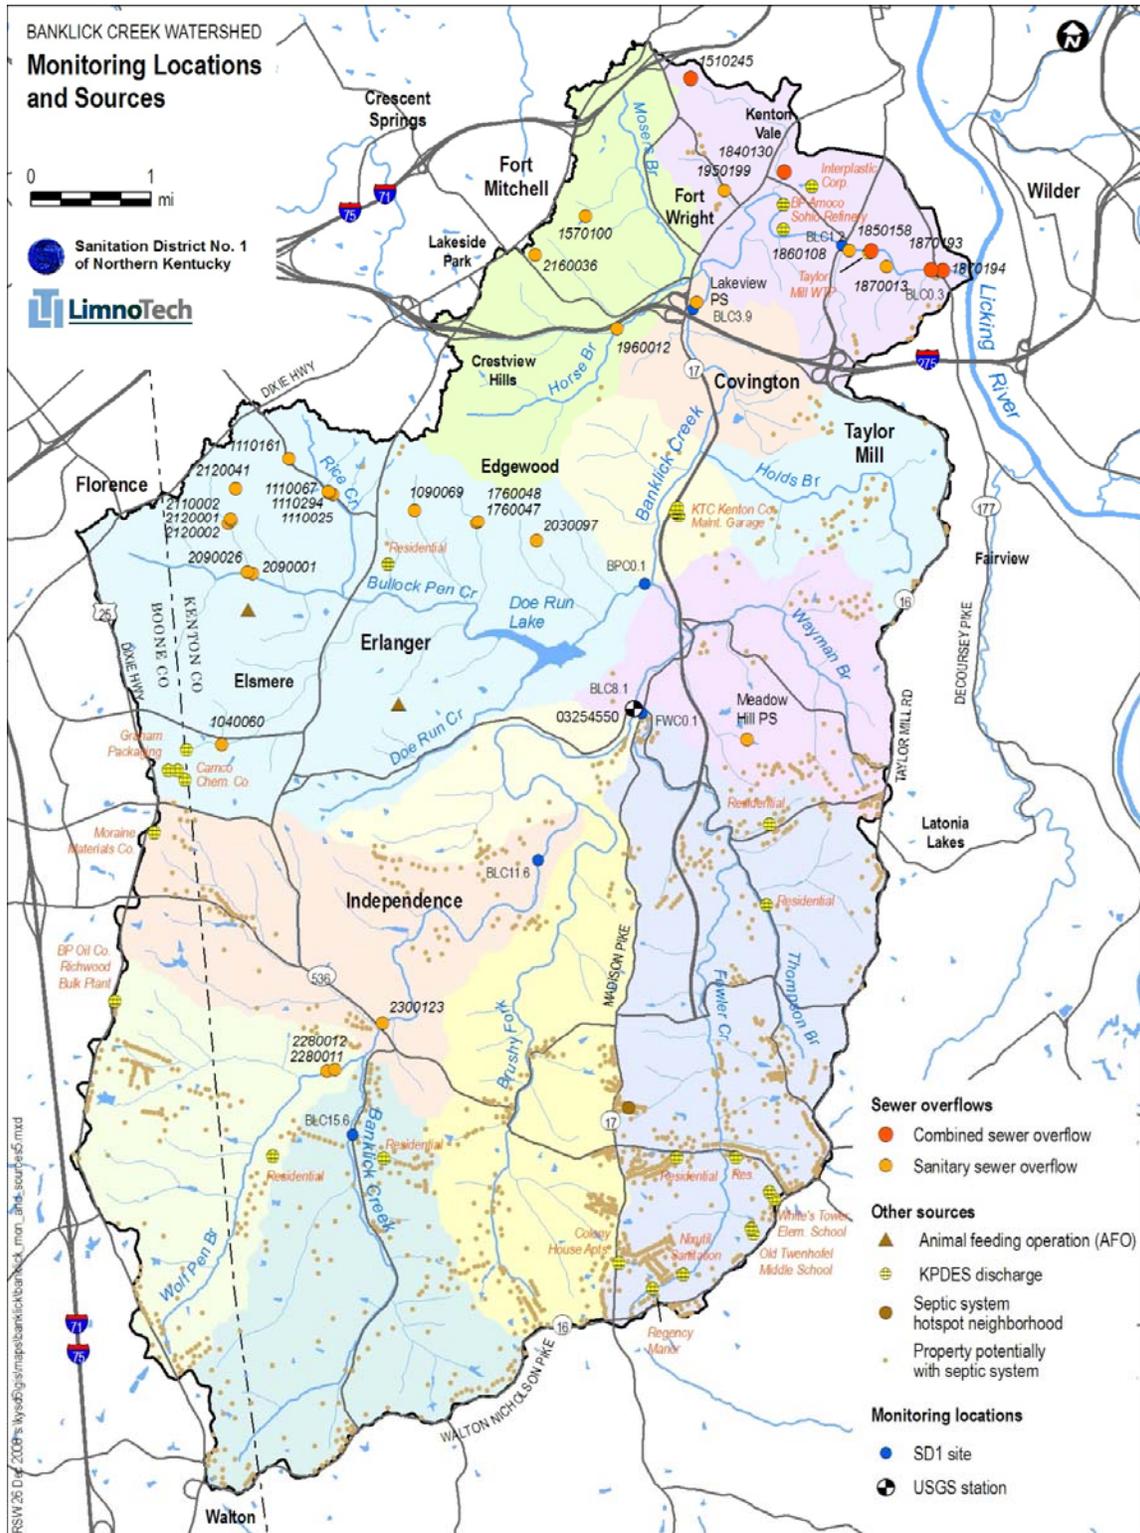
Figure 11. Monitoring Locations and Sources

Potential sources of bacteria were identified within the Banklick Creek watershed, based on the watershed characterization information discussed previously. Bacteria exceedances have been observed during both base flow and storm flow conditions at all locations recently monitored. These sources are summarized in Table 14 and their location is shown in Figure 11.

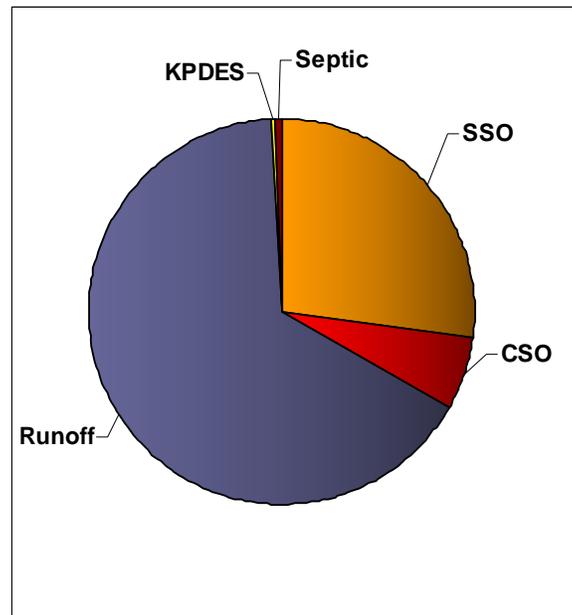
Figure 12. Initial Year-Round WAT! Results for Fecal Coliform

The sources identified through the process of watershed characterization have been quantified using the WAT!. WAT! has been applied for a five-year period (1992-1996 climatological conditions), to quantify fecal coliform contributions by source. Together the characterization and WAT! results help inform source prioritization for improvement or elimination.

Under year-round conditions, the largest source of fecal coliform bacteria is storm water runoff. Septic systems are not a significant contributor to the total annual bacteria load; however, during base flow conditions they are estimated to contribute the majority of the fecal coliform load.
