Elijahs Creek Watershed Characterization Report

Prepared for: Sanitation District No. 1 of Northern Kentucky

January 2009

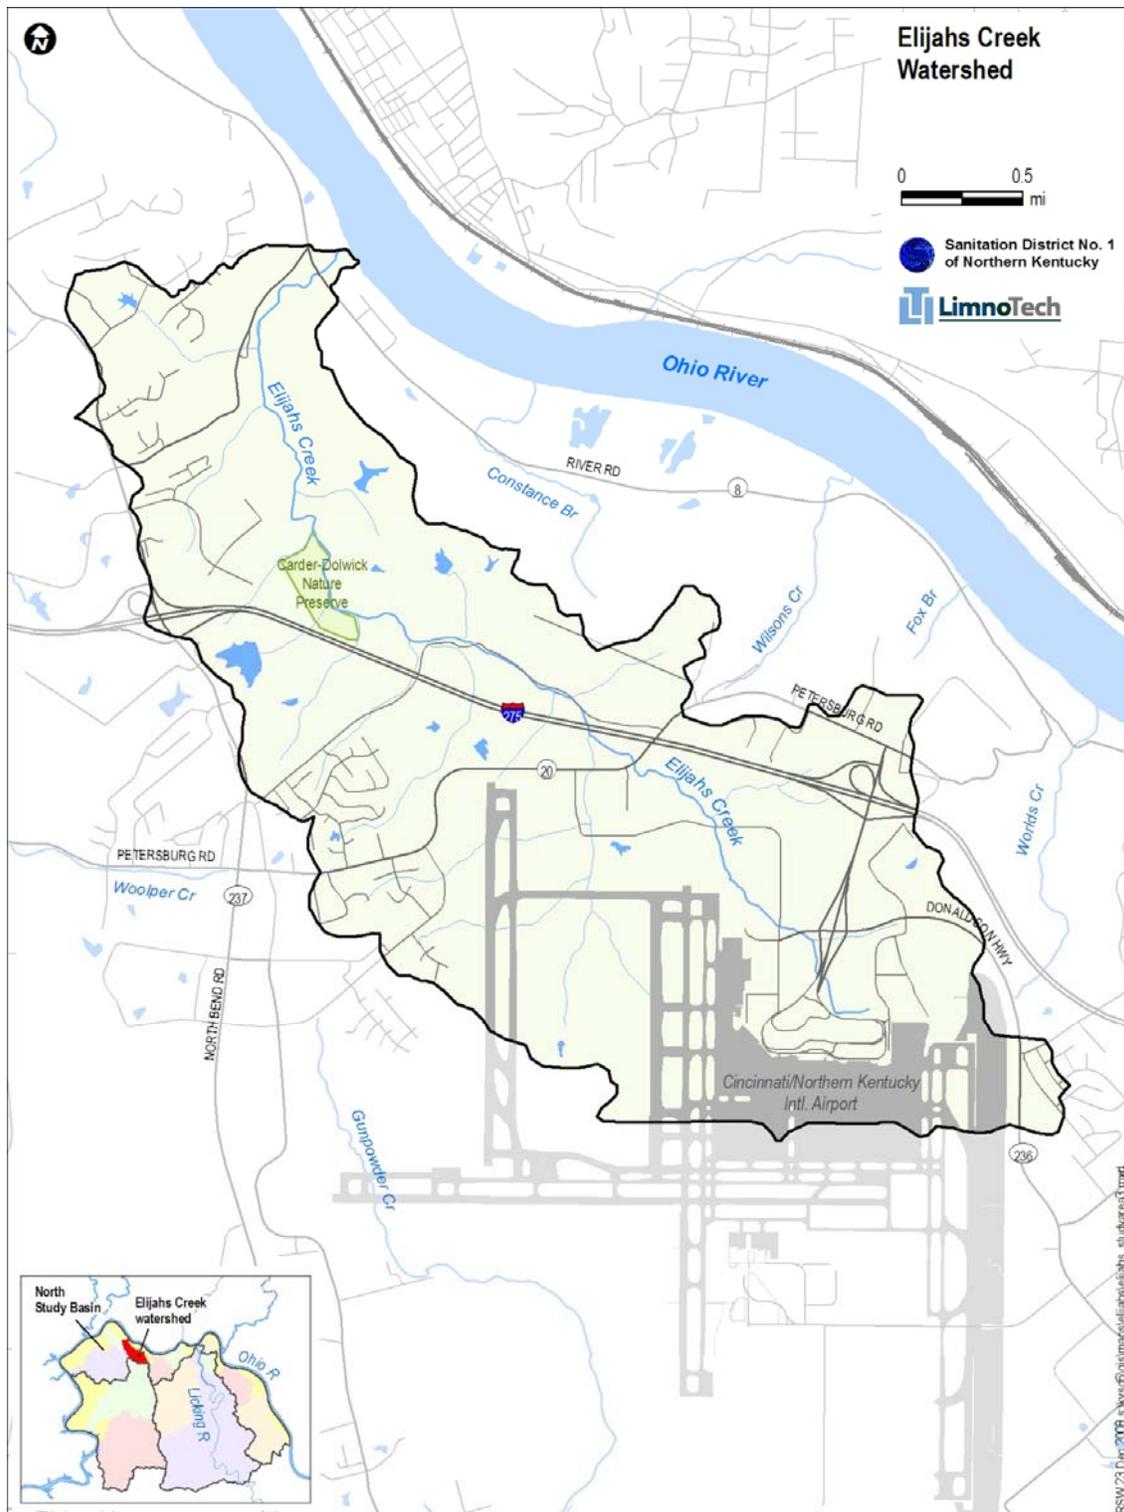
Figure 1. Elijahs Creek Watershed

The Elijahs Creek watershed is located in Boone County, in the North Study Basin (Figure 1). Elijahs Creek is one of the smaller watersheds in the study area but has the highest percent imperviousness. Developed lands comprise 68% of the watershed, with the Cincinnati/Northern Kentucky International Airport located in the headwaters area.

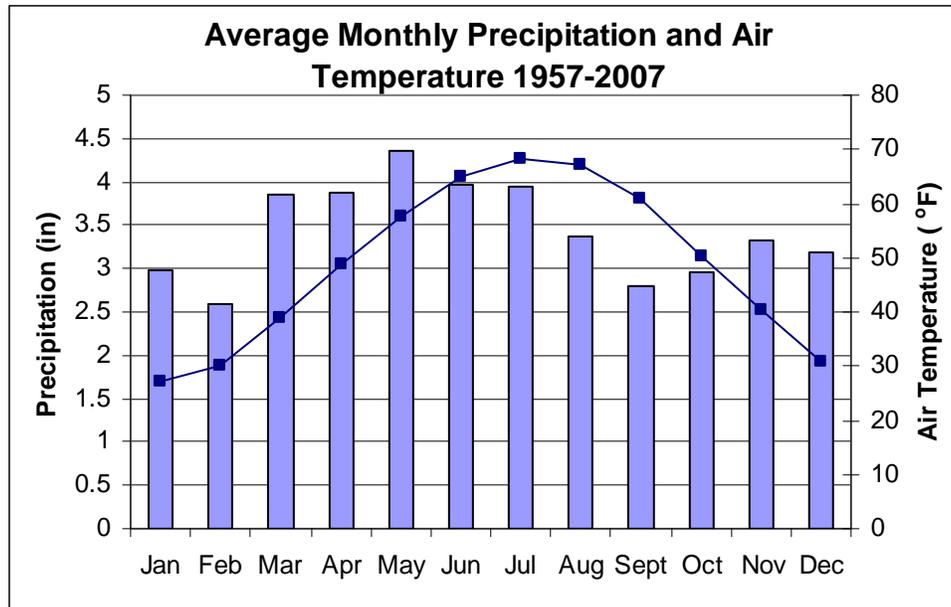
Figure 2. Average Monthly Precipitation and Air Temperature at the Cincinnati Northern Kentucky Airport (1957-2007)

The temperatures in this area are generally lowest in January and highest in July. Precipitation averages 41.2 inches annually, with the wettest months observed between March and July. Minimum precipitation is recorded in the fall and late winter as shown in Figure 2 (NCDC, 2008).

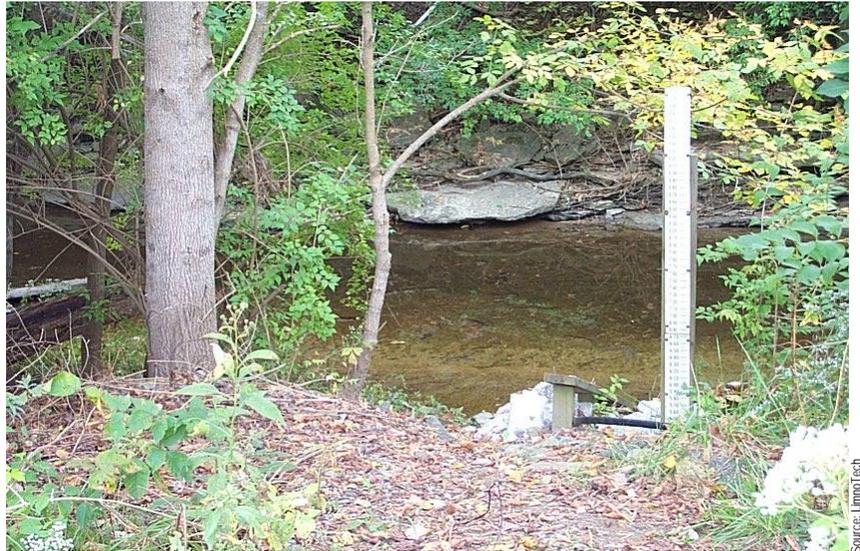
Figure 3. Elijahs Creek

Elijahs Creek is steep in some areas and has limited riparian areas. Some underlying bedrock occurs within the stream margins, but fine sediments are common instream (Figure 3).

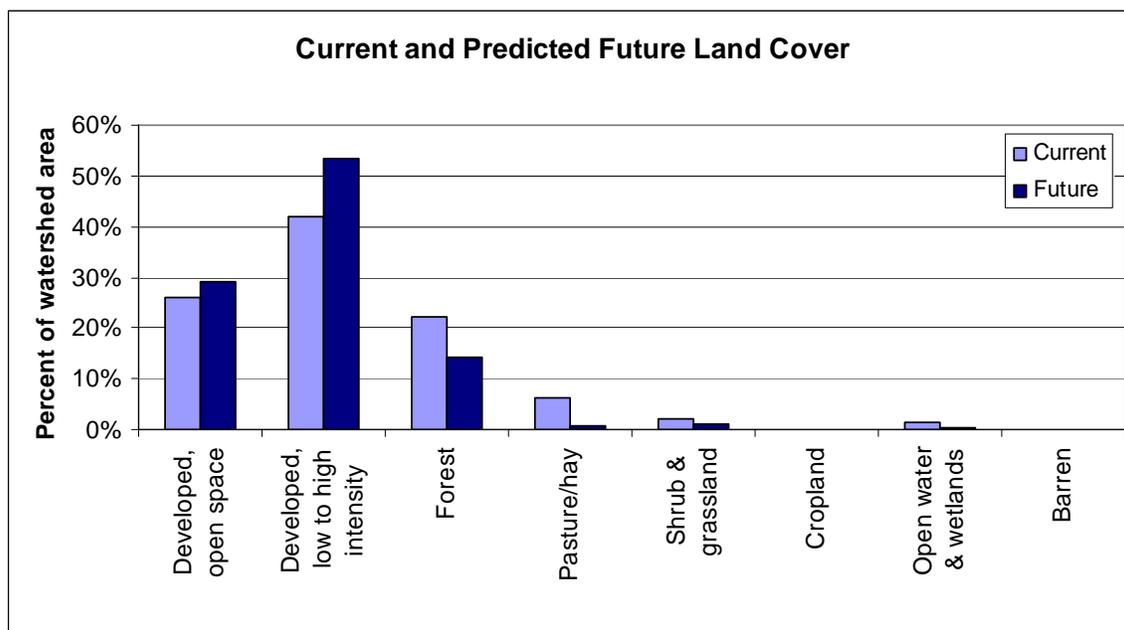
Figure 5. Current and Predicted Future Land Cover

Future land cover was developed by modifying 2007 land cover to reflect potential future conditions (roughly 2030) obtained from SD1 and the Northern Kentucky Area Planning Commission (NKAPC). Development is predicted to primarily replace forest and pasture lands (Figure 5). If development occurs as predicted, this will become the most developed of the 16 watersheds (83% developed land). Impervious surfaces in the watershed are predicted to increase from 25% to 31%.

The Kentucky Division of Geographic Information, Commonwealth Office of Technology provided a GIS dataset showing 2005 Kentucky land cover. This dataset was updated and improved to approximate 2007 land cover conditions (Figure 4) using a variety of other datasets that represent current impervious conditions (roads, parking lots, buildings), open space lands (including parks), and surface waters.

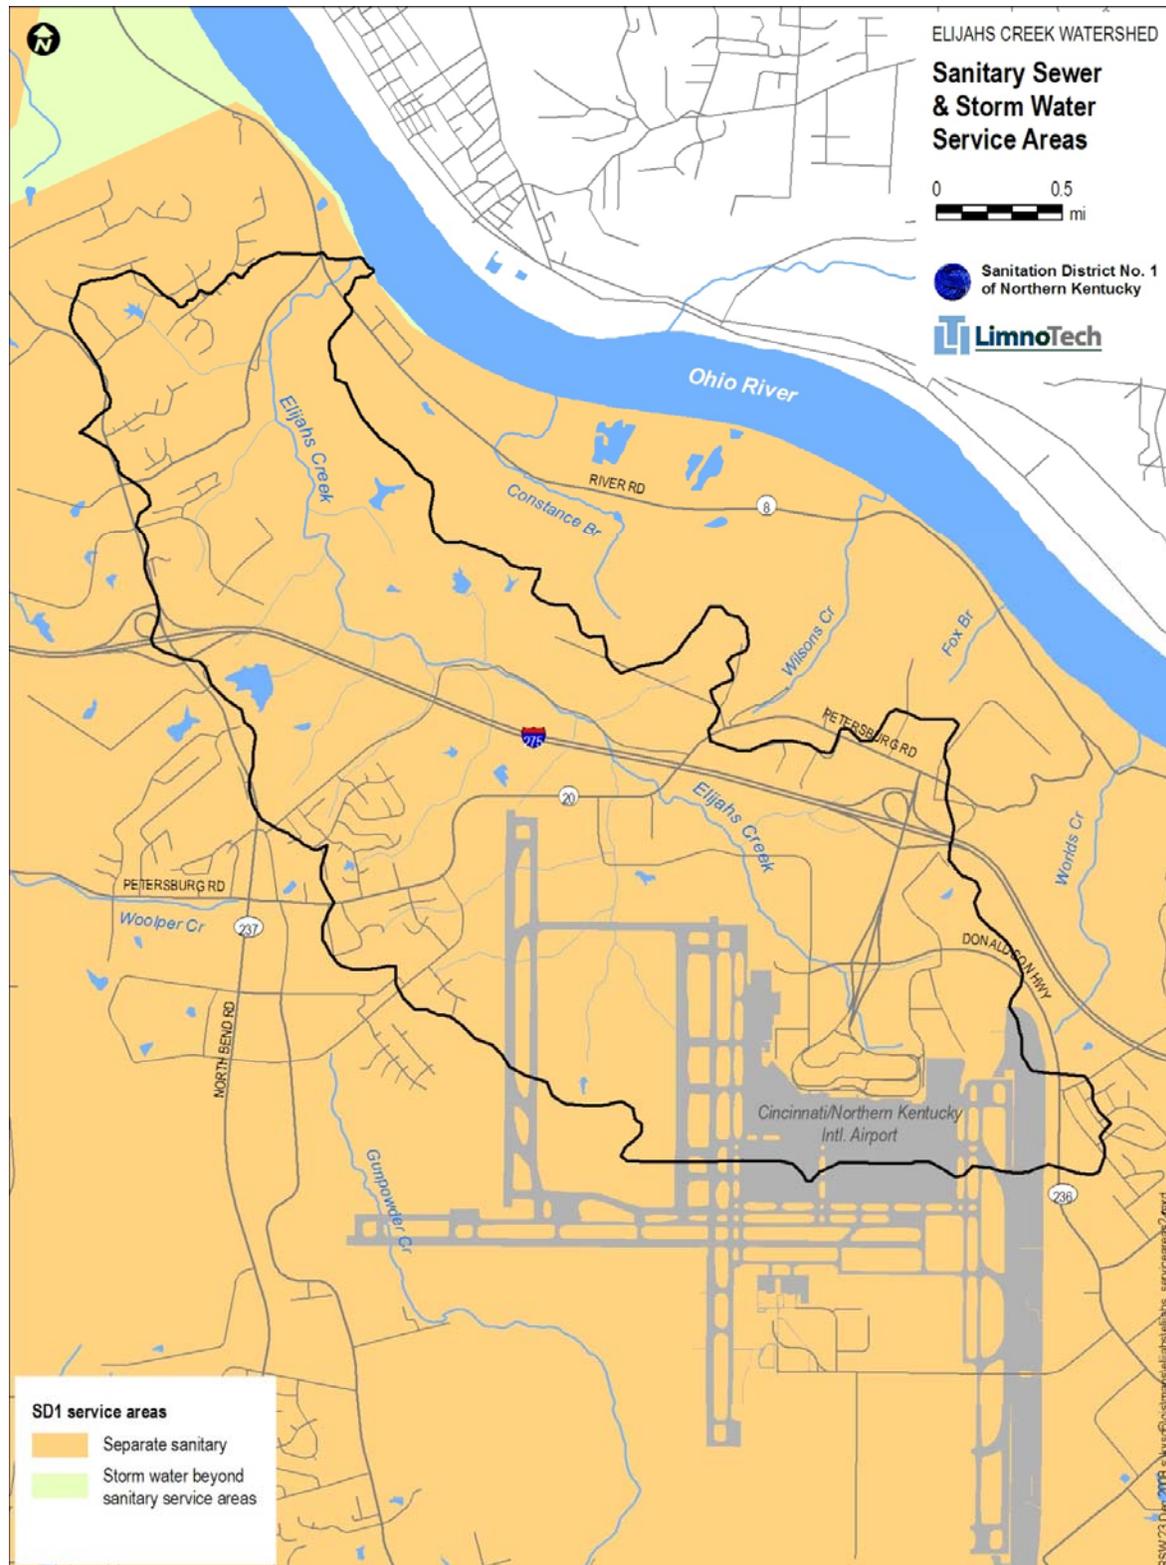
Figure 6. Sanitary Sewer and Storm Water Service Areas

There is no combined sewer system area in this watershed. The extent of the sanitary and storm water service area within this watershed is shown in Figure 6.

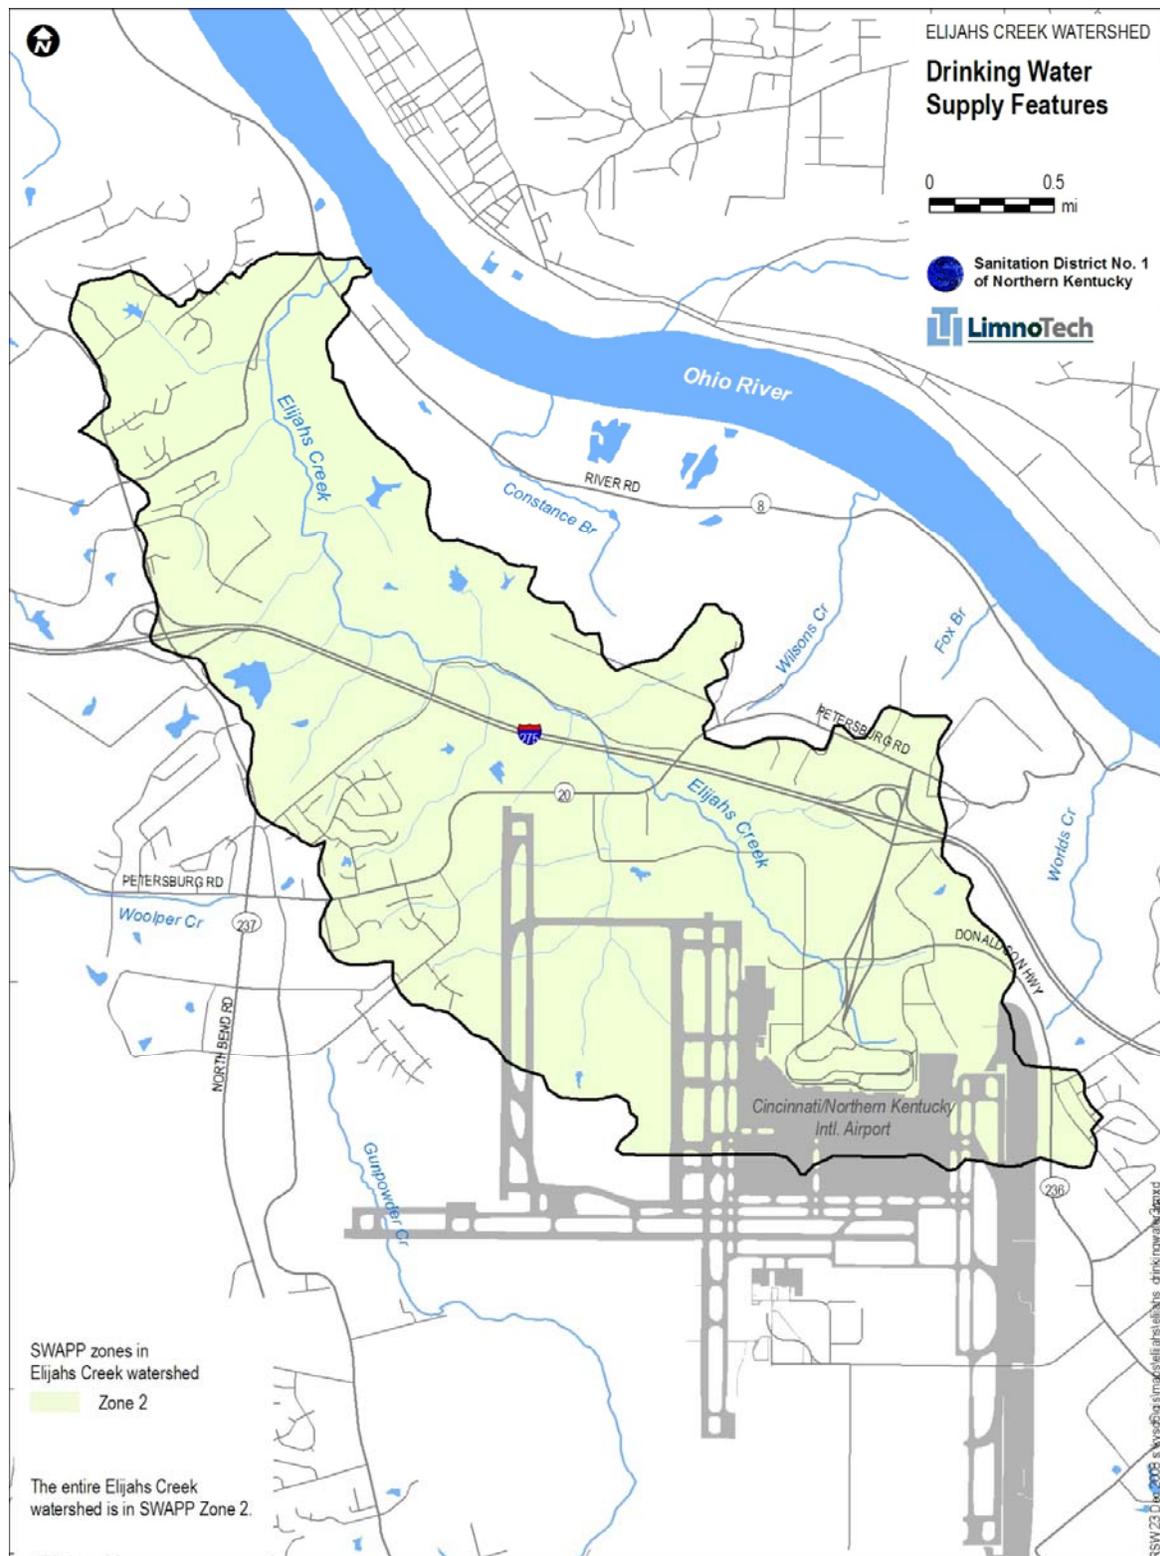
Figure 7. Drinking Water Supply Features

Drinking water supply features are shown in Figure 7.

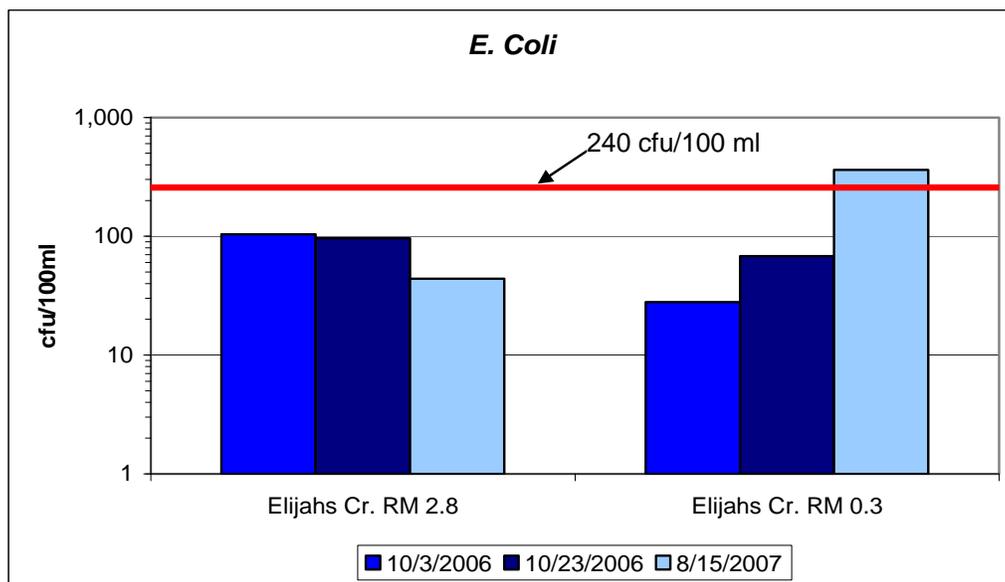
Figure 8. 2006-07 Base Flow *E. Coli* Concentrations Compared to 240 cfu/100 ml Criterion

E. coli data were available for base flow conditions. As shown in Figure 8, one of the six samples exceeded the applicable criteria for *E. coli*. A base flow *E. coli* concentration of 362 cfu/100 ml was observed at RM 0.3 on August 15, 2007. None of the fecal coliform samples exceeded applicable criteria.

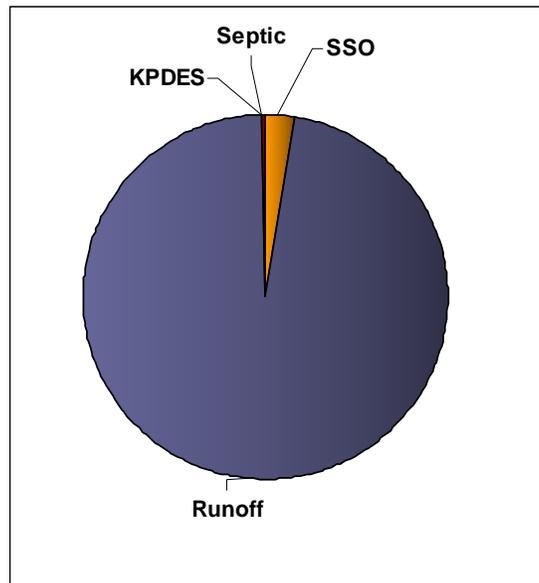
Figure 10. Initial Year-Round WAT! Results for Fecal Coliform

The relative fecal coliform load generated by source is shown in Figure 10. These WAT! results incorporate predicted sewer overflow volumes from infrastructure model simulations for 1992-1996 climatological conditions¹¹. CSOs were not a factor in the WAT! results, as none occur in the watershed; however, flow estimates were available for one of the SSOs in this watershed.

Under year-round conditions, the largest source of fecal coliform bacteria is storm water runoff. Septic systems are not a significant contributor to the total annual bacteria load; however, during base flow conditions they are estimated to contribute the majority of the fecal coliform load.
