Big Bone Creek Watershed Characterization Report

Prepared for: Sanitation District No. 1 of Northern Kentucky

January 2009

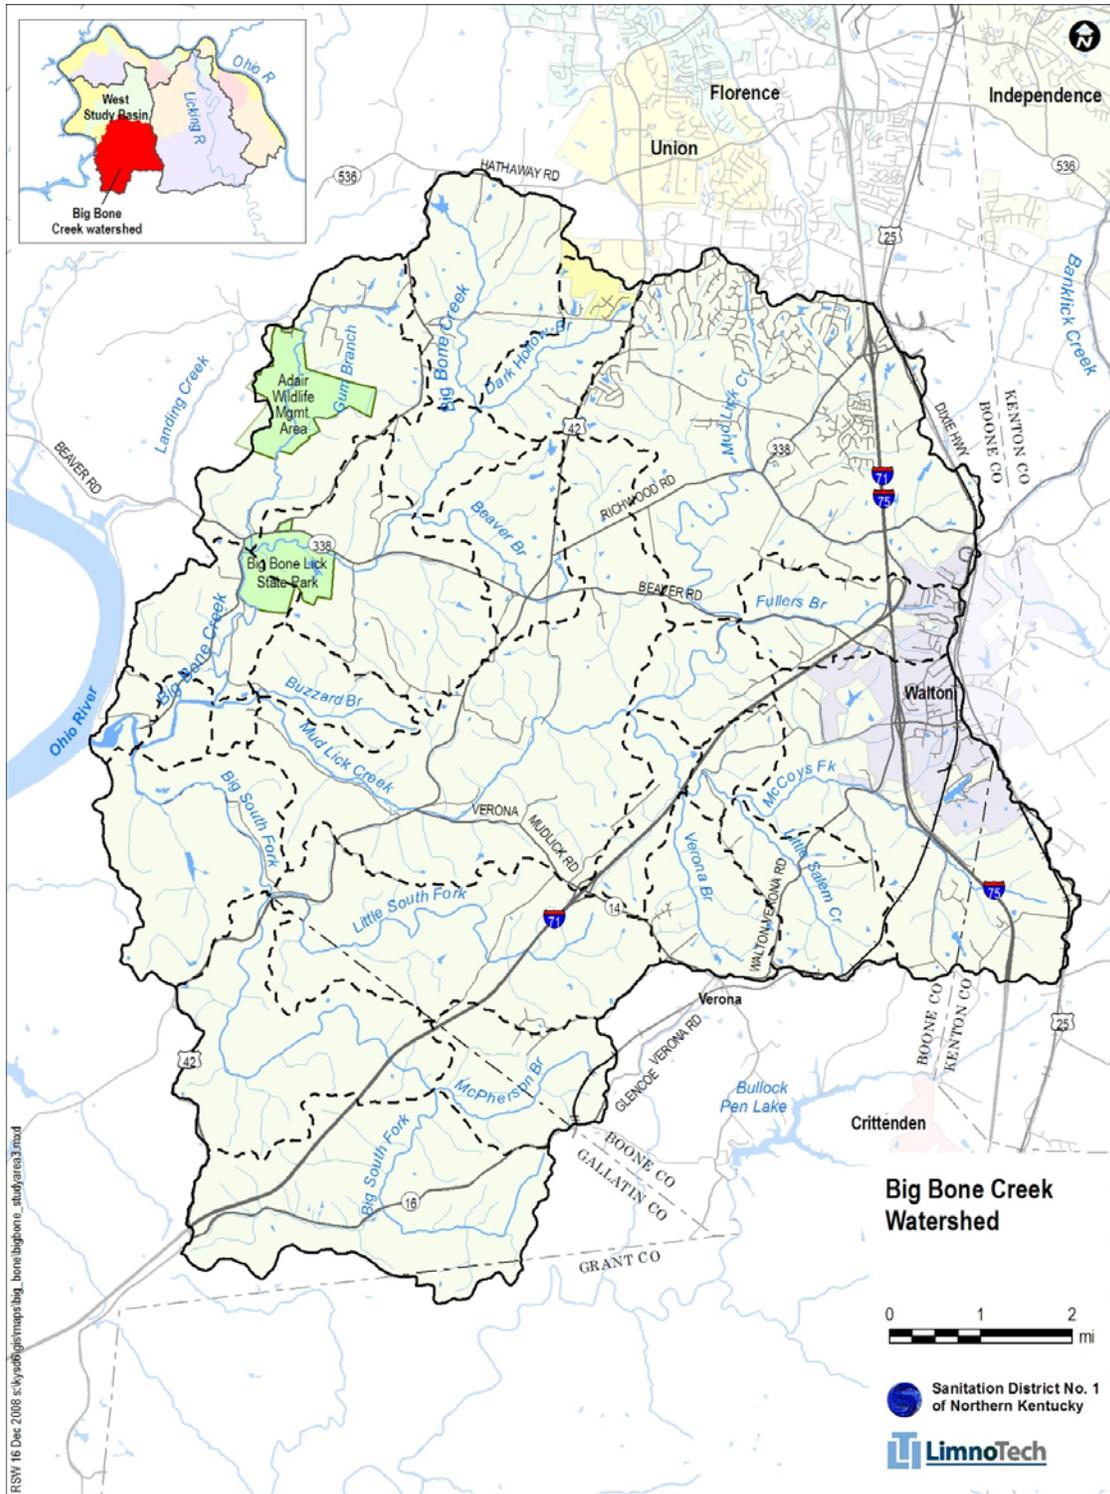
Figure 1. Big Bone Creek Watershed

The Big Bone Creek watershed is 82.6 square miles in size and is located primarily in Boone County (Figure 1), in the West Study Basin. This watershed is predominantly rural, with some developed areas located in the northeastern part of the watershed.

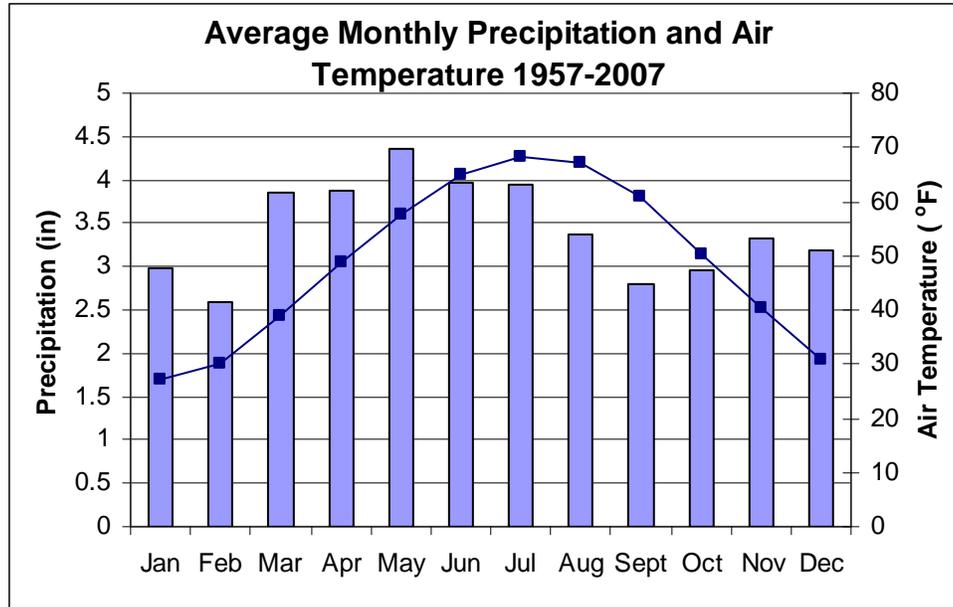
Figure 2. Average Monthly Precipitation and Air Temperature at the Cincinnati Northern Kentucky Airport (1957-2007)

The temperatures in this area are generally lowest in January and highest in July. Precipitation averages 41.2 inches annually, with the wettest months observed between March and July. Minimum precipitation is recorded in the fall and late winter as shown in Figure 2 (NCDC, 2008).

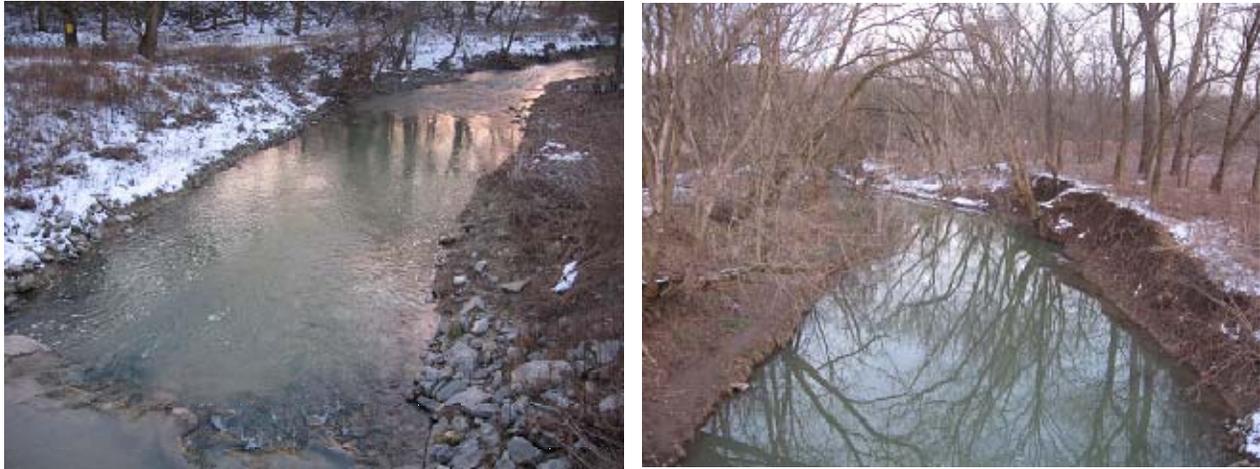
Figure 3. Big Bone Creek Within Big Bone Lick State Park

Aquatic habitats vary throughout the watershed. Erosion, eutrophication and aquatic habitat modification were visible during site visits in January 2007 (Figure 3). Instream habitat has been assessed⁷ at eight sites in the Big Bone Creek watershed and indicates variable habitat conditions (Table 1).

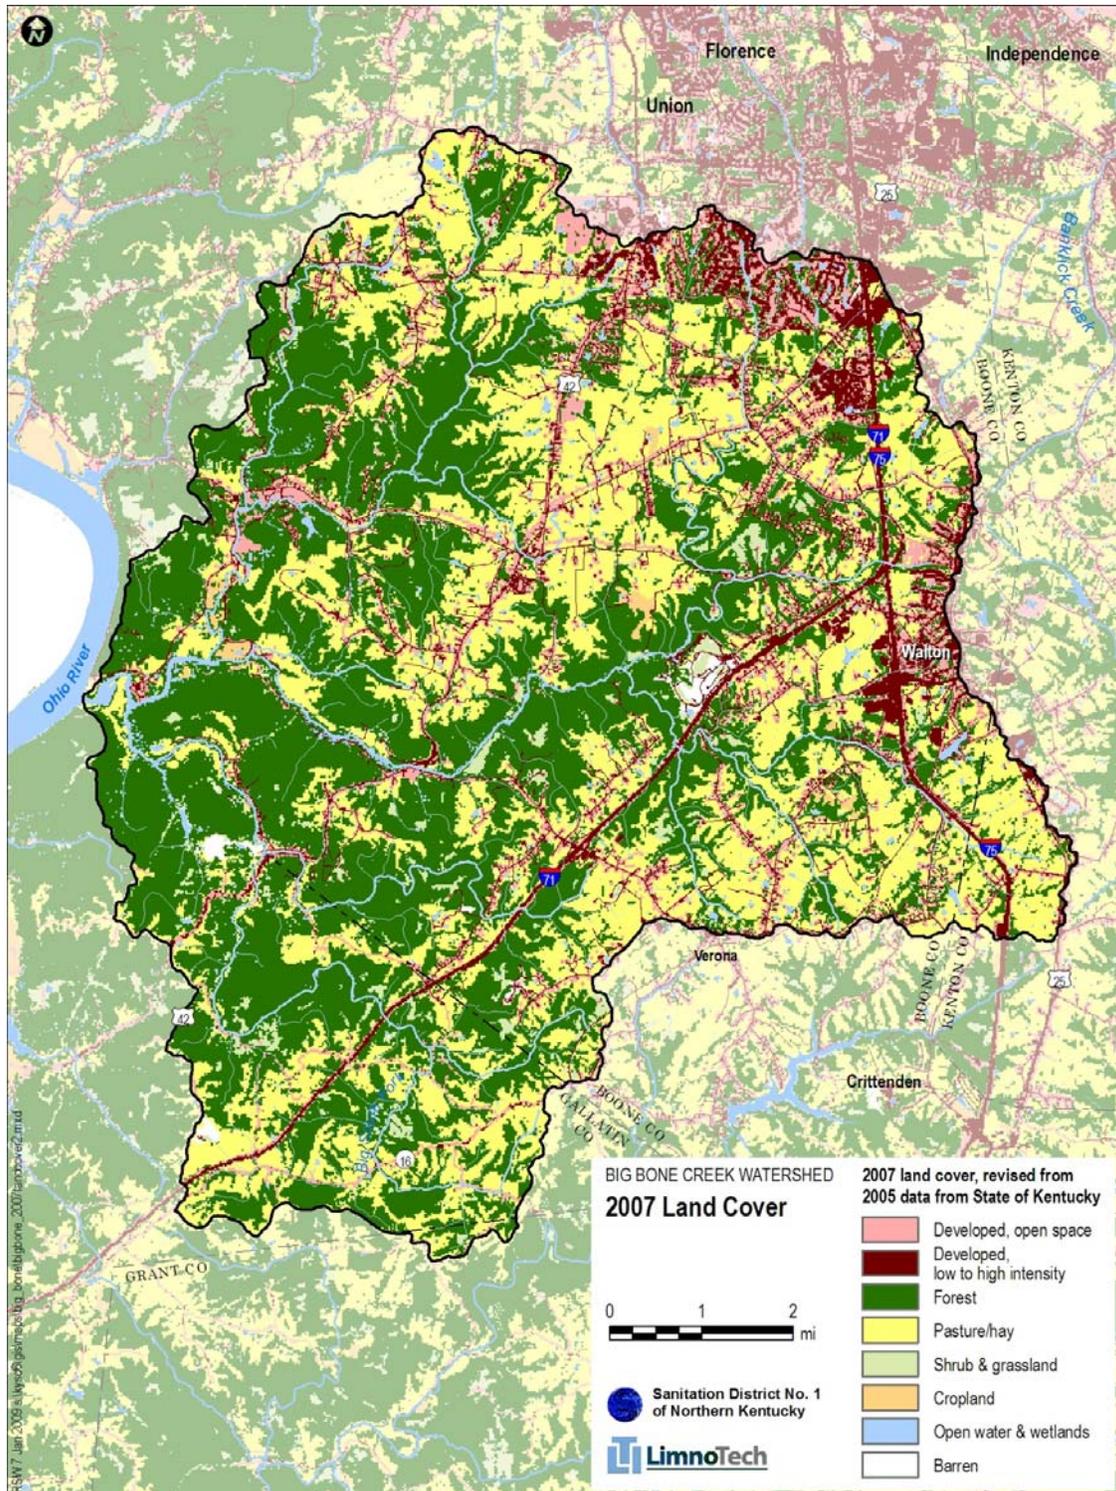
Figure 4. 2007 Land Cover

The Kentucky Division of Geographic Information, Commonwealth Office of Technology provided a GIS dataset showing 2005 Kentucky land cover. This dataset was updated and improved to approximate 2007 land cover conditions (Figure 4) using a variety of other datasets that represent current impervious conditions (roads, parking lots, buildings), open space lands (including parks), and surface waters.

Development in the watershed is concentrated along roads and is primarily found in Union and Walton, the two incorporated communities located in the watershed. Other small communities in the watershed include Verona and Big Bone.

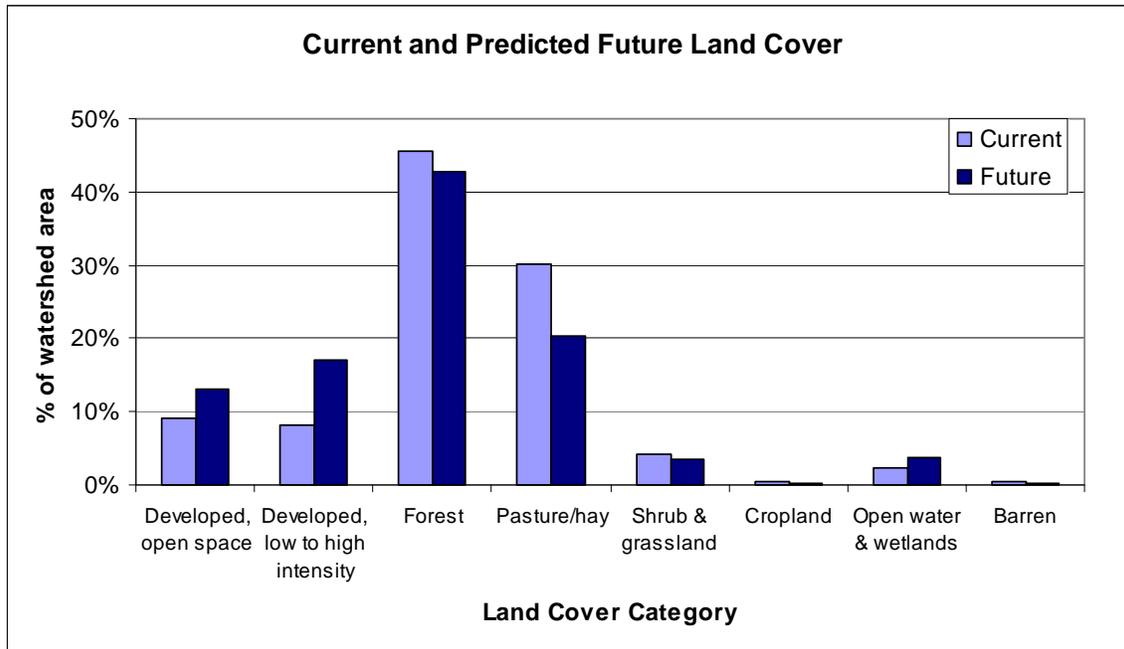
Figure 5. Current and Predicted Future Land Cover

Future land cover was developed by modifying 2007 land cover to reflect potential future conditions (roughly 2030) obtained from SD1 and the Northern Kentucky Area Planning Commission (NKAPC). It is predicted that development will primarily replace pasture and forest lands (Figure 5). Developed lands are predicted to increase from 17% to 30% and impervious surfaces in the watershed are predicted to increase from 3% to 6%.

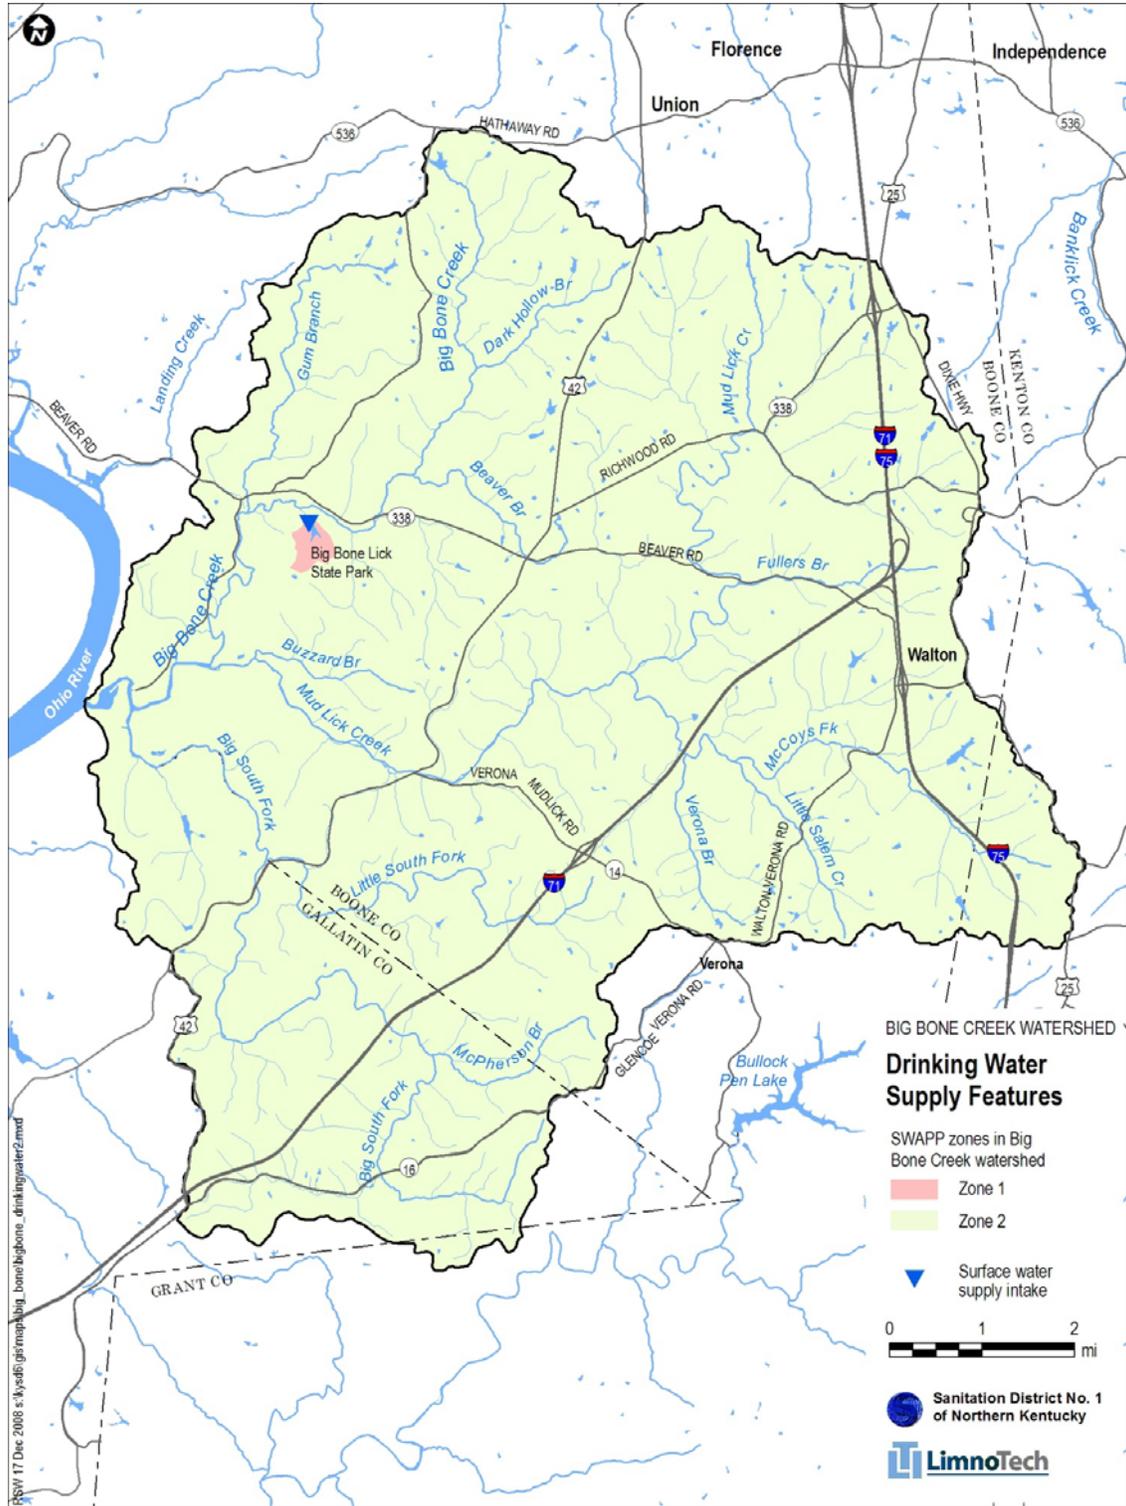
Figure 8. Drinking Water Supply Features

Source Water Assessment and Protection (SWAPP) zones are delineated to identify potential contaminants upstream of water intakes and are not used to support identification of sources potentially impacting the intakes. The entire watershed draining to Big Bone Lake lies within SWAPP Zone 1, due to the water intake for the State Park (Figure 8).

The Ohio River Valley Water Sanitation Commission (ORSANCO) has determined that the remainder of this watershed lies within SWAPP Zone 2, reflecting the fact that this watershed is more than 25 miles upstream of the Louisville intake.

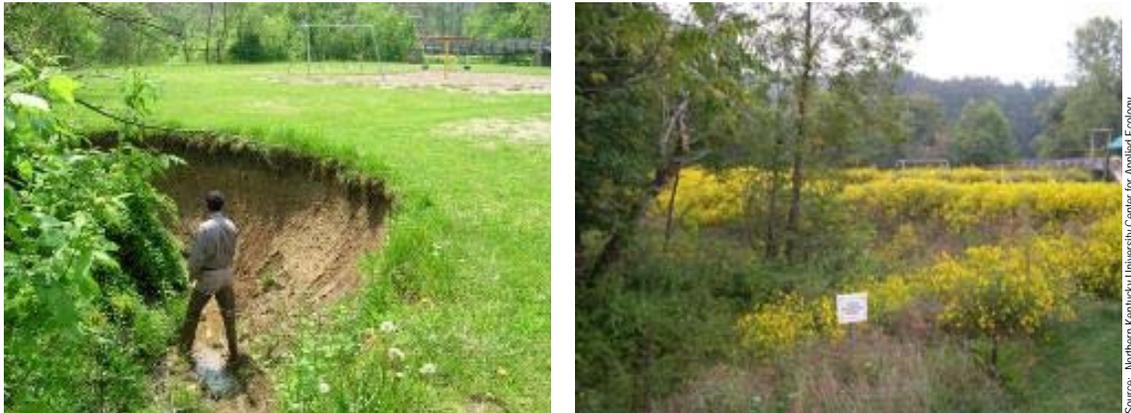
Figure 9. Stream Restoration of Big Bone Creek Tributary

The Big Bone Lick State Park Stream Corridor Restoration projects were implemented between 2003 and 2007. One project on a Big Bone Creek tributary included the stabilization of 200 feet of stream bank and 24 acres of native riparian vegetation restoration (Figure 9). In 2003, instream habitat was improved in Big Bone Lick State Park by removing a dam and adding rock riffles (Figure 10). This project was conducted to stop headcutting and incision within the creek. Another aspect of these projects was to move a small buffalo herd away from lowland/wetland areas in the park to reduce soil erosion and impacts to aquatic habitats. A 2.5-acre wildlife viewing area was also created.

Photos show before (left) and after (right)

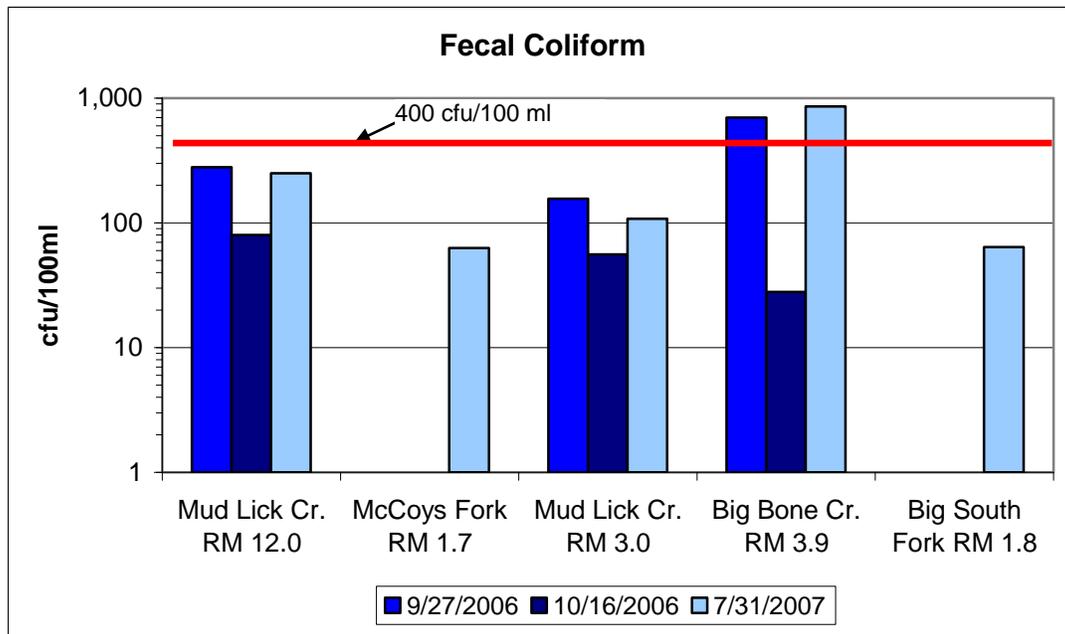
Figure 11. 2006-2007 Base Flow Sampling Results for Fecal Coliform Compared to 400 cfu/ 100 ml Criterion

As shown in Figure 11, two fecal coliform samples from Big Bone Creek exceeded the applicable criterion. The maximum fecal coliform concentration, 860 cfu/100 ml, was observed on July 31, 2007 at RM 3.9.

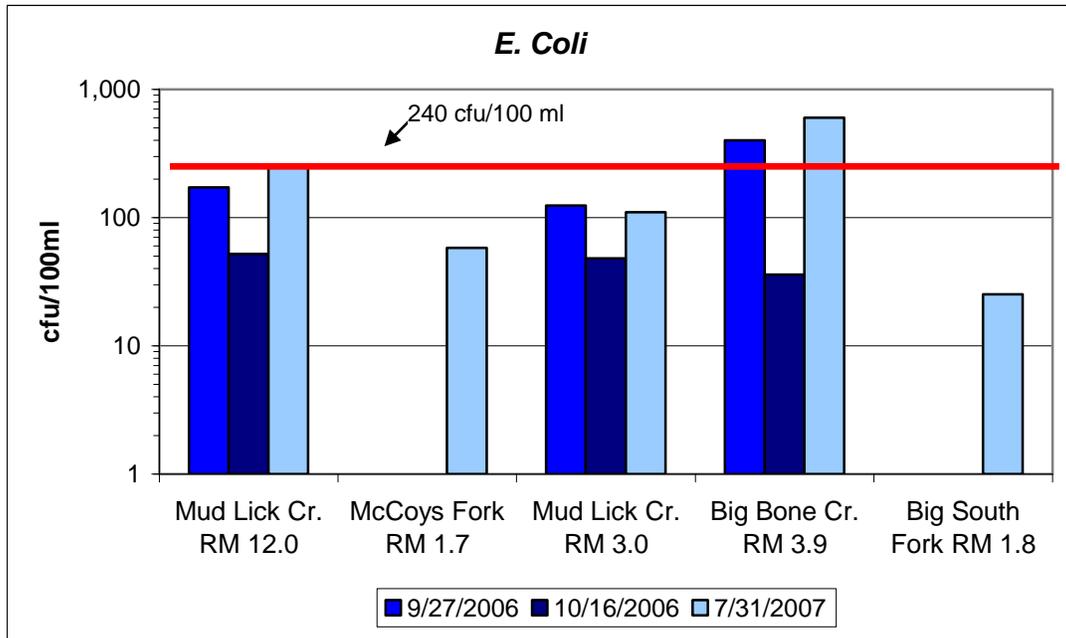
Figure 12. 2006-2007 Base Flow Sampling Results for *E. Coli* Compared to 240 cfu/100 ml Criterion

As shown in Figure 12, two *E. coli* samples from Big Bone Creek exceeded the applicable criterion, as did one sample from Mud Lick Creek. The maximum *E. coli* concentration, 600 cfu/100 ml, was observed on July 31, 2007 at RM 3.9.

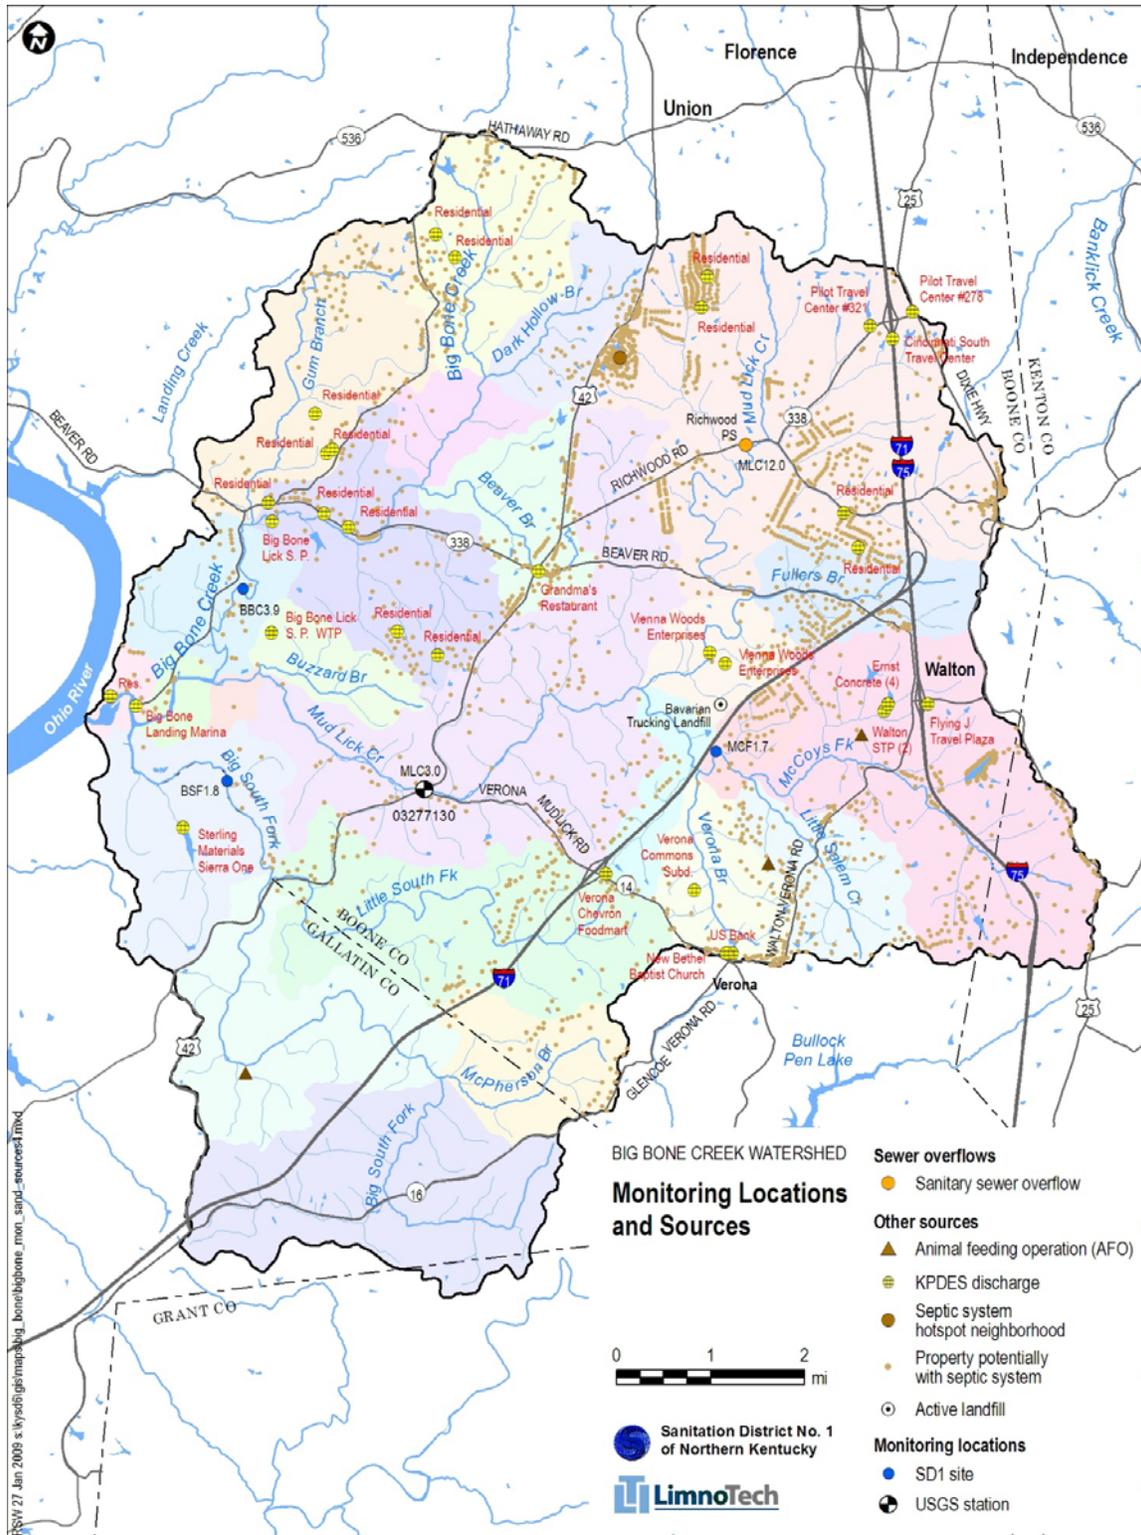
Figure 13. Monitoring Locations and Sources

Potential sources of bacteria and oxygen-demanding constituents were identified within the Big Bone Creek watershed, based on the watershed characterization information provided. Recent water quality issues were observed during base flow conditions; however, all potential sources currently identified are summarized in Table 11 and their location is shown in Figure 13. As shown in this table, there are no CSOs in this watershed.

SD1 estimates that approximately 31% of all parcels in the Big Bone Creek watershed, within Boone County⁸ are potentially serviced by septic systems (Figure 13). Properties potentially serviced by septic systems are found in the highest densities in the eastern portion of the watershed, near the headwaters of an unnamed tributary to Mud Lick Creek, Fullers Branch and McCoys Fork.

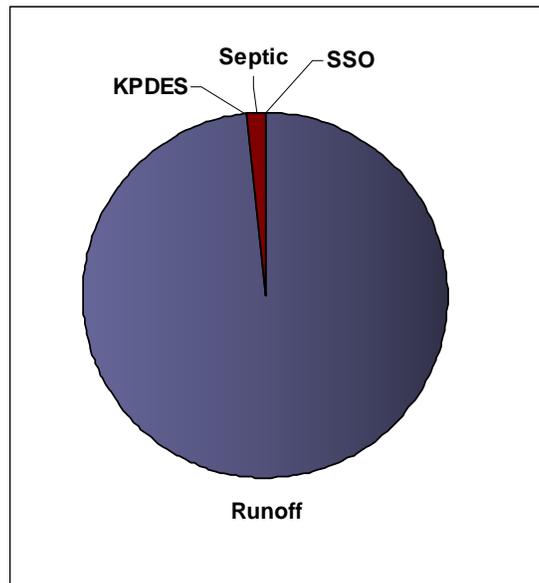
Figure 14. Initial Year-Round WAT! Results for Fecal Coliform

The relative fecal coliform load generated by source is shown in Figure 14. These WAT! results incorporate predicted sewer overflow volumes from infrastructure model simulations for 1992-1996 climatological conditions¹³. CSOs were not a factor in the WAT! results, as none occur in the watershed. The one SSO in this watershed is not predicted to overflow under the modeled climate conditions.

Under year-round conditions, the largest source of fecal coliform bacteria is overland storm water runoff. Septic systems are not a significant contributor to the total annual bacteria load; however, during base flow conditions they are estimated to contribute the majority of the fecal coliform load.

WAT! is still under development. All results presented here are for illustrative purposes only. The results are subject to change and should therefore not be relied on or considered definitive.
