Fourmile Creek Watershed Characterization Report

Prepared for: Sanitation District No. 1 of Northern Kentucky

January 2009

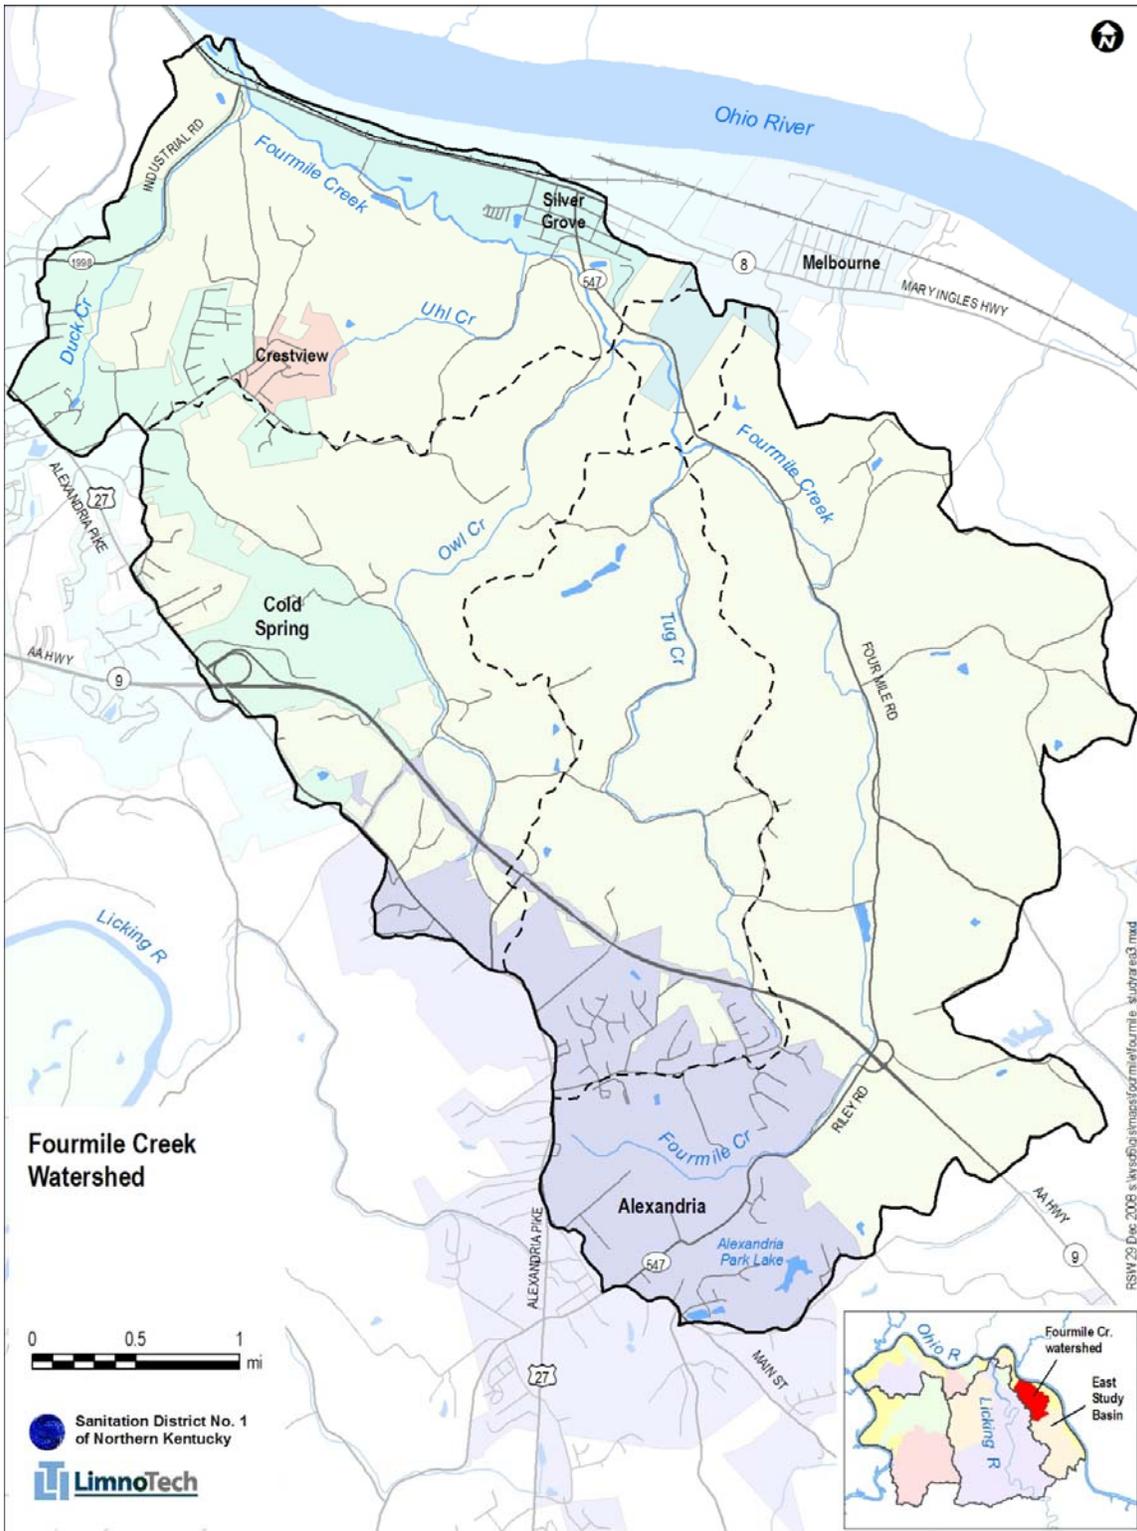
Figure 1. Fourmile Creek Watershed

The Fourmile Creek watershed is 17.8-square miles in size and is located entirely within Campbell County in the East Study Basin (Figure 1). This creek originates near Alexandria and flows northward to the Ohio River. The watershed is primarily rural and approximately 34% is developed.

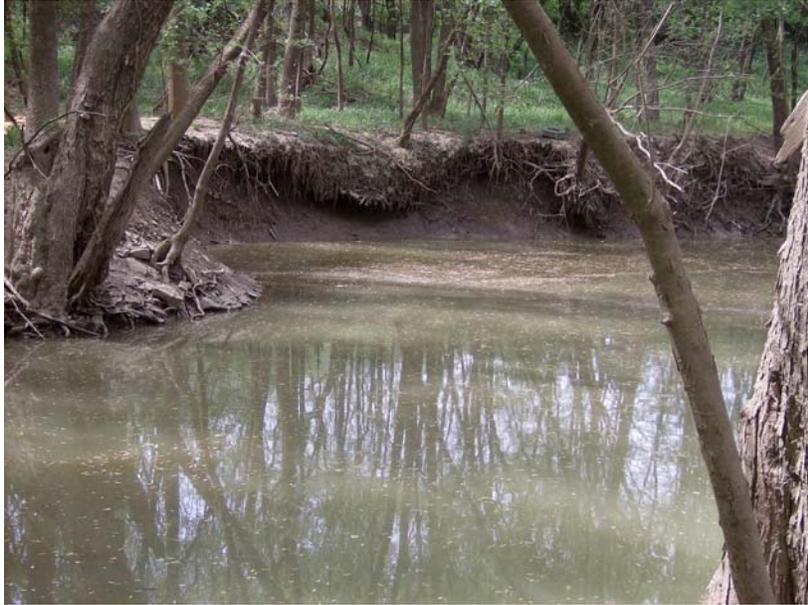
Figure 2. Fourmile Creek at KY 8 (RM 0.5)

watershed is rural, but development is expected to increase in the future (Section 2.2). Severe streambank erosion is currently occurring within this watershed (Figures 2 and 3).
