Ohio River East Tributaries Watershed Characterization Report

Prepared for: Sanitation District No. 1 of Northern Kentucky

January 2009

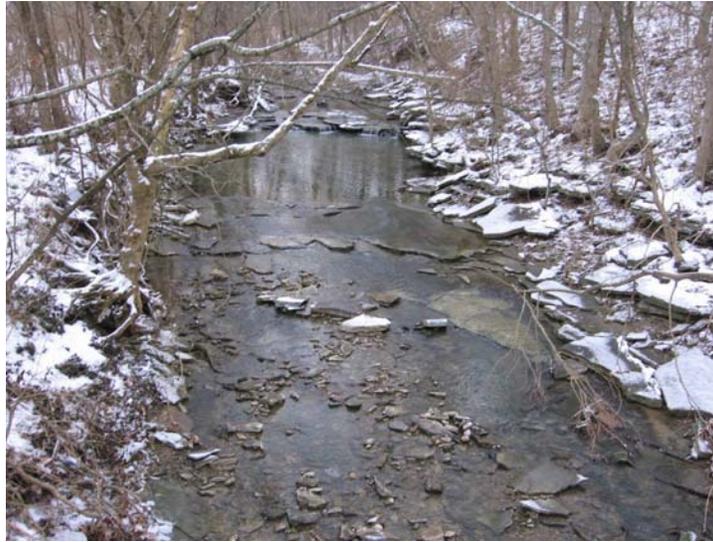
Figure 3. Tenmile Creek at Mary Ingles Highway

Areas in this watershed that are south of the Twelvemile Creek mouth lie within the Hills of the Bluegrass ecoregion, which has slender ridges and hills leading down into narrow valleys. Streams have steep gradients and are generally lower in nutrients than those in the Outer Bluegrass ecoregion, but may suffer higher erosion rates (Woods et al., 2002). Stream bank erosion has been observed in Tenmile Creek, within the Hills of Bluegrass ecoregion (Figure 3).
