Twelvemile Creek Watershed Characterization Report

Prepared for: Sanitation District No. 1 of Northern Kentucky

January 2009

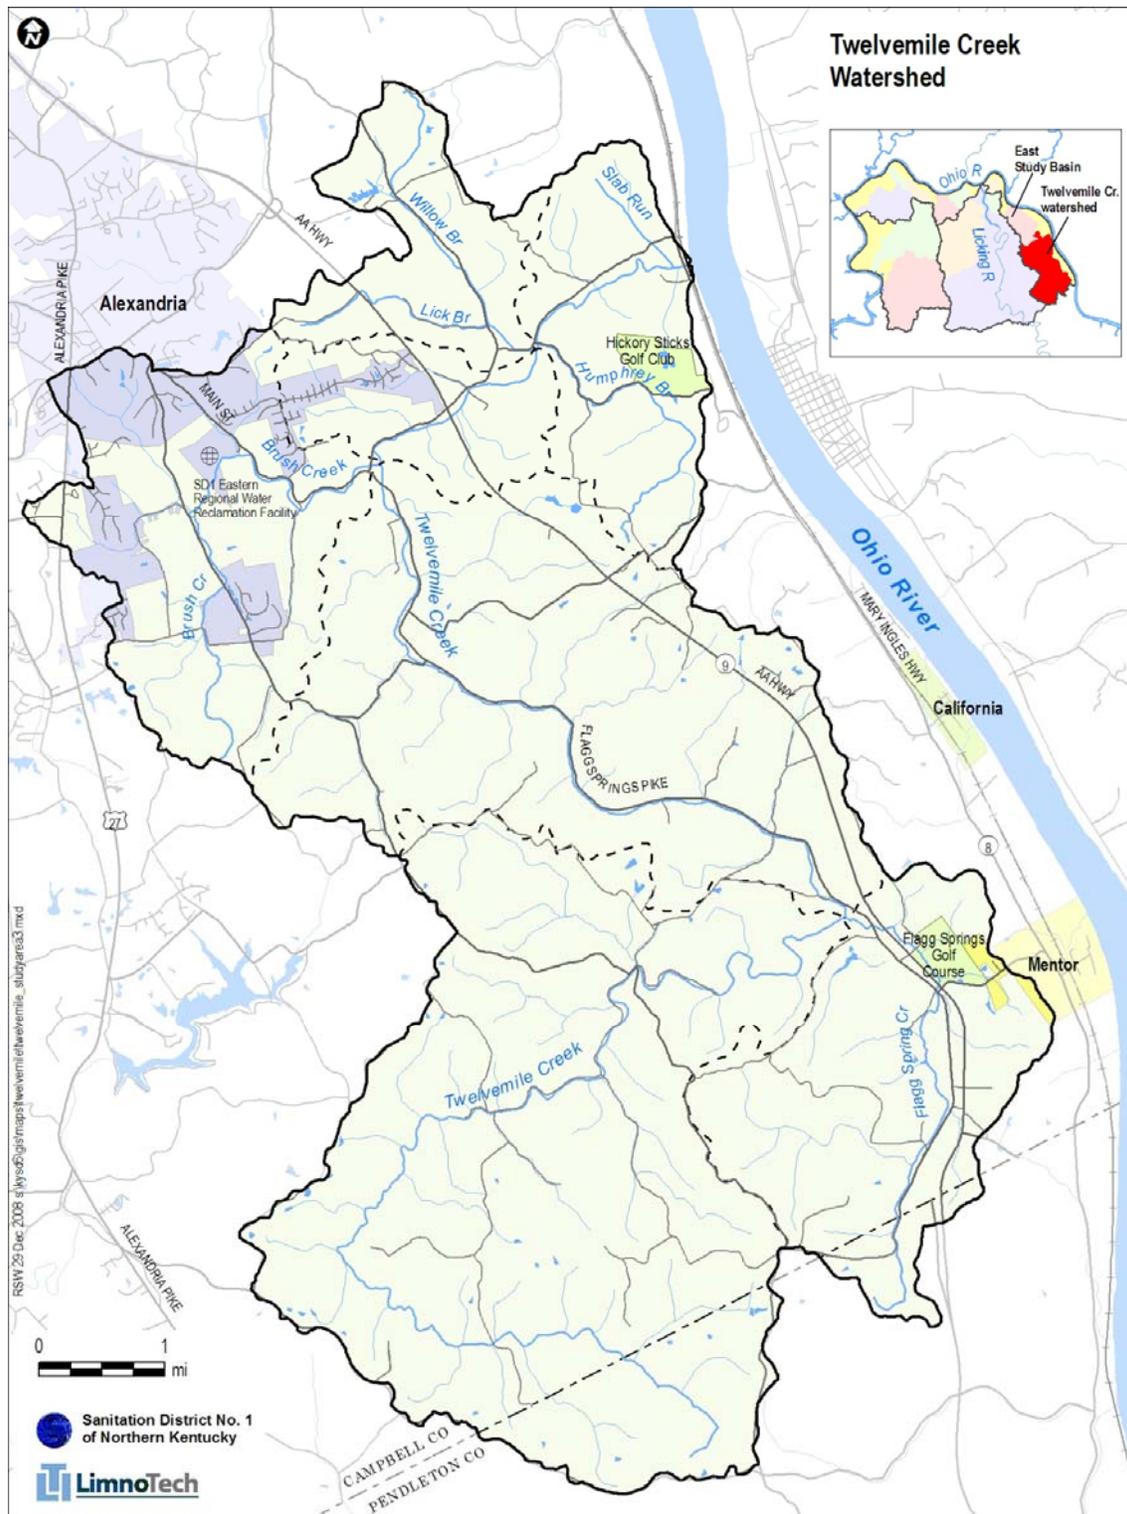
Figure 1. Twelvemile Creek Watershed

Twelvemile Creek is a 22-mile long perennial stream located in the East Study Basin (Figure 1). The 46.1-square mile watershed is predominantly rural, with forest and pasture/hay being the dominant land cover. This watershed is located primarily in Campbell County, but a small portion of the area extends into Pendleton County.

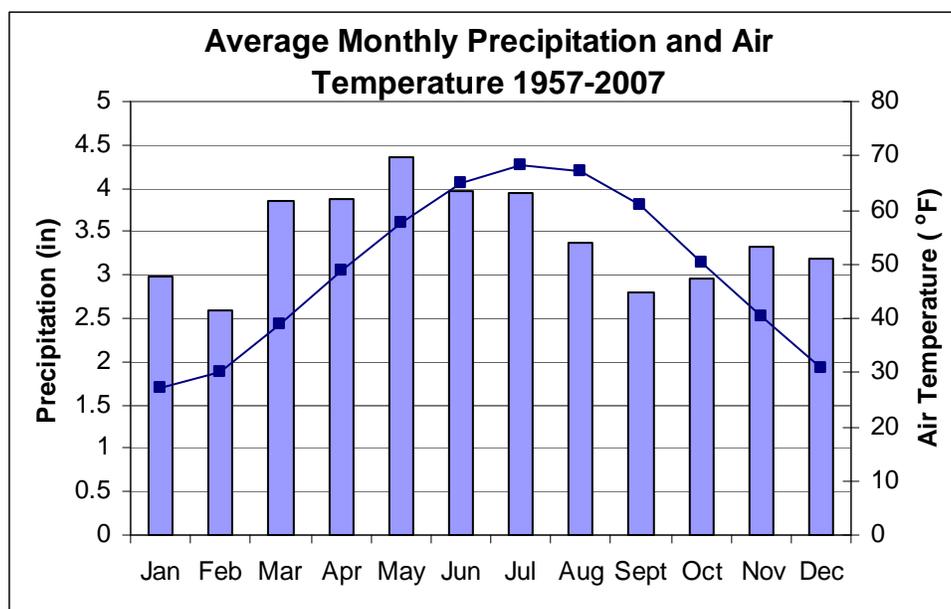
Figure 2. Average Monthly Precipitation and Air Temperature at the Cincinnati Northern Kentucky Airport (1957-2007)

The temperatures in this area are generally lowest in January and highest in July. Precipitation averages 41.2 inches annually, with the wettest months observed between March and July. Minimum precipitation is recorded in the fall and late winter as shown in Figure 2 (NCDC, 2008).

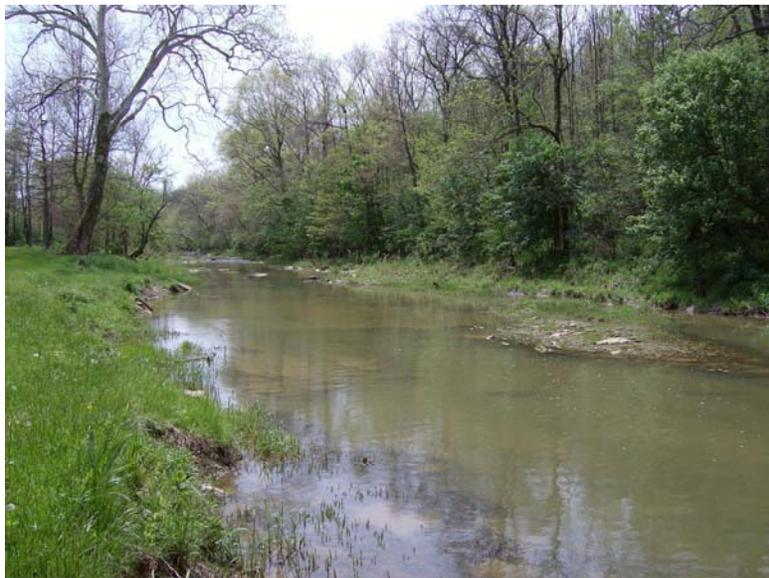
Figure 3. Twelvemile Creek at California Road (RM 9.3)

Aquatic habitat varies throughout the watershed. In the upper watershed, Twelvemile Creek is wide and turbid, and shows little aquatic habitat variation (Figure 3). Farther downstream, some habitat heterogeneity is observed. Here, turbid waters flow through glide and pool habitats and the riparian zone is greater than 30 feet wide in some areas (Figure 4). Near the mouth, this creek is wide and it often receives Ohio River backwater flow. Reduced water clarity, possibly due to sedimentation and eutrophication, and a relatively wide riparian zone occur here (Figure 5). The size of the riparian zone⁶ varies throughout the watershed, depending upon the proximity of the creek to Flagg Springs Pike (this road parallels Twelvemile Creek for much of its length) or the type of land the creek traverses (e.g., agricultural).

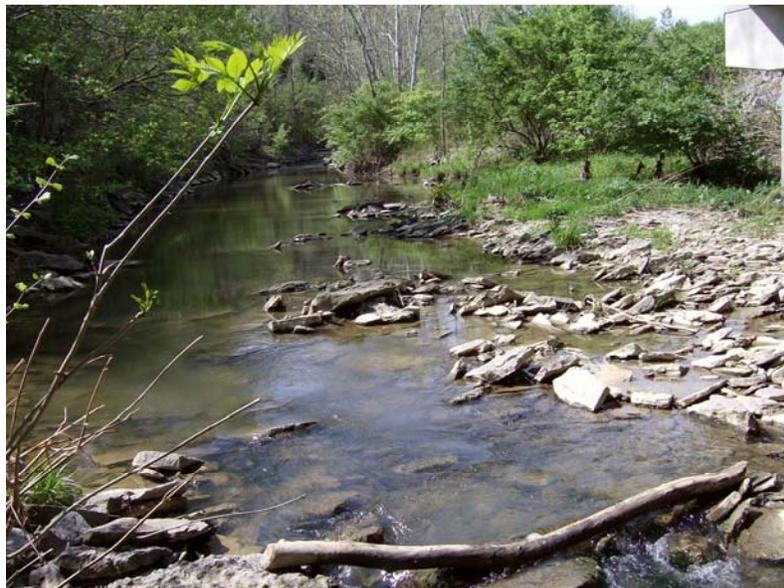
Figure 6. Brush Creek at Flagg Springs Pike (Brush Creek RM 0.3)

The Brush Creek tributary to Twelvemile Creek has limestone bedrock features (Figure 6) and intact riparian zones; however, aquatic habitats appear to be impacted by land use which has led to streambank erosion and a reduced riparian zone (Figure 7).

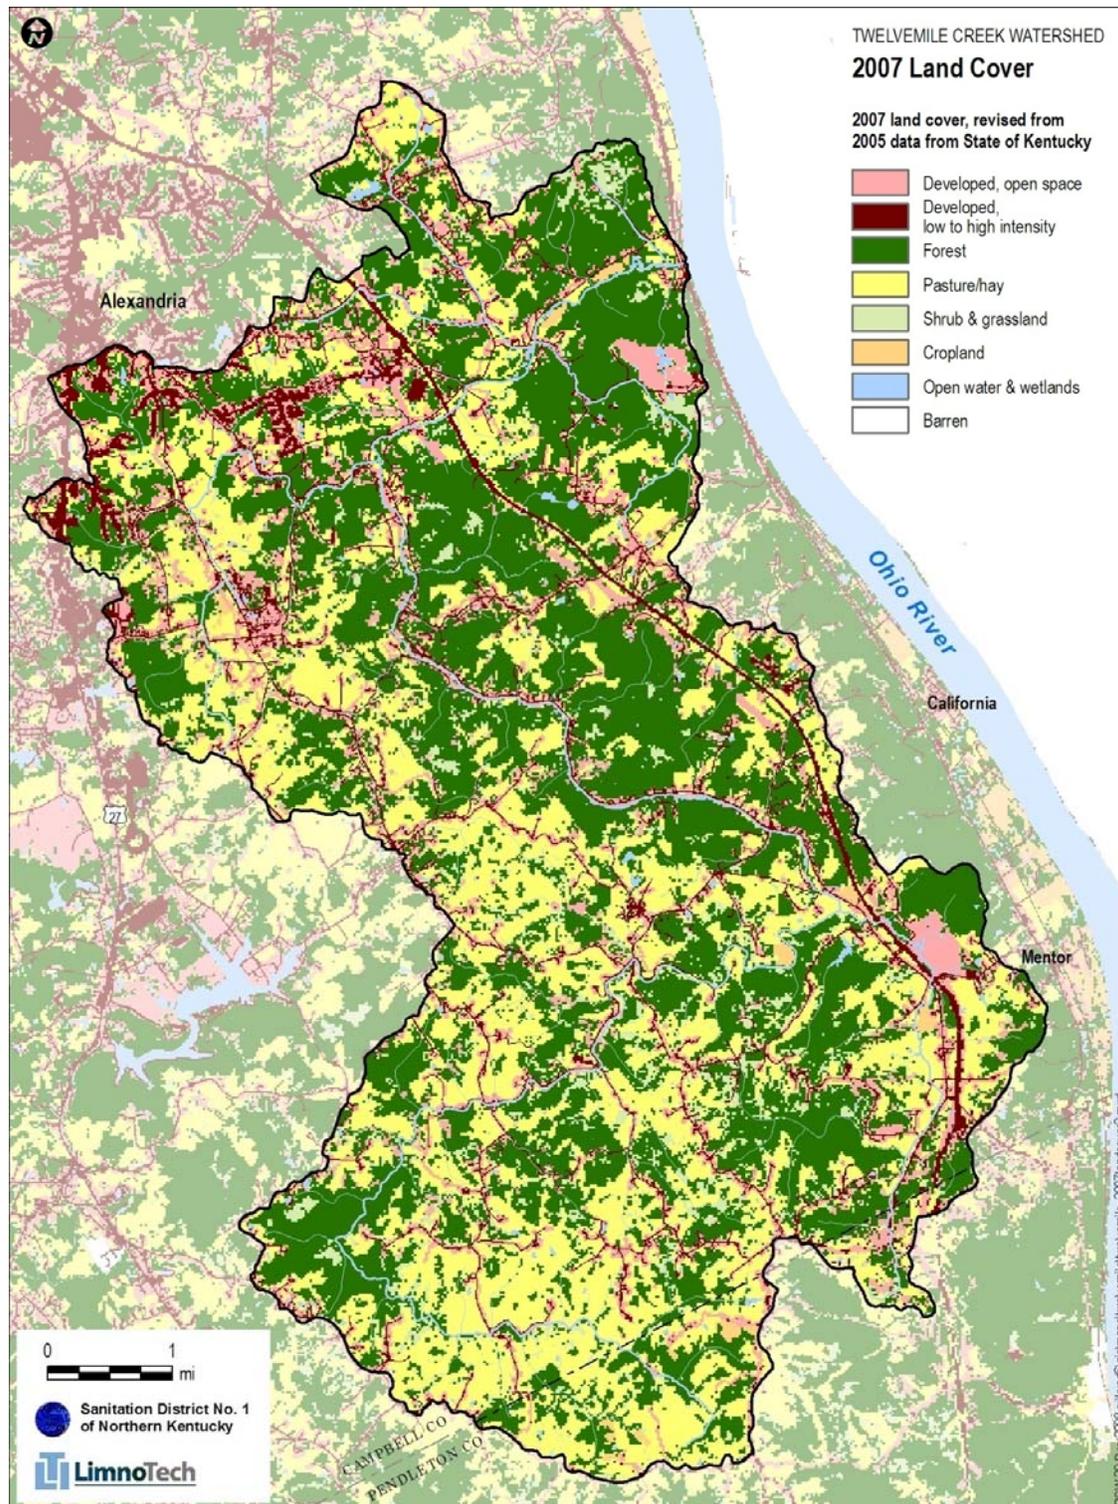
Figure 8. 2007 Land Cover

The Kentucky Division of Geographic Information, Commonwealth Office of Technology provided a GIS dataset showing 2005 Kentucky land cover. This dataset was updated and improved to approximate 2007 land cover conditions (Figure 8) using a variety of other datasets that represent current impervious conditions (roads, parking lots, buildings), open space lands (including parks), and surface waters.

The Twelvemile Creek watershed is rural, comprised primarily of forest and agricultural land. During a recent site visit, it was observed that much of the forest is mixed with agricultural land uses. Developed lands, including portions of Alexandria and Mentor, are primarily located in the northern portion of the watershed. Roughly 19% of this watershed is developed and roughly 3% is impervious.

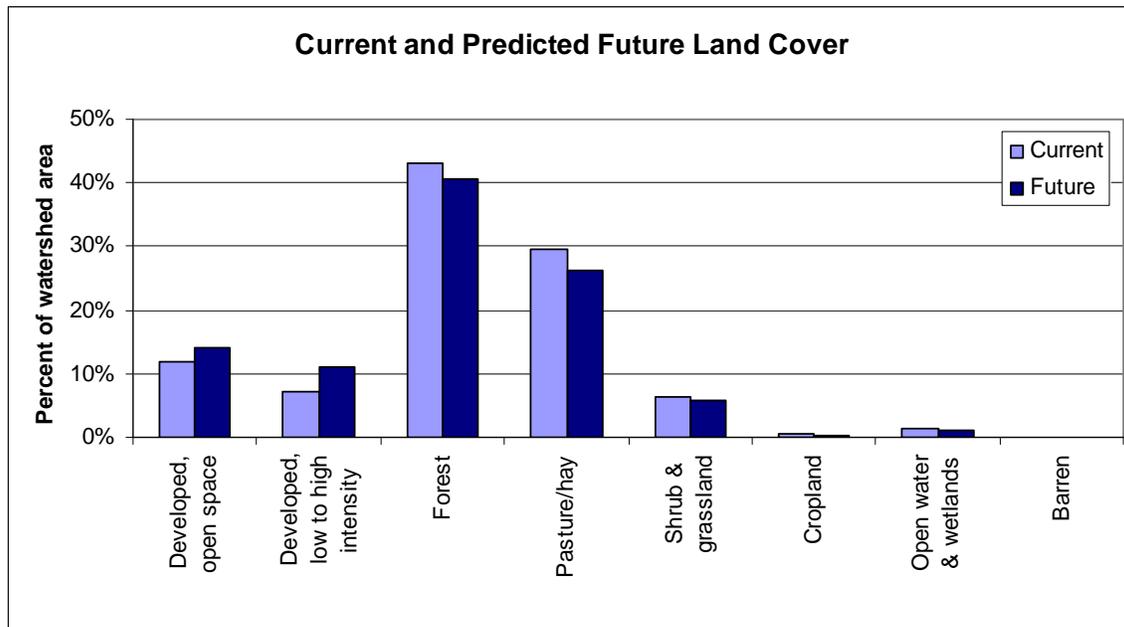
Figure 9. Current and Predicted Future Land Cover

Future land cover was developed by modifying 2007 land cover to reflect potential future conditions (roughly 2030) obtained from SD1 and the Northern Kentucky Area Planning Commission (NKAPC). It is predicted that development will continue, with developed lands replacing forest and pasture/hay lands. Forest and pasture/hay are expected to remain the dominant land cover. Developed lands are predicted to increase from 19% to 25% and impervious surfaces in the watershed are predicted to increase from 3% to 4%.

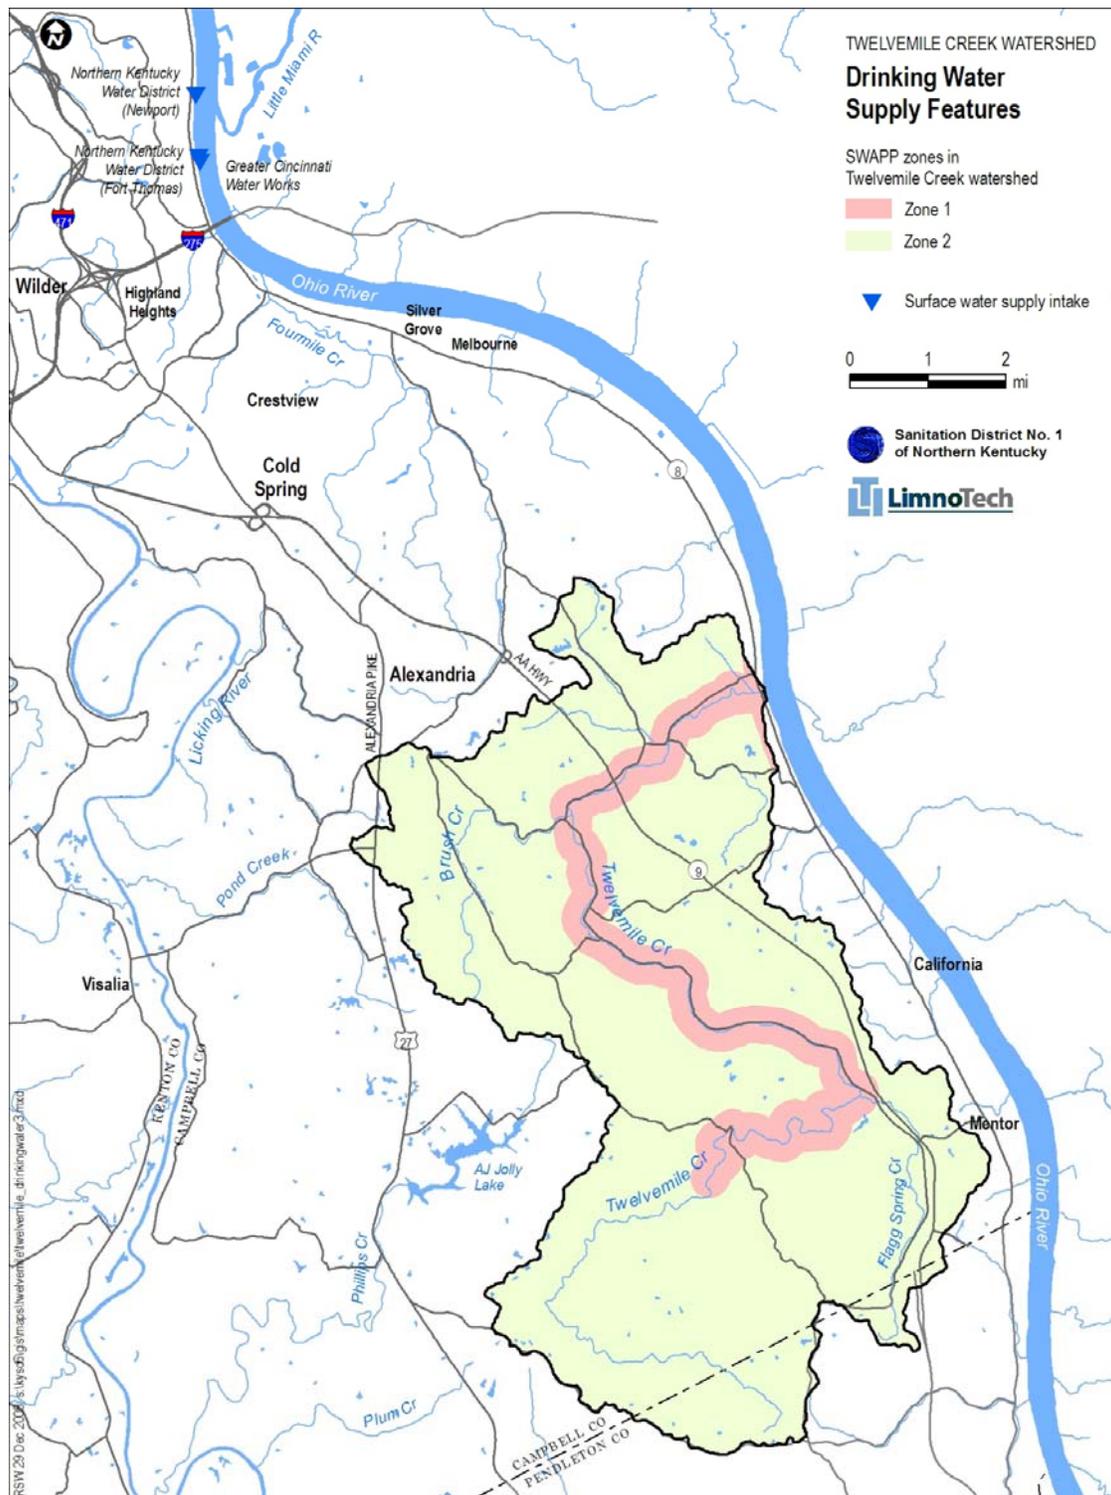
Figure 11. Drinking Water Supply Features

Drinking water supply features are shown in Figure 11.

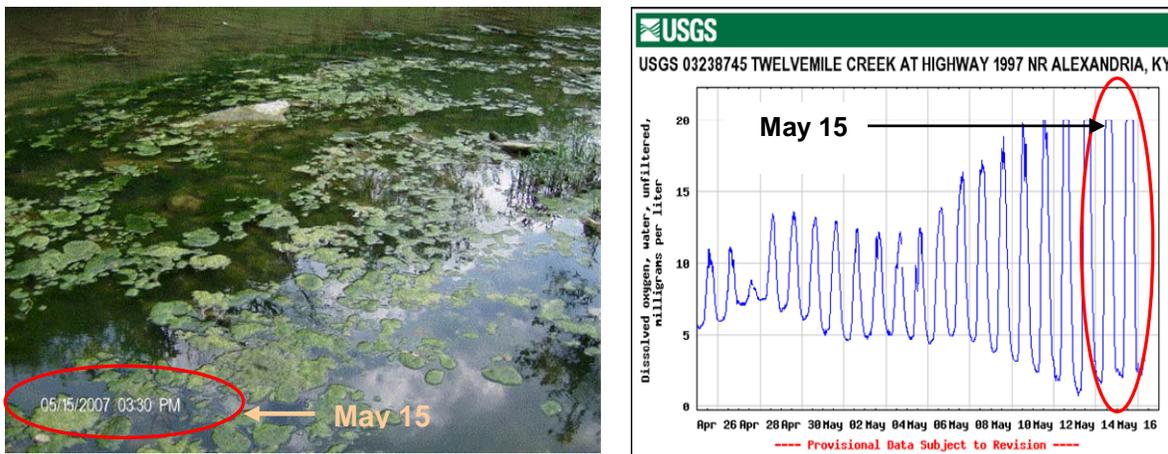
Fifteen-minute dissolved oxygen measurements were analyzed for periods when violations were noted. Significant diurnal variations (i.e., DO ranging from less than 2 mg/l to greater than 18 mg/l) were observed, and algal growth (Figure 12) is believed to contribute to the dissolved oxygen fluctuations at this site.

Figure 12. Twelvemile Creek algal growth (May 15, 2007) and dissolved oxygen during the same period

pH violations have been observed in all years analyzed (WY 2001-2005). pH measurements greater than 9 su have been observed and pH fluctuations of more than 1 su over a 24 period have also been observed. pH fluctuations are the most frequent cause of pH criteria violation observed in this creek and are thought to be caused by algae.

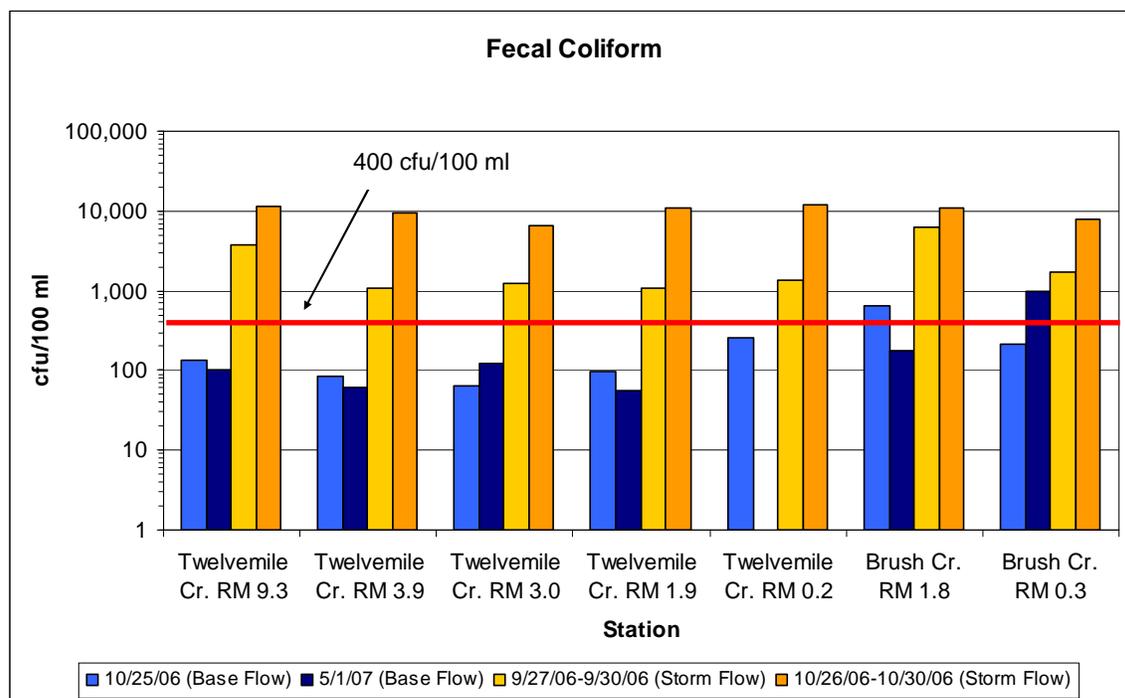
Figure 13. 2006-07 Base Flow and Average Storm Flow Fecal Coliform Concentrations Compared to 400 cfu/100 ml Criterion

Fecal coliform and *E. coli* data were available for both base flow and storm conditions. As shown in Figure 13, base flow fecal coliform concentrations exceeded the applicable criterion in Brush Creek in two of the four base flow samples. Storm flow samples exceeded the criterion throughout Twelvemile and Brush Creeks. The maximum base flow fecal coliform concentration, 960 cfu/100 ml, was observed at Brush Creek RM 0.3 on May 1, 2007. The highest storm flow concentration, 11,771 cfu/100 ml, was observed at Twelvemile Creek RM 0.2 during the October 26-30, 2006 sampling event.

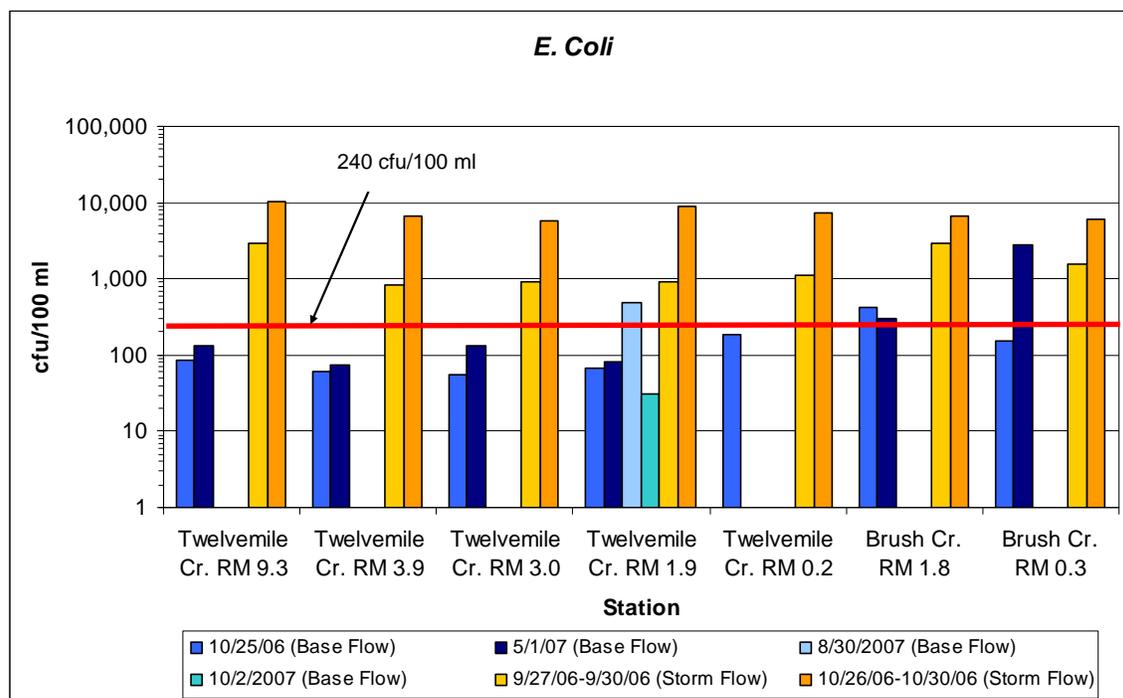
Figure 14. 2006-07 Base Flow and Average Storm Flow *E. coli* Concentrations Compared to 240 cfu/100 ml Criterion

Figure 14 shows a similar pattern for *E. coli*. Base flow *E. coli* concentrations exceeded the applicable criterion Brush Creek in three of the four base flow samples. Storm flow samples exceeded the criterion throughout Twelvemile and Brush Creeks. The maximum base flow *E. coli* concentration, 2,747 cfu/100 ml, was observed at Brush Creek RM 0.3 on May 1, 2007. The highest storm flow concentration, 10,381 cfu/100 ml, was observed at Twelvemile Creek RM 0.2 during the October 26-30, 2006 sampling event.

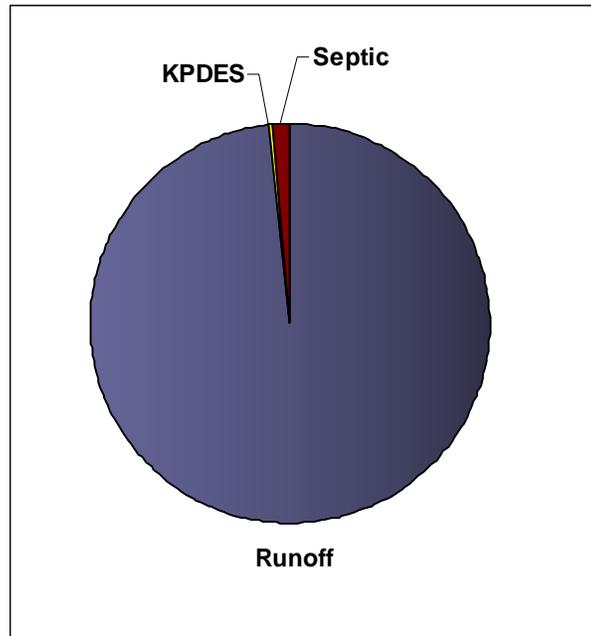
Figure 16. Initial Year-Round WAT! Results for Fecal Coliform

The relative fecal coliform load generated by source is shown in Figure 16. These WAT! results incorporate predicted sewer overflow volumes from infrastructure model simulations for 1992-1996 climatological conditions¹³. Neither CSOs nor SSOs were a factor in the WAT! results, as none occur in the watershed.

Under year-round conditions, the largest source of fecal coliform bacteria is storm water runoff. Septic systems are not a significant contributor to the total annual bacteria load; however, during base flow conditions they are estimated to contribute the majority of the fecal coliform load.
