Sanitation District No. 1
January 30, 2018

Consent Decree
Quarterly Report No. 41
(October 1, 2017 through December 31, 2017)

CONSENT DECREE QUARTERLY REPORT NO. 41

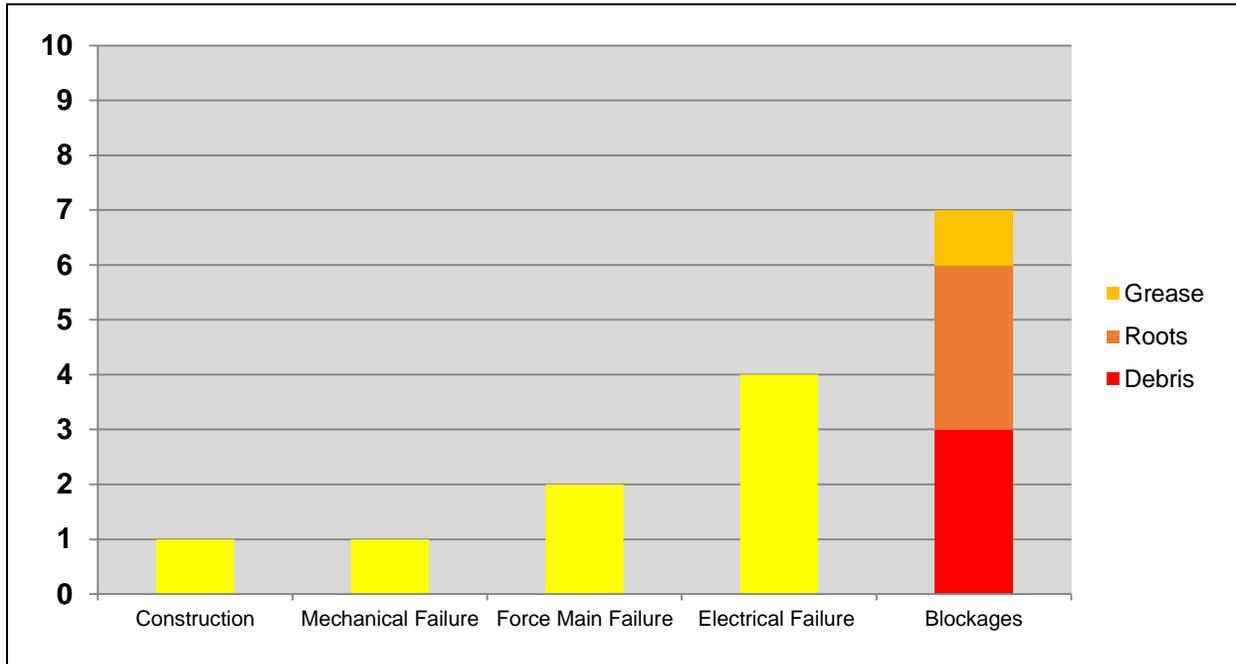
Figure 2.1 Occurrences of SSO Due to Operational Issues per Cause
 (October 1, 2017 through December 31, 2017)

Figure 2.1 demonstrates the primary causes of the overflows and Figure 2.2 demonstrates the corresponding total estimated overflow volume of each category of operational failure.

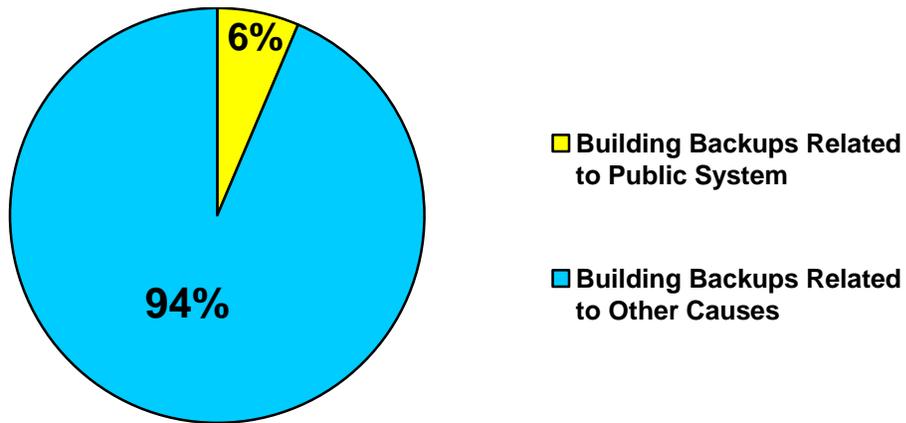
Figure 2.3 Building Backups: Public System vs. Other Causes
(October 1, 2017 through December 31, 2017)

During the current reporting period, there were approximately 128 building backups recorded throughout SD1's service area. Of these 128 backups, approximately eight were related to the condition or operation of the public sewers, during normal conditions, and 120 were caused by other issues, as demonstrated in Figure 2.3.

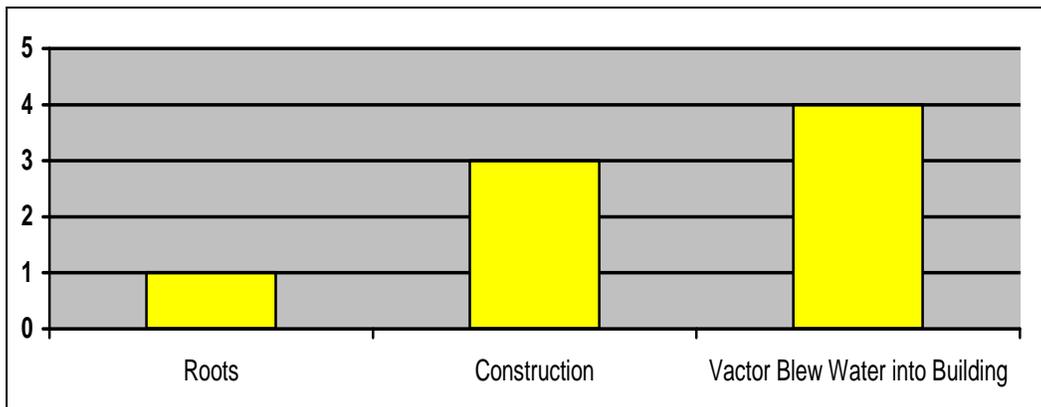
Figure 2.4 Occurrences of Public System Related Building Backups per Cause
(October 1, 2017 through December 31, 2017)

The building backups determined to not be related to the condition or operation of the public sewers, were caused by blockages in private service laterals and internal plumbing issues. The causes of the eight building backups determined to be related to the condition or operation of the public sewer lines are detailed in Figure 2.4.

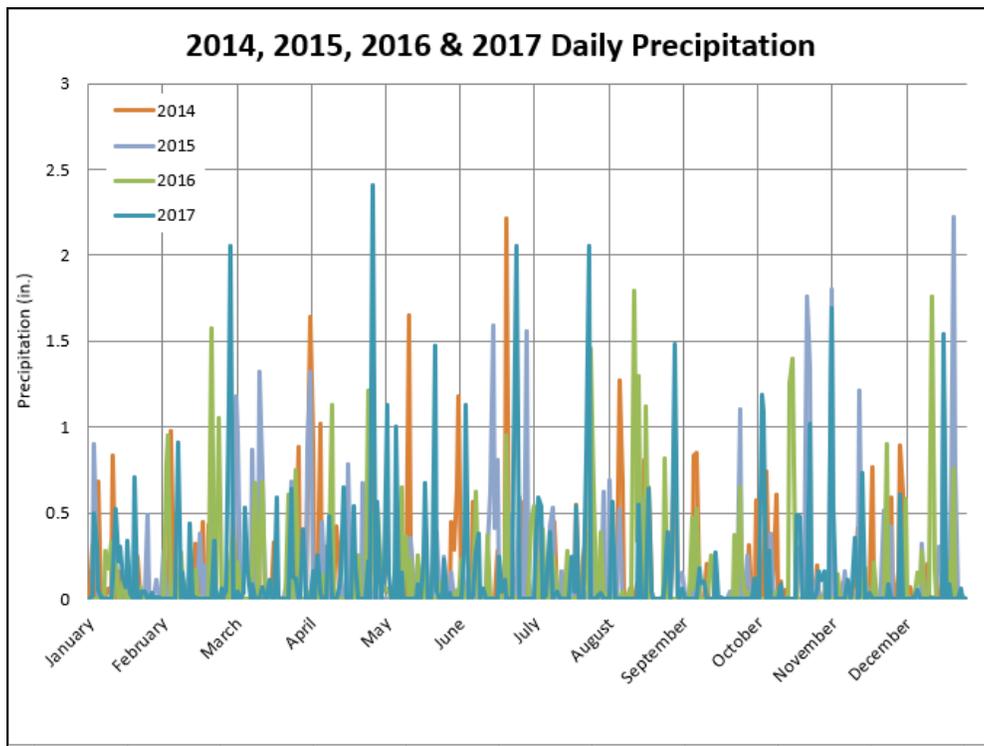
Figure 3.1 Daily Precipitation (2014 - 2017)

The daily precipitation statistics, provided on the following page in Figures 3.1 and 3.2, are also derived from daily rainfall totals maintained by the NWS rain gauge at CVG.

The cumulative depth of rainfall in 2017 at CVG was 49.88 inches, which is approximately 15 percent more than the total recorded at CVG in 2016. The number of rainfall events in 2017 were nearly identical to the 2016 total. While there were a few events recorded in 2016 that produced statistically more intense rainfalls than those recorded in 2017, on average the rainfall intensities throughout 2017 were larger than average 2016 intensities. The cumulative rainfall depth in 2017 of 49.88 inches is 22 percent higher than the typical year rainfall amount of 40.81 inches; while the average storm size of 0.45 inches per storm is slightly larger than the typical year average storm size of 0.40 inches per storm. The average storm event in 2016 was less than the typical year average. The annual totals and average storm size recorded in 2017 are the highest of the previous four years at CVG.

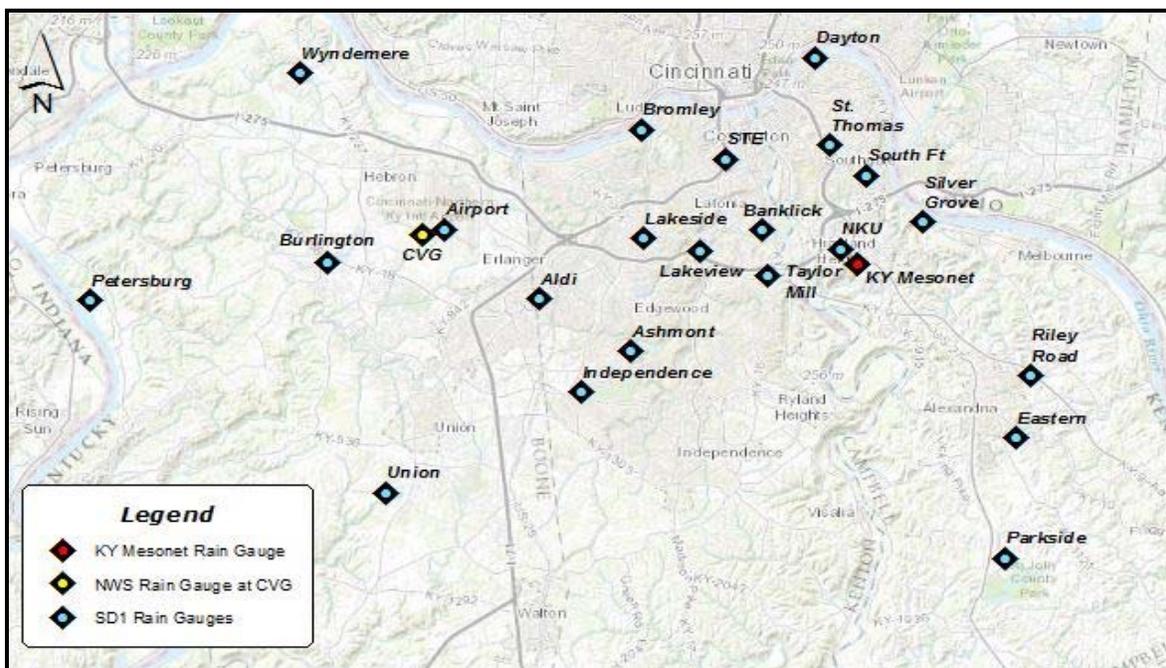
Figure 3.3 Rain Gauge Locations

In 2017, the Mesonet weather station in Highland Heights recorded a cumulative rainfall depth of 49.89 inches which is nearly identical to the CVG cumulative depth of 49.88 inches. Figure 3.3 provides further clarification on the locations of all SD1, NWS, and state-owned rain gauges that are used for modeling and reporting. Table 3.3 details the variations in the maximum return periods of 2017 for each SD1 rain gauge, as compared to maximum returns at CVG. While the CVG rain gauge did not match the maximum return periods across the SD1 service area in 2016, the same comparison in 2017 indicates that the CVG rain gauge recorded rainfall totals and maximum return periods comparable to the SD1 rain gauge network used for wet-weather modeling.

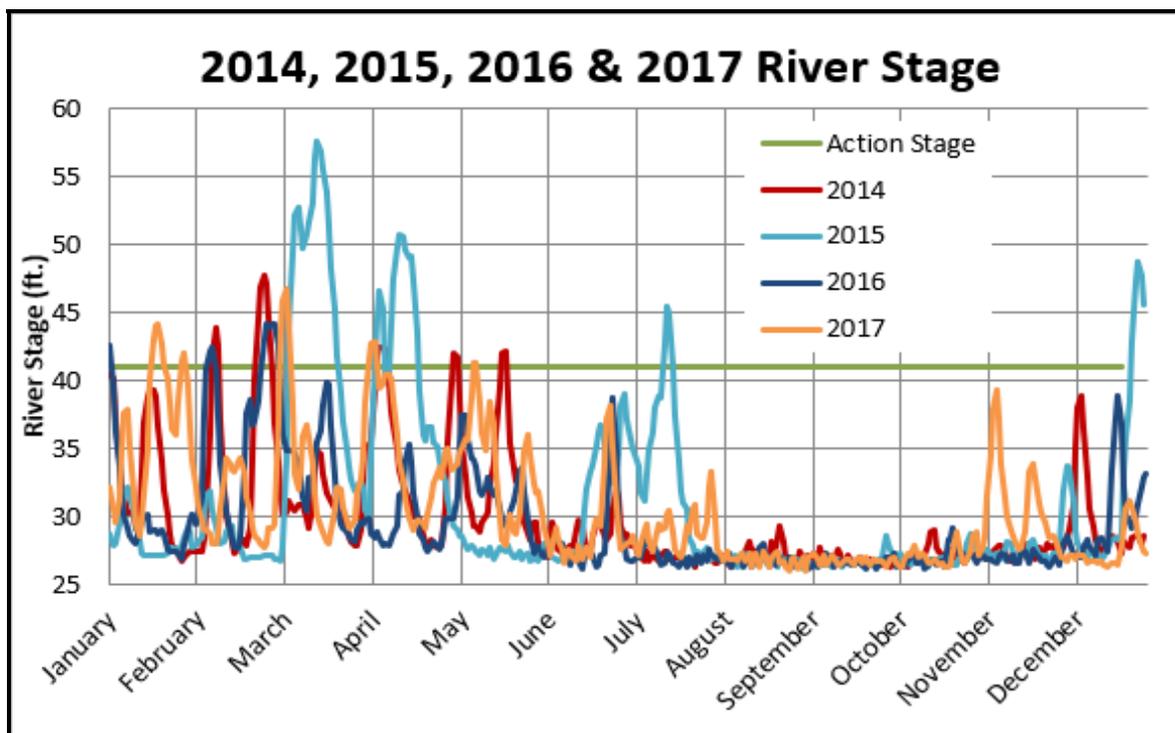
Figure 3.4 Daily River Stage (2014 - 2017)

SD1’s collections system is influenced in multiple ways by the local Ohio River stage level. In addition to increasing groundwater levels that cause infiltration to occur, SD1’s system is also impacted by flood control operations when the river stage is at or above 41 feet, as shown in Figure 3.4. When the Ohio River reaches the Army Corps of Engineers’ specified river stages during flood conditions, flood gates on the CSO outfalls are closed to isolate the sewer system from high river water. Other sewer system flood gates are opened or closed to isolate portions of the interceptor and combined sewers to re-route sewer flows to the flood pumping stations. The flood pumping stations and gates were designed by the Army Corps of Engineers to protect the river cities from flooding internally due to elevated river levels, or during rain events when the flows in the combined sewers cannot flow out into the river due to the elevated river levels. SD1 continues to work on eliminating river water intrusion through a program to install duckbill-style check valves on CSO outfalls, effective up to river levels of 47 feet.

In 2017, the Ohio River stage level of 41 feet was exceeded for 17 days. While 2017 high river occurrences increased over 2016, they were 9 days less than the 35-year average. The Ohio River stage exceedances above 41 feet occurred only in the first and second quarters of 2017. The maximum Ohio River stage level reached in 2017 was 46.9 feet. A review of high river occurrences over the past four years shows historic high river conditions in 2015 which had a significant influence on CSO volumes. Additional summary of the above information and how it relates to changes in wet-weather CSO frequency and volume is included in Section 3.4 of this report.
