Re: Consent Decree Case No. 2:05-cv-00199-WOB

# **Nine Minimum Controls 2010 Annual Compliance Report**

# **NINE MINIMUM CONTROLS 2010 ANNUAL COMPLIANCE REPORT**

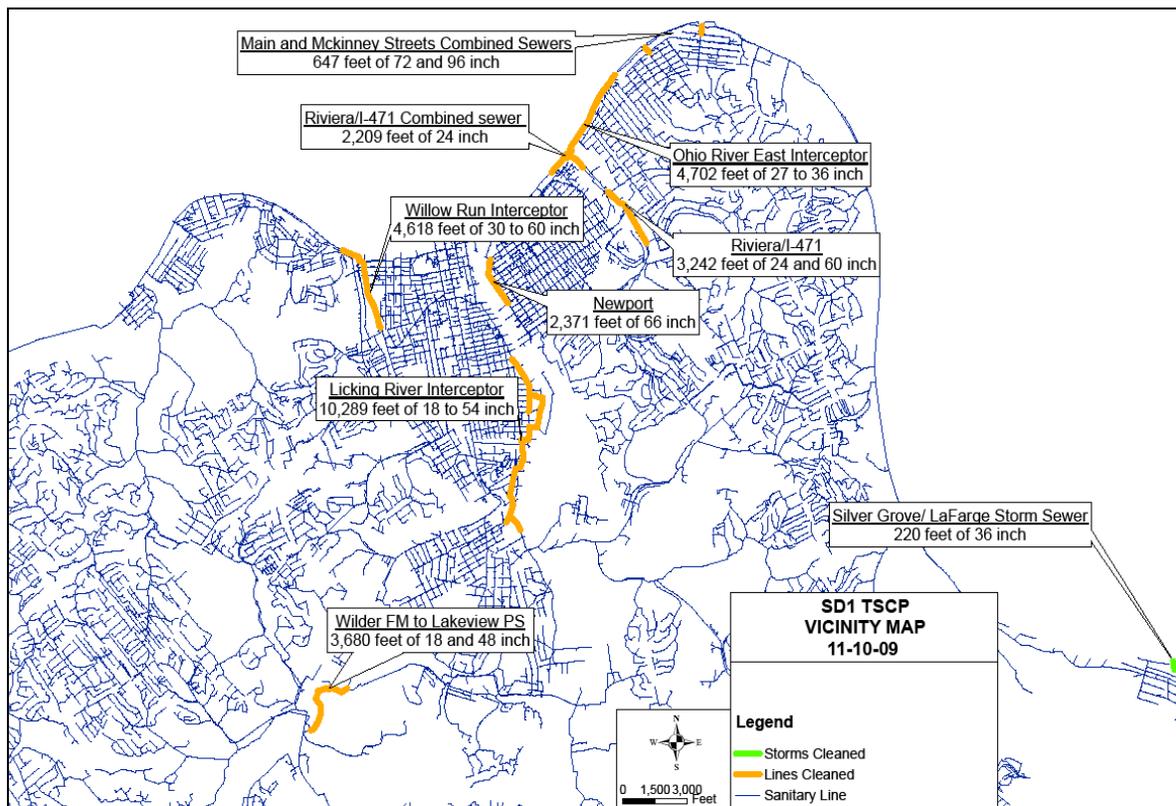
**Figure 2.1 Targeted Sewer Cleaning Program Vicinity Map**

Since July 2008, SD1 has contracted with Doetsch Industrial Services to clean and inspect approximately 30,450 feet of combined and interceptor sewers, as identified in Figure 2.1. As of November 2009, approximately 1,520 tons (3,040,000 pounds) of debris has been removed, which equates to an average of 100 pounds of debris per foot of pipe. This targeted interceptor cleaning is estimated to reduce typical year overflow volume by 20 million gallons. Flow monitors have been placed in strategic locations within the targeted sewers to assess the changes in capacity and its related effects on overflow volumes. Additional targeted sewer cleaning in the CSS is currently being identified and additional cleaning will be performed in the summer of 2010.

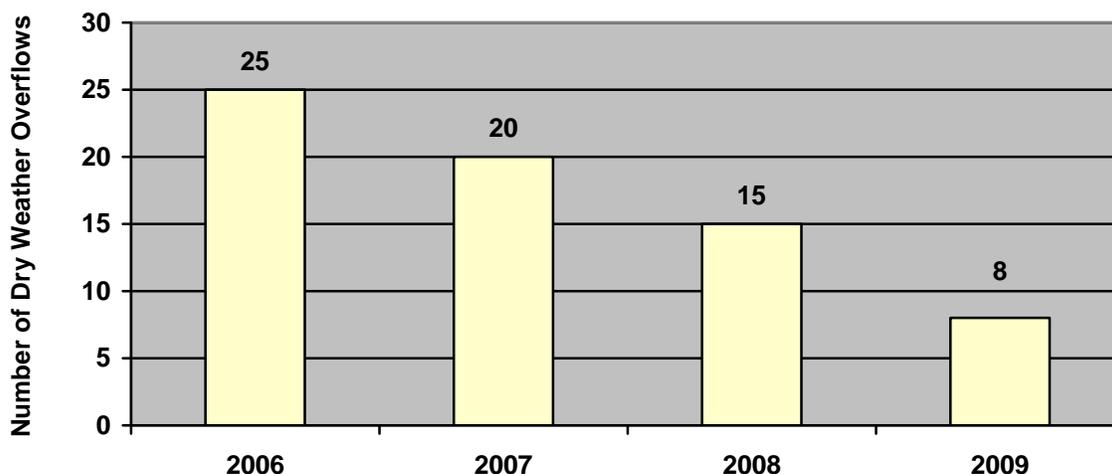
**Figure 2.2 Elimination of Dry Weather CSOs (2006 through 2009)**

SD1 has made significant progress with these efforts in eliminating dry weather CSOs during the last four years, as summarized in Figure 2.2.
